ORNL/RASA-88/51

**RESULTS OF THE RADIOLOGICAL SURVEY
AT THE NATIONAL COMMUNITY BANK, 113 ESSEX STREET,
MAYWOOD, NEW JERSEY (MJ021)**

Date Published - September 1989

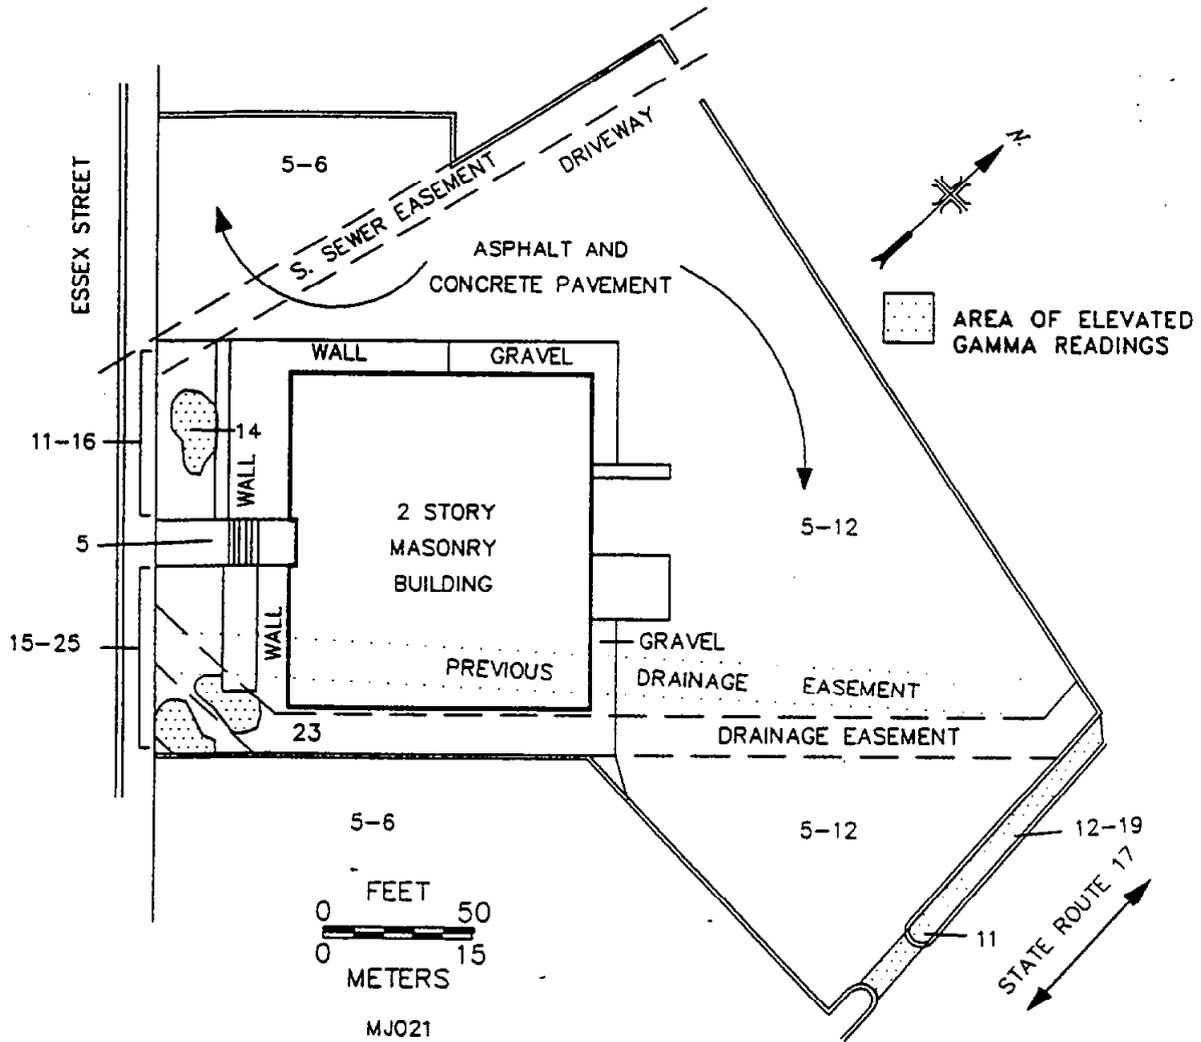
ORNL-DWG 89-10731

Before the bank was built in the mid-1960s, the contaminated Lodi Brook crossed the property in four 24-inch concrete pipes underground (Fig. 1). Presently, it crosses the bank property in a new concrete box culvert a few feet southeast of the original easement. From the original point of entry to the property at State Route 17, the new easement parallels the southeast wall of the building until it reaches the front lawn, where it angles back to the original easement and goes under Essex Street.

Gamma radiation levels measured during a gamma scan of the property surface are given in Fig. 1. Gamma exposure rates over the major portion of the property ranged from 5 to 12 μ R/h. The highest measurements ranged from 11 to 25 μ R/h and were found in front of the building on either side of the steps. Soil samples B1 and B2 were taken from this area. Elevated gamma levels were also evident along the eastern boundary of the

property, measuring from 11 to 19 $\mu\text{R/h}$. Soil samples B3 and B4 were taken in this area.

Fig. 1. Gamma radiation levels ($\mu\text{R/h}$) measured on the surface at the National Community Bank, 113 Essex Street, Maywood, New Jersey (MJ021).

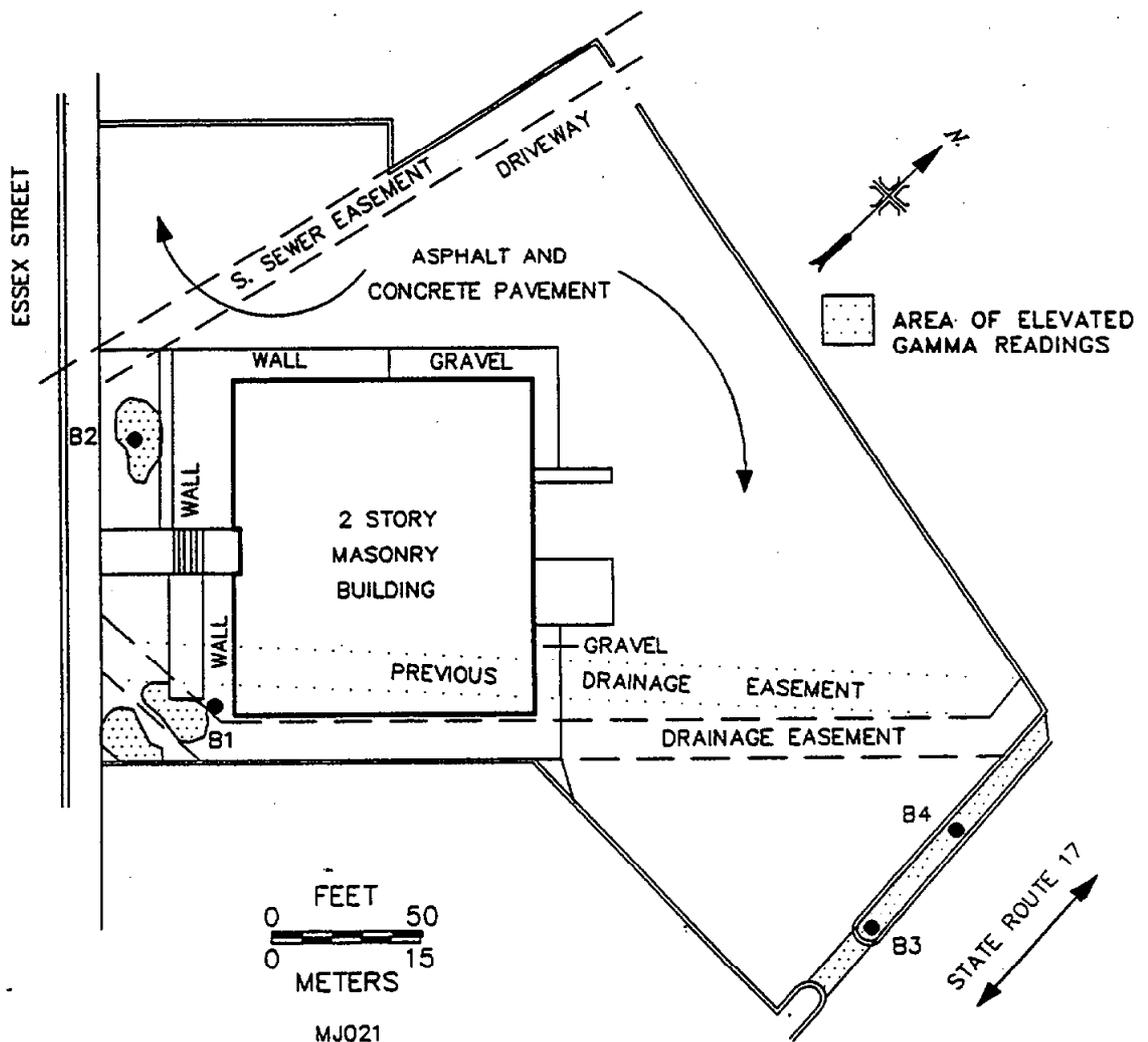
ORNL-DWG 89-10732

Biased soil samples were taken from various locations on the property for radionuclide analyses. Locations of these samples (B) are shown in Fig. 2, with results of laboratory analyses provided in Table 3. Concentrations of radium, thorium, and uranium in these samples ranged from 1.0 to 2.0 pCi/g, 1.5 to 8.5 pCi/g, and 0.98 to 3.1 pCi/g, respectively. All samples were near or above background levels for the northern New Jersey area (Table 2). Thorium levels in biased soil samples B1A and B2A were 8.5 pCi/g and 6.5 pCi/g, respectively; both of these concentrations were in excess of DOE criteria (Table 1).

Fig. 2. Diagram showing locations of soil samples taken at the National Community Bank, 113 Essex Street, Maywood, New Jersey (MJ021).

Sample ^a	Depth (cm)	Radionuclide concentration (pCi/g)		
		²²⁶ Ra ^b	²³² Th ^b	²³⁸ U ^c
Biased samples ^d				
B1A	0-15	2.0±0.2	8.5±0.8	3.1
B1B	15-30	1.8±0.1	6.5±0.6	2.1
B2A	0-15	1.7±0.06	6.5±0.7	2.9
B2B	15-30	1.5±0.09	4.4±0.1	1.9
B3A	0-15	1.4±0.06	1.5±0.2	0.98
B3B	15-30	1.3±0.1	1.6±0.2	1.2
B3C	30-45	1.1±0.05	2.0±0.2	1.1
B4A	0-15	1.3±0.05	4.9±0.3	2.2
B4B	15-30	1.3±0.04	2.9±0.2	1.3
B4C	30-45	1.0±0.09	2.3±0.4	1.2

Measurements and results of soil sample analyses taken at the National Community Bank indicate that the property contained radioactive contamination primarily from the ^{232}Th decay chain, with slight contamination from both ^{226}Ra and ^{238}U . These radionuclide distributions are typical of the type of material originating from the processing operations at the MCW site. The concentration and extent of ^{232}Th on this property is in excess of the applicable DOE criteria (Table 1). This material was found at sample locations B1 and B2, as shown in Fig. 2. Based on the results of this radiological assessment, it is recommended that this site be considered for inclusion in the DOE remedial action program.

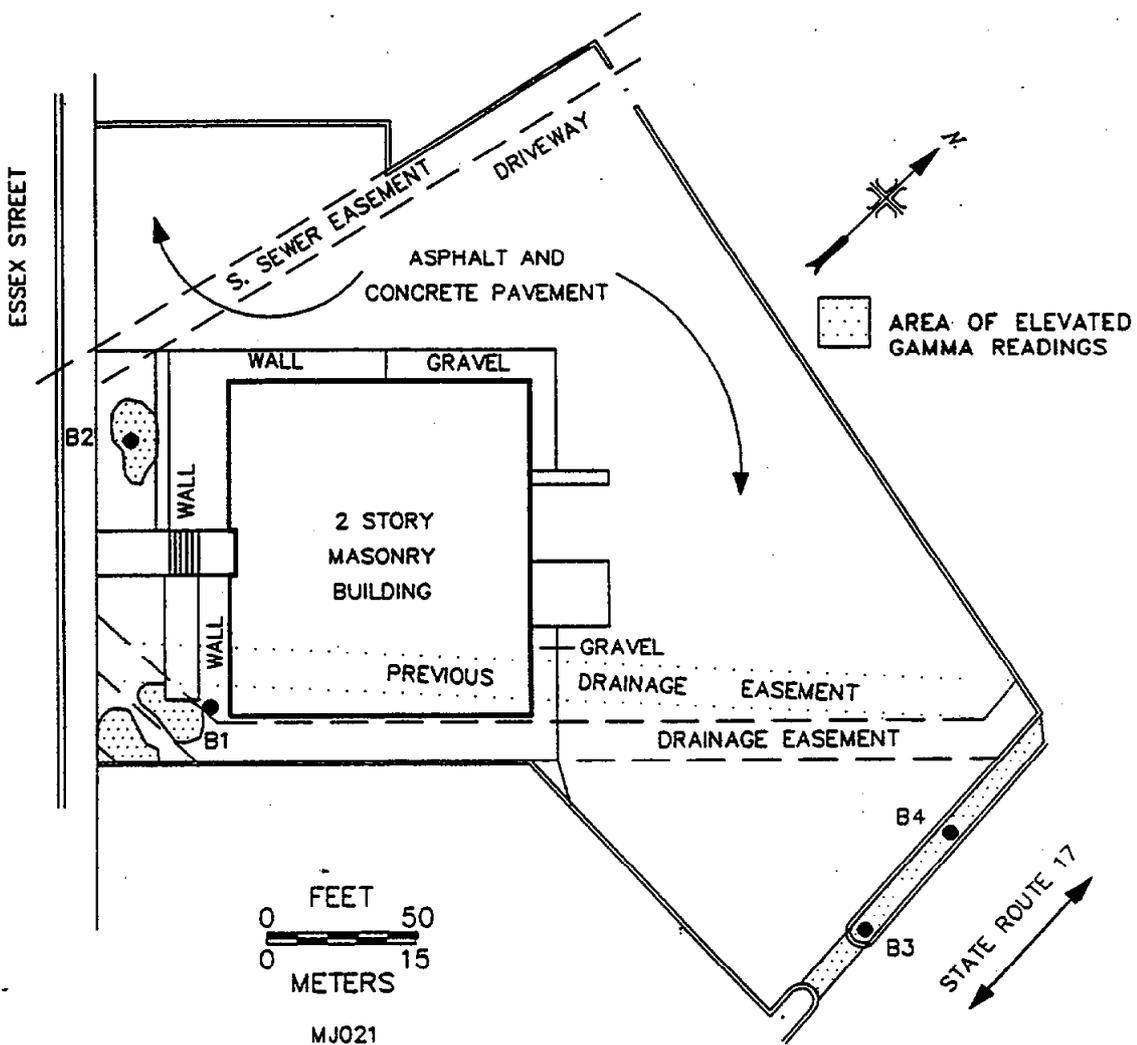
ORNL-DWG 89-10732

Fig. 2. Diagram showing locations of soil samples taken at the National Community Bank, 113 Essex Street, Maywood, New Jersey (MJ021).
