# RADIOLOGICAL CHARACTERIZATION REPORT FOR THE RESIDENTIAL PROPERTY AT 20 LONG VALLEY ROAD

## Lodi, New Jersey

November 1988

Bechtel National, Inc.

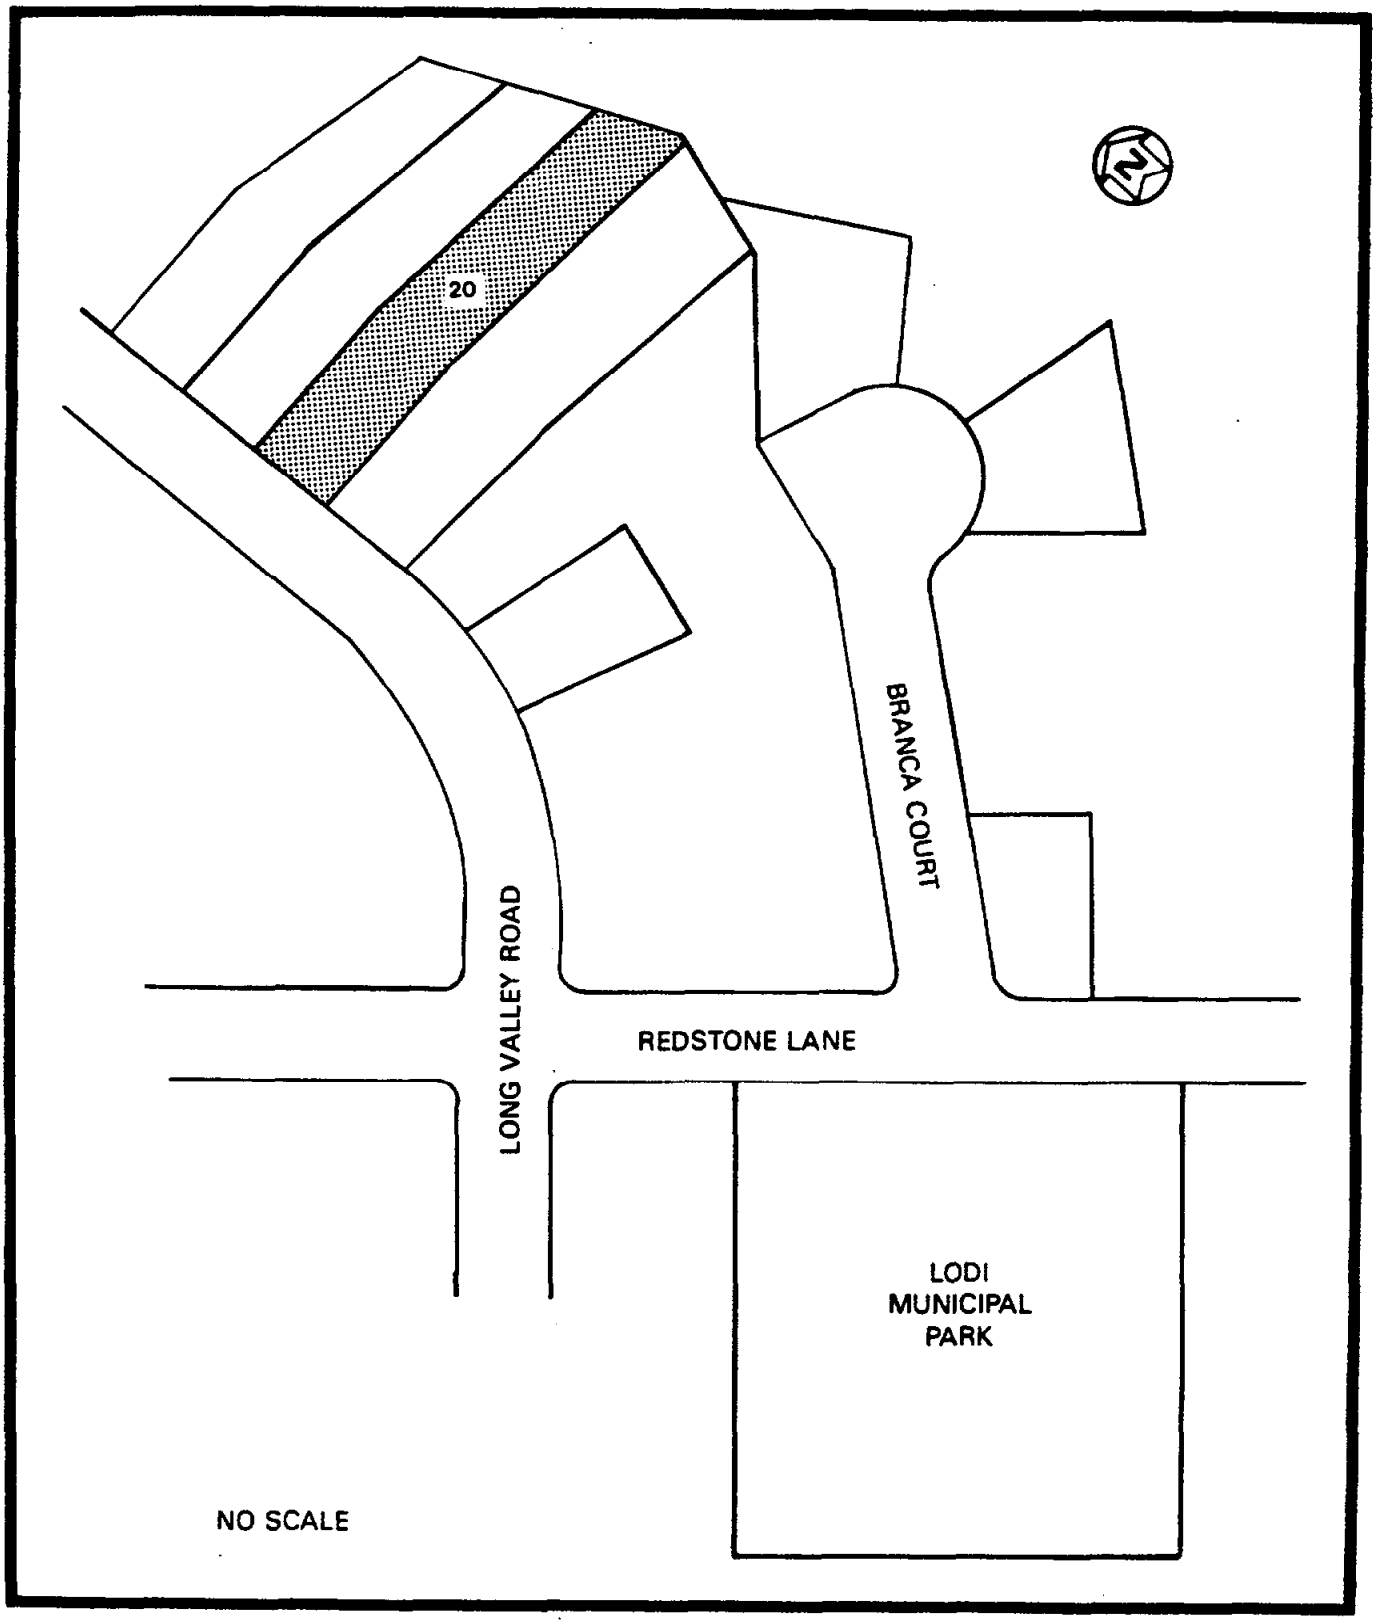
FIGURE 1-2 LOCATION OF 20 LONG VALLEY ROAD

Soil analysis data for this property showed surface contamination. Subsurface investigation by gamma logging indicated contamination to a depth of 1.5 ft.

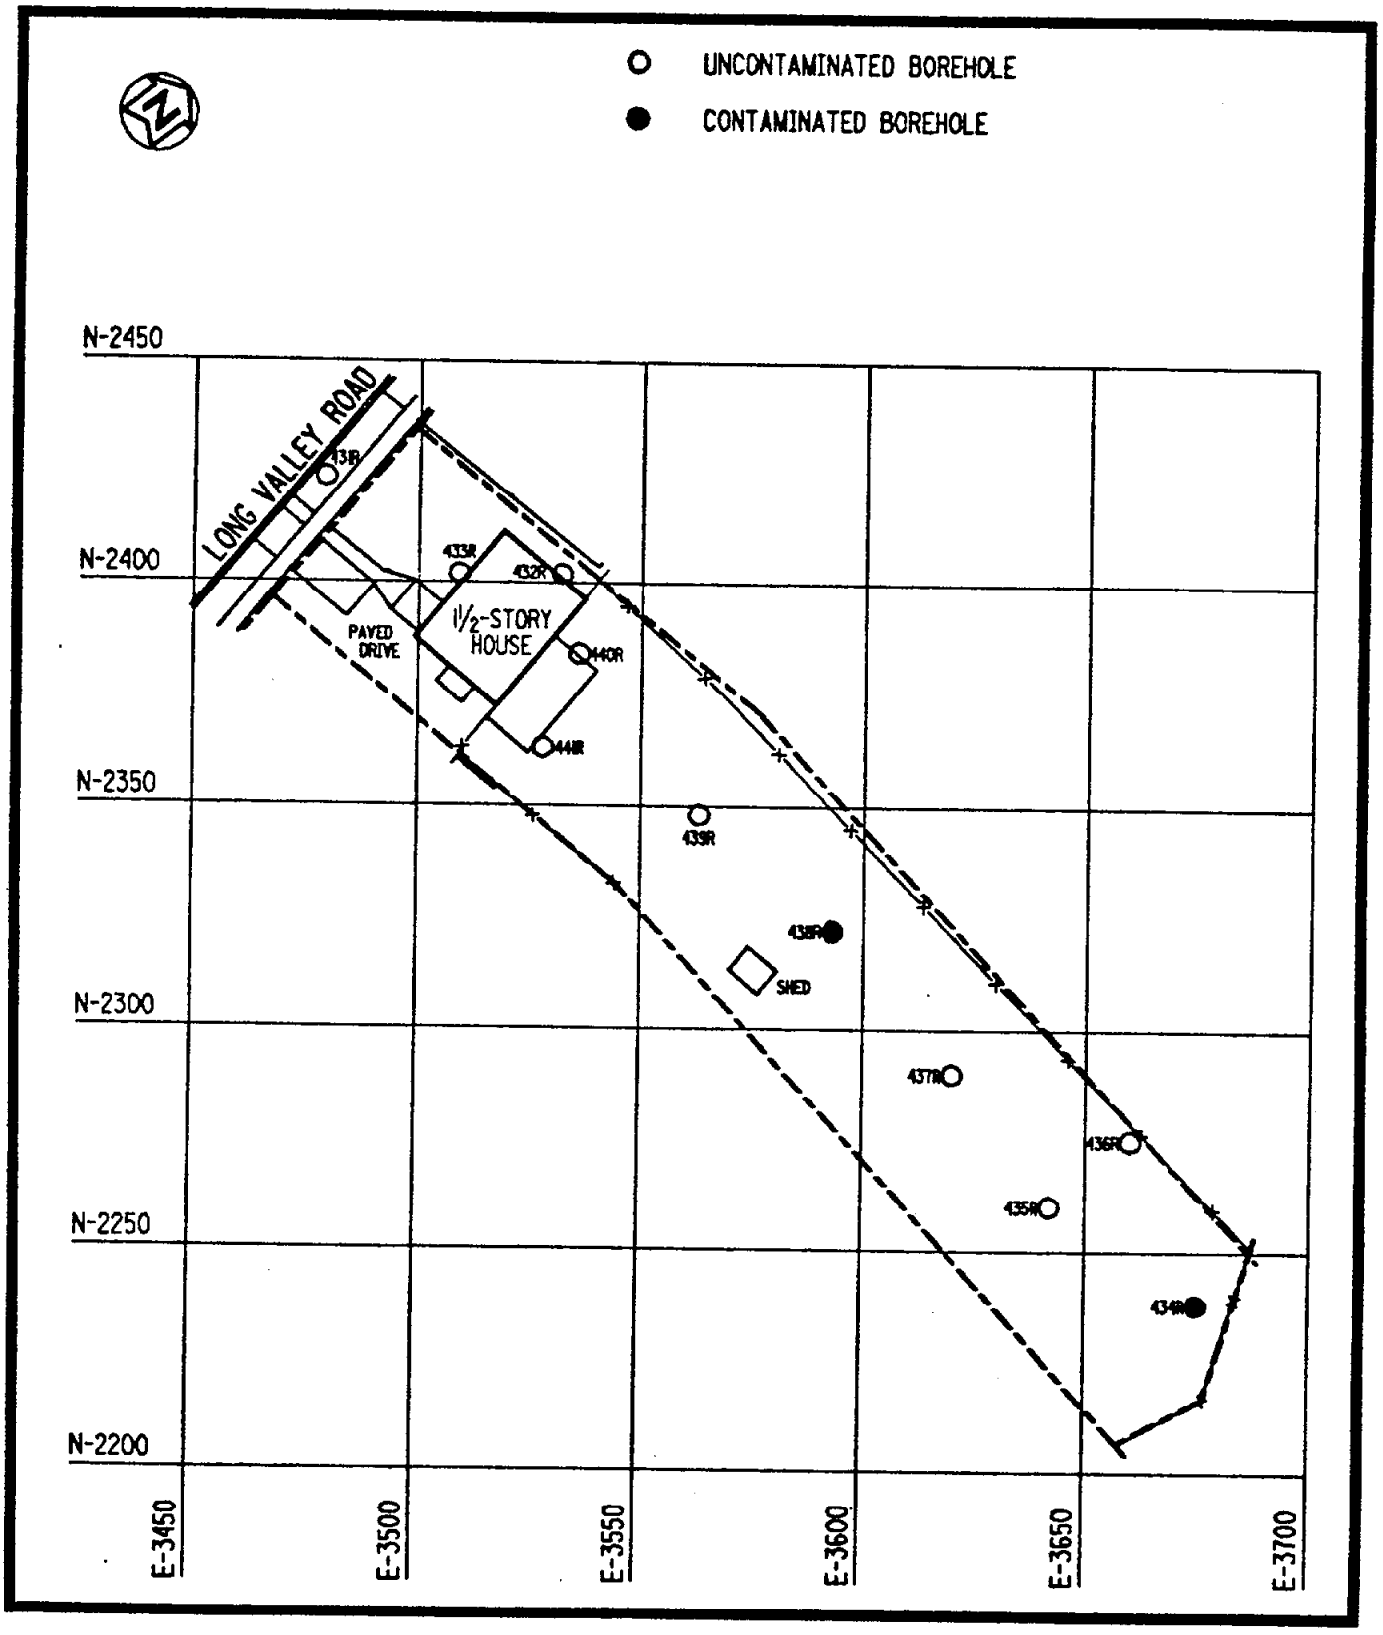
FIGURE 4-1 BOREHOLE LOCATIONS AT 20 LONG VALLEY ROAD

locate subsurface contamination where there is no surface manifestation. The subsurface characterization consisted of drilling and gamma logging 11 boreholes (Figure 4-1) using either a 3-in.- or 6-in.-diameter auger bit; holes were drilled to depths determined in the field by the radiological and geological support representatives.

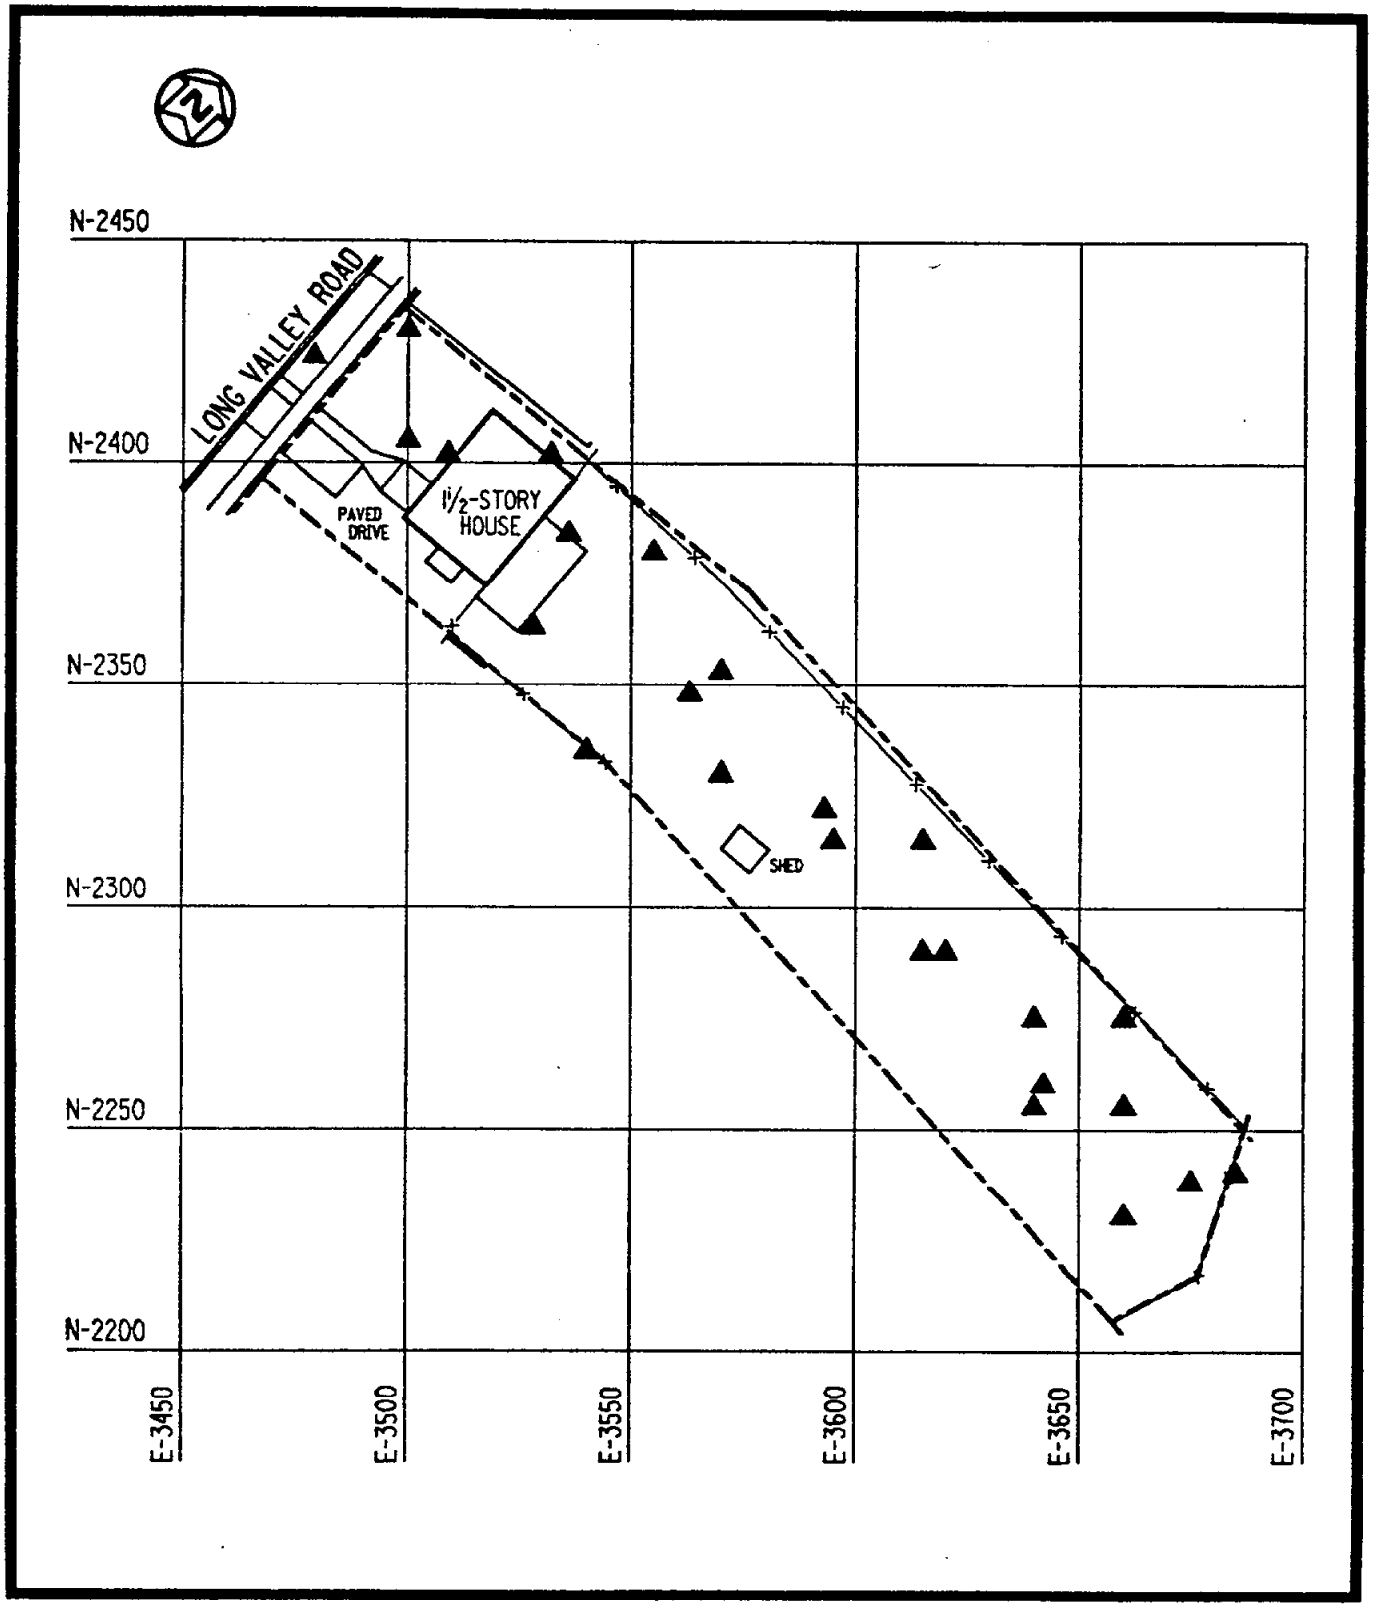
FIGURE 4-2 SURFACE AND SUBSURFACE SOIL SAMPLING LOCATIONS AT 20 LONG VALLEY ROAD

Subsurface soil samples were collected from 25 locations (Figure 4-2) using the side wall sampling method and were analyzed to compare laboratory soil sample results to downhole gamma radiation measurements. A cup or can attached to a steel pipe or wooden stake was inserted into the borehole and used to scrape samples off the side of the borehole at a specified depth. The subsurface soil samples were analyzed for radium-226, thorium-232, and uranium-238 in the same manner as the surface soil samples.

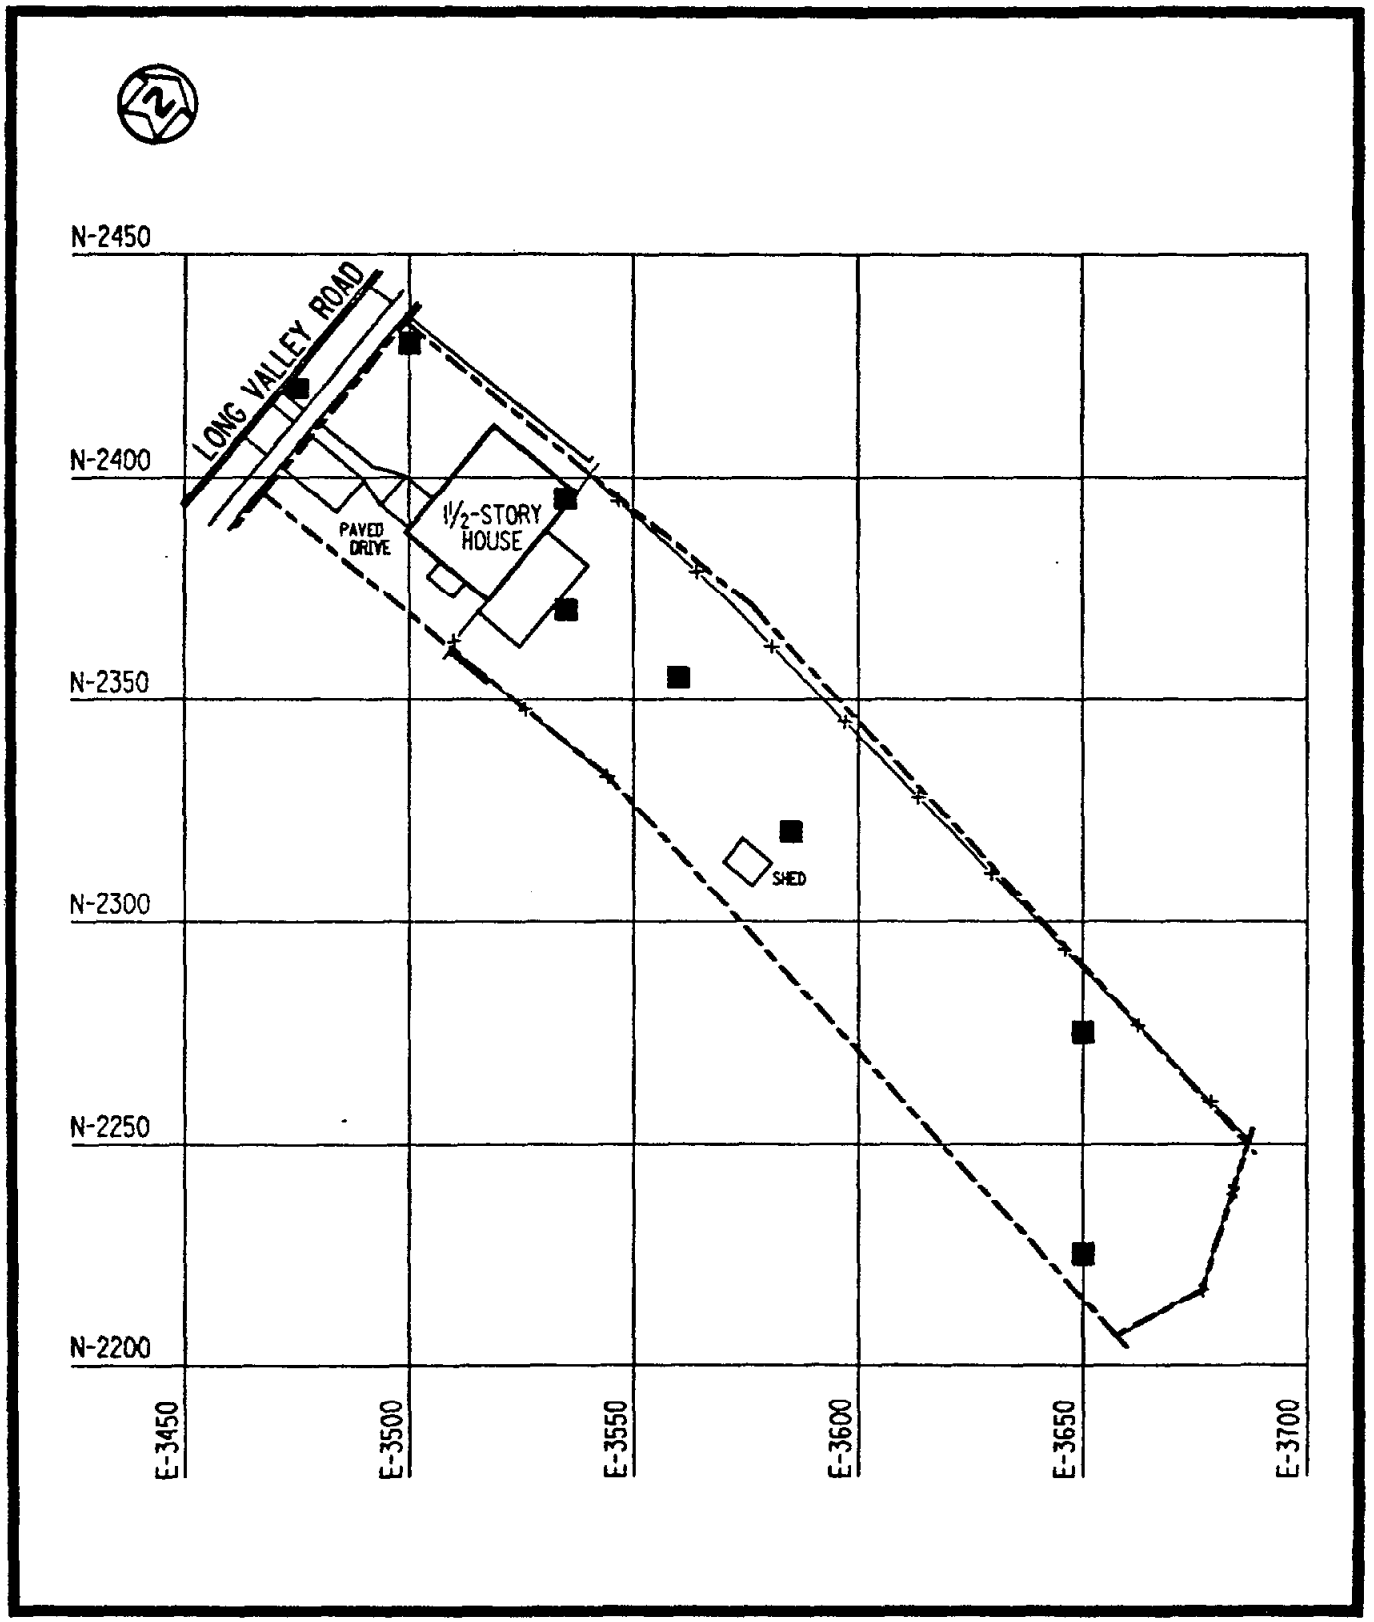
FIGURE 4-3 EXPOSURE RATE MEASUREMENT LOCATIONS AT 20 LONG VALLEY ROAD

Exterior gamma radiation exposure rate measurements ranged from 6 to 27 μR/h, including background. The indoor exposure rate measurement was 6 μR/h, including background. Two of the nine exterior measurements exceed the DOE guideline of 100 mrem/yr for public exposure. This is based on the assumption of 16 hours occupancy per day for 365 days per year (5,840 hours) and subtracting average background of 9 μR/h (Ref. 12). These results can be found in Table 5-3.

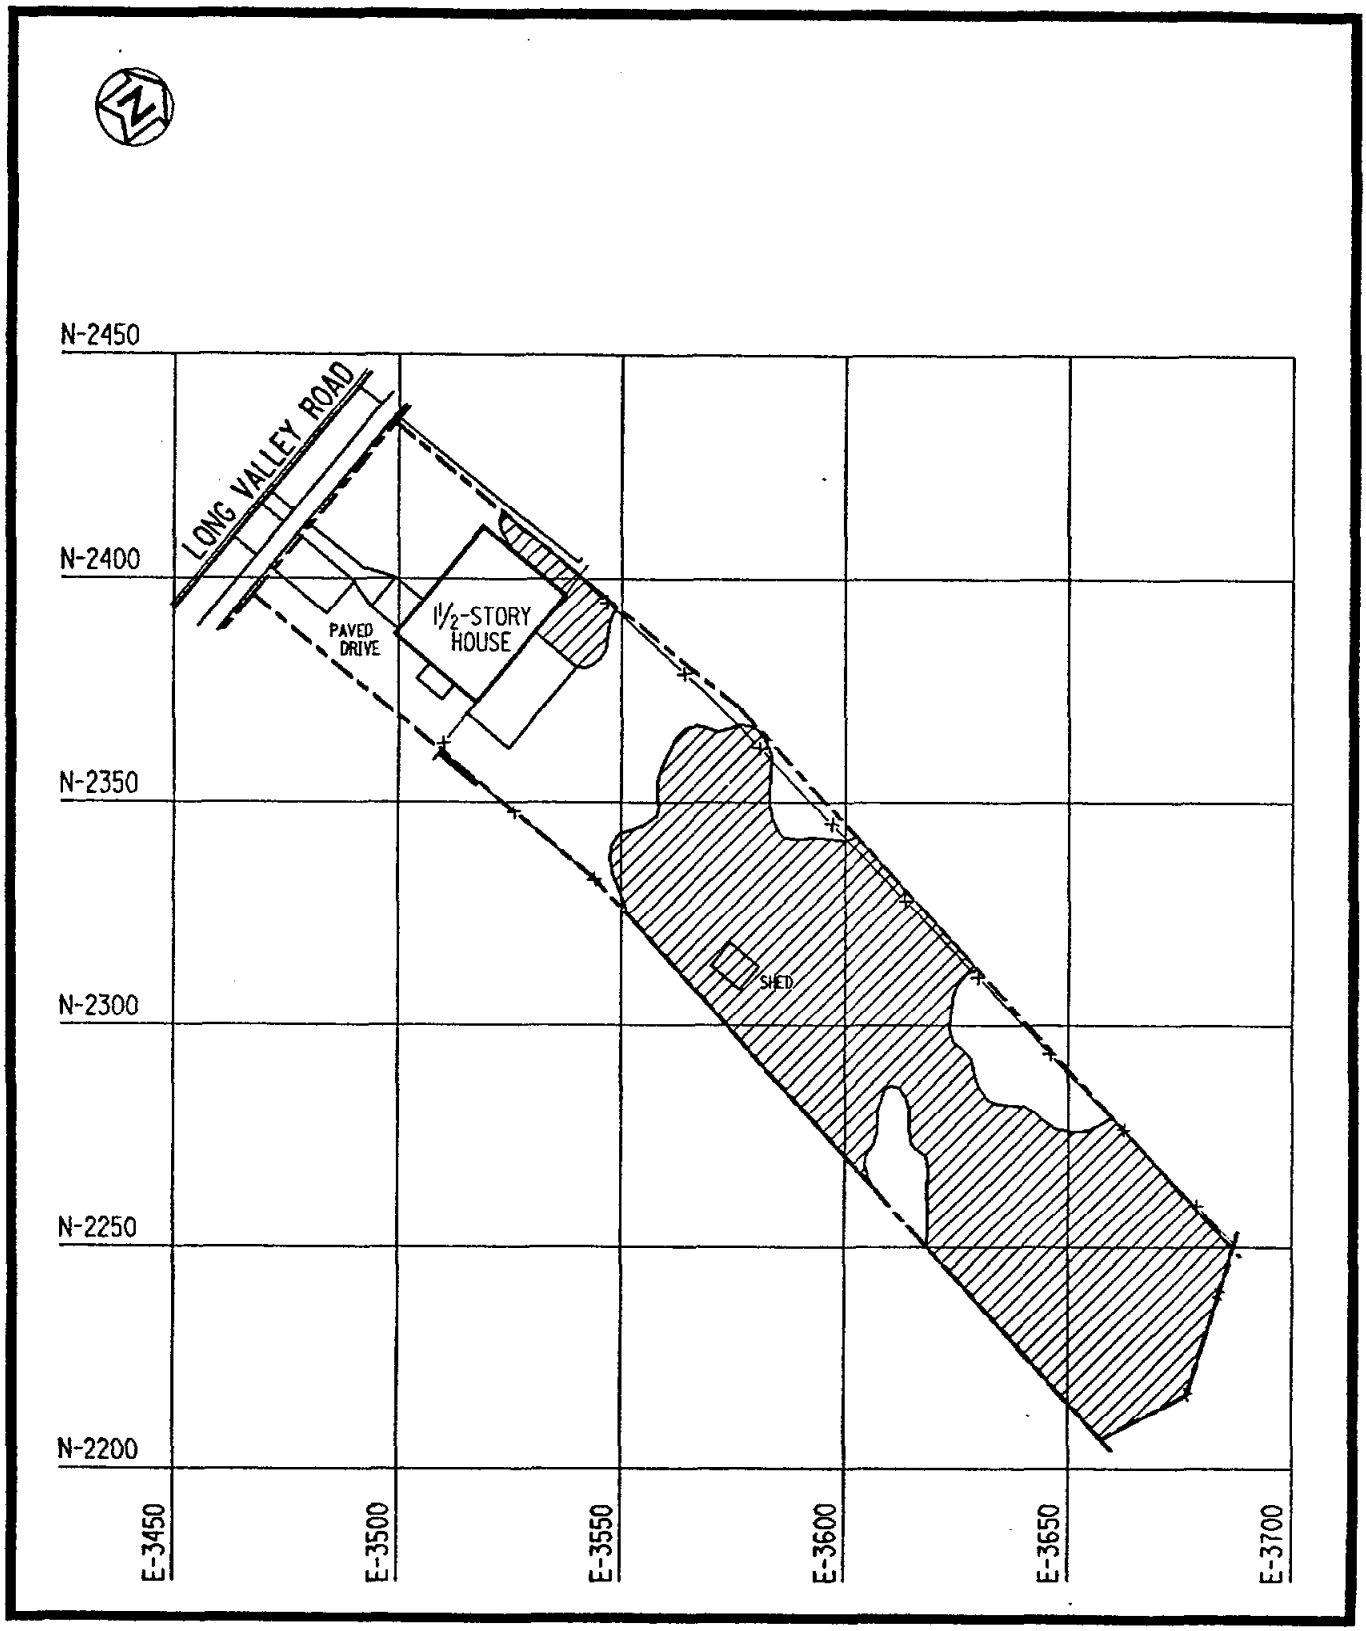
FIGURE 5-1 AREAS OF SURFACE CONTAMINATION AT 20 LONG VALLEY ROAD

This characterization confirmed that thorium-232 is the primary radioactive contaminant at this property. Results of surface soil samples for 20 Long Valley Road showed maximum concentrations of thorium-232 and radium-226 to be 36.8 and 4.5 pCi/g, respectively. The maximum concentration of uranium-238 was 26.7 pCi/g. Subsurface soil sample concentrations ranged from 1.2 to 55.1 pCi/g for thorium-232, from 0.6 to 2.7 pCi/g for radium-226, and from 9.3 to less than 33.1 pCi/g for uranium-238. The average background level in this area for both radium-226 and thorium-232 is 1.0 pCi/g.
