RADIOLOGICAL CHARACTERIZATION REPORT FOR THE RESIDENTIAL PROPERTY AT 6 HANCOCK STREET

Lodi, New Jersey

September 1989

Bechtel National, Inc.

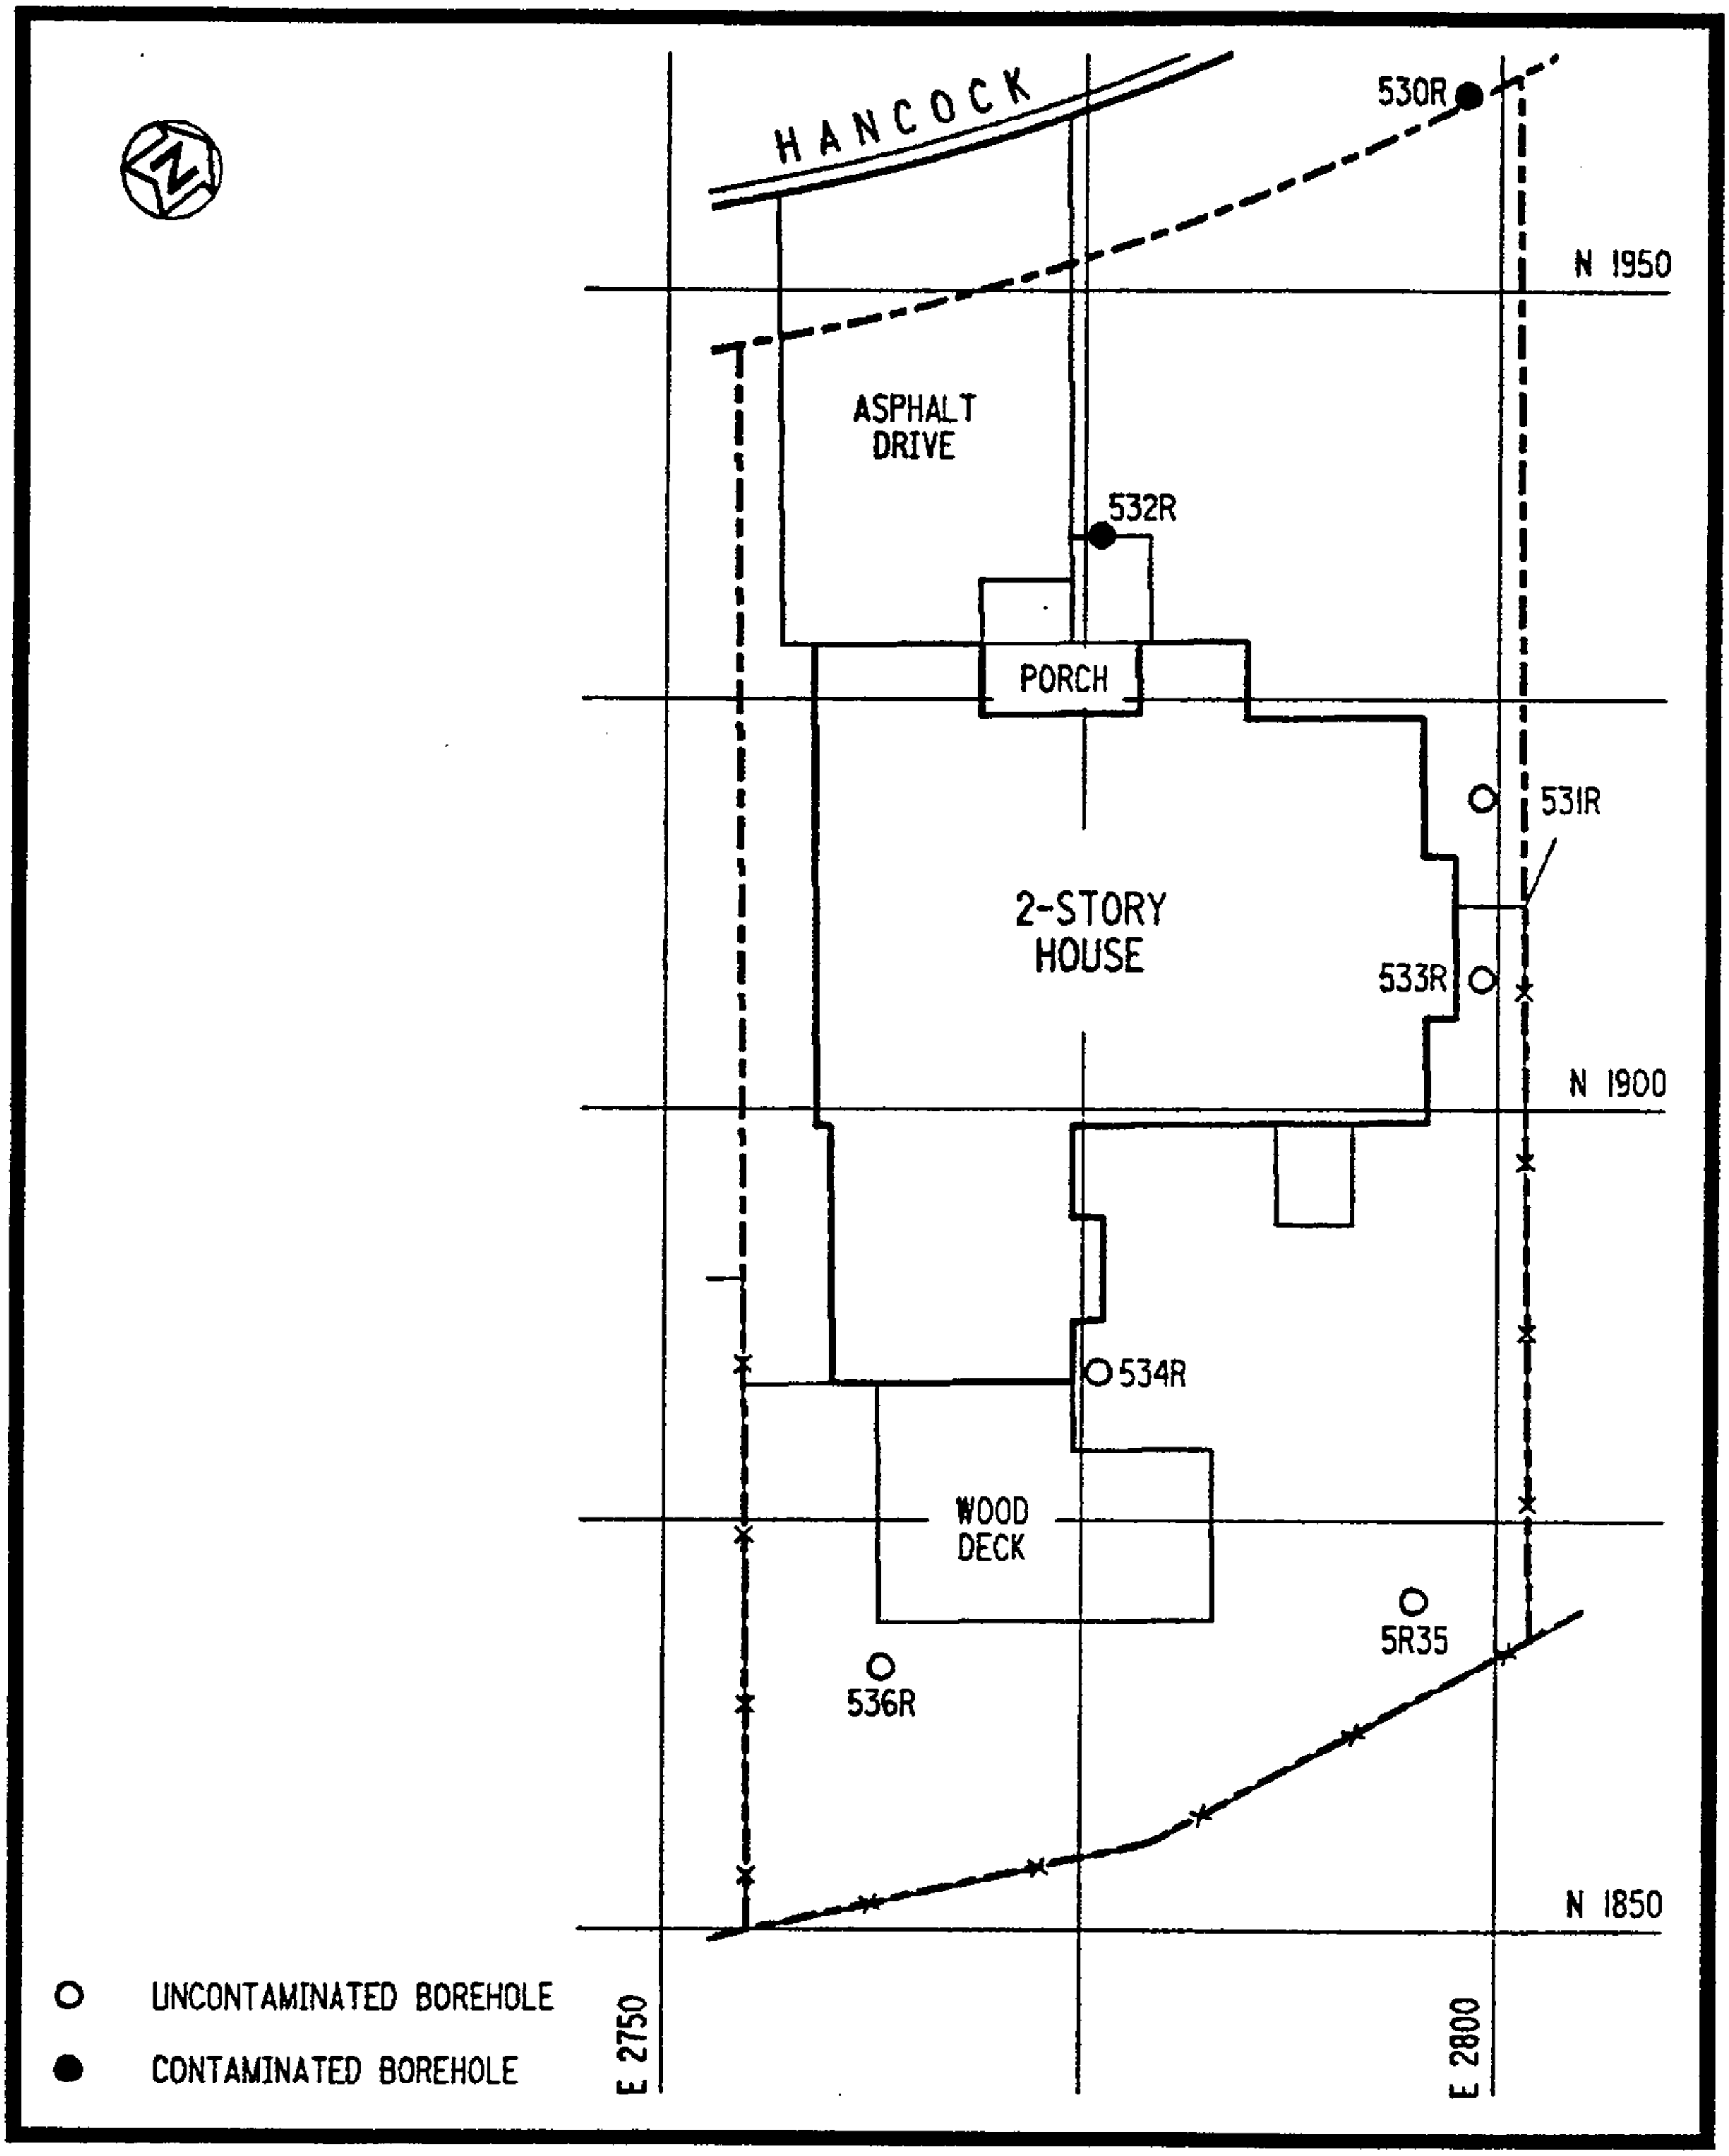
FIGURE 4-1 BOREHOLE LOCATIONS AT 6 HANCOCK STREET

A subsurface investigation was conducted to determine the depth to which the previously identified surface contamination extended and to locate subsurface contamination where there was no surface manifestation. The subsurface characterization consisted of drilling seven boreholes (Figure 4-1) [using either a 7.6-cm- (3-in.-) or 15.2-cm- (6-in.-) diameter auger bit], and gamma logging them. The boreholes were drilled to depths determined in the field by the radiological and geological support representatives.

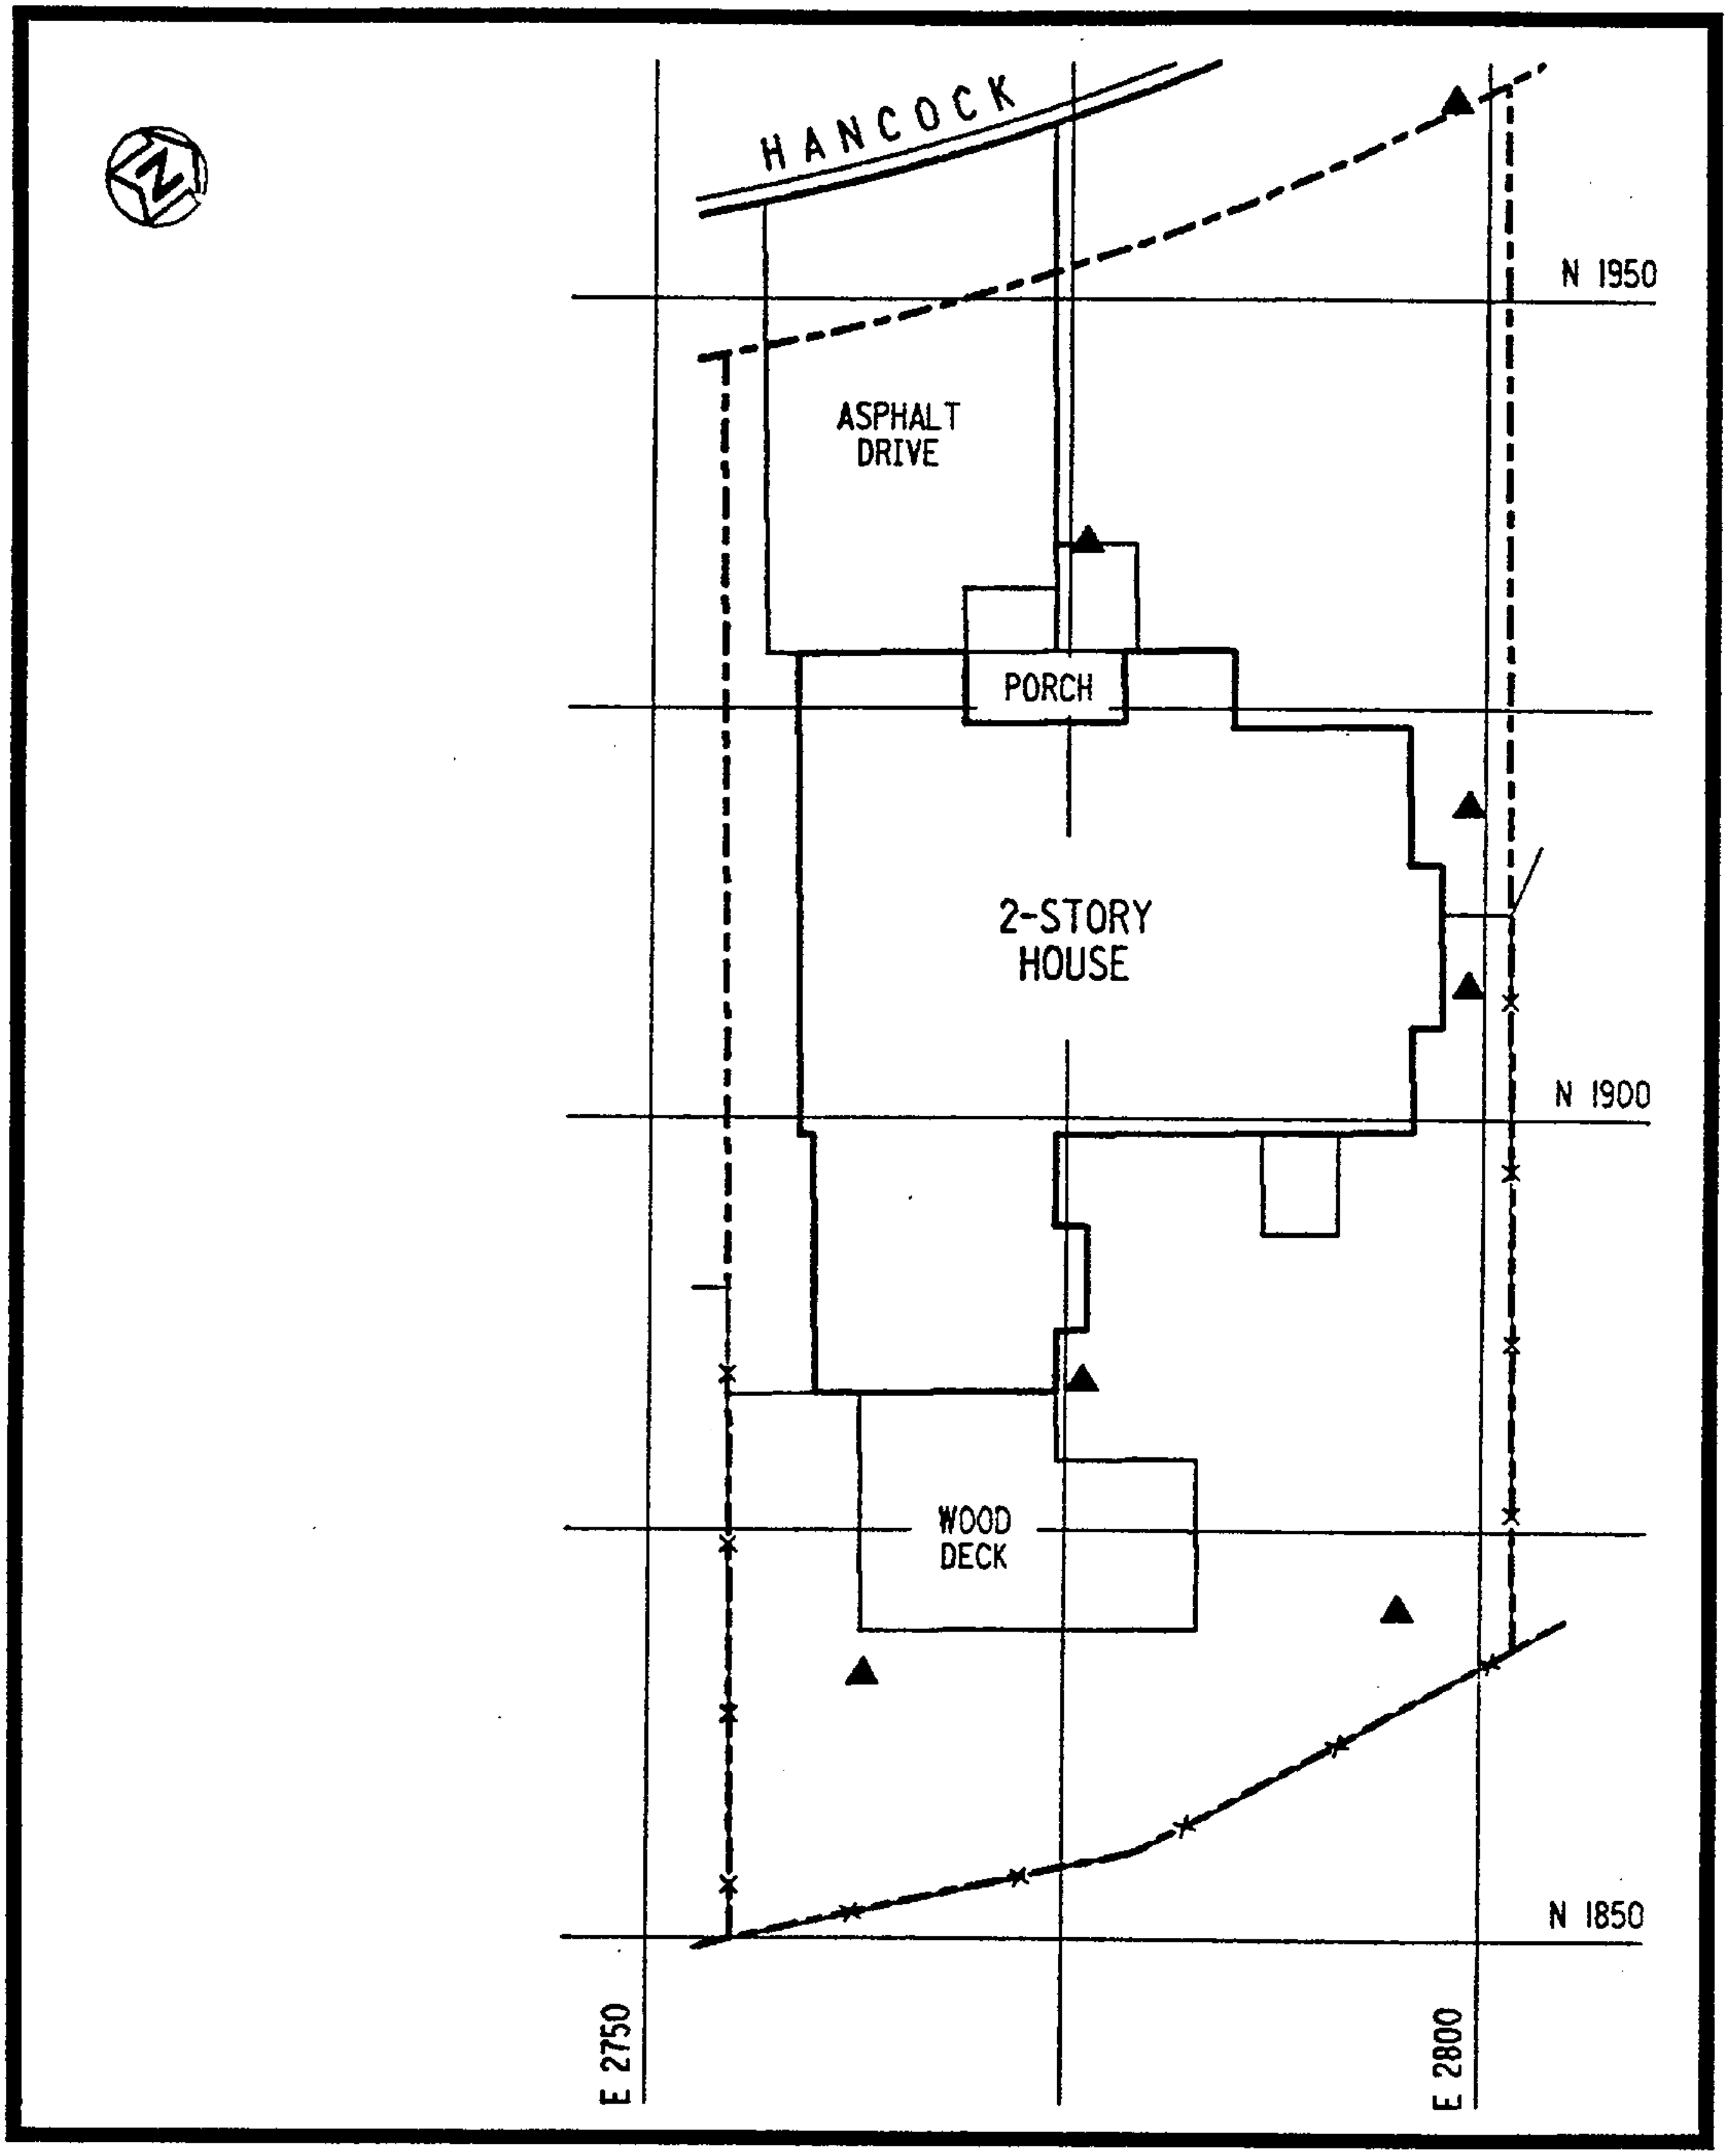
FIGURE 4-2 SURFACE AND SUBSURFACE SOIL SAMPLING LOCATIONS AT 6 HANCOCK STREET

Surface soil samples [depths from 0.0 to 15.2 cm (0.5 in.)] were taken at seven locations on the property and one location in the street immediately adjacent to the property (Figure 4-2). These samples were analyzed for thorium-232, uranium-238, and radium-226. The concentrations in these samples ranged from less than 6.7 to less than 11.1 pCi/g for uranium-238, from 1.5 to 22.5 pCi/g for thorium-232, and from less than 0.9 to 11.8 pCi/g for radium-226. Analytical results for surface soils are provided in Table 5-1; these data showed concentrations of thorium-232 in excess of DOE guidelines (5 pCi/g plus background of 1 pCi/g for surface soils) with a maximum concentration of 22.5 pCi/g. In addition, one surface soil sample showed concentrations of radium-226 in excess of DOE guidelines (5 pCi/g plus background of 1 pCi/g for surface soils) with a maximum

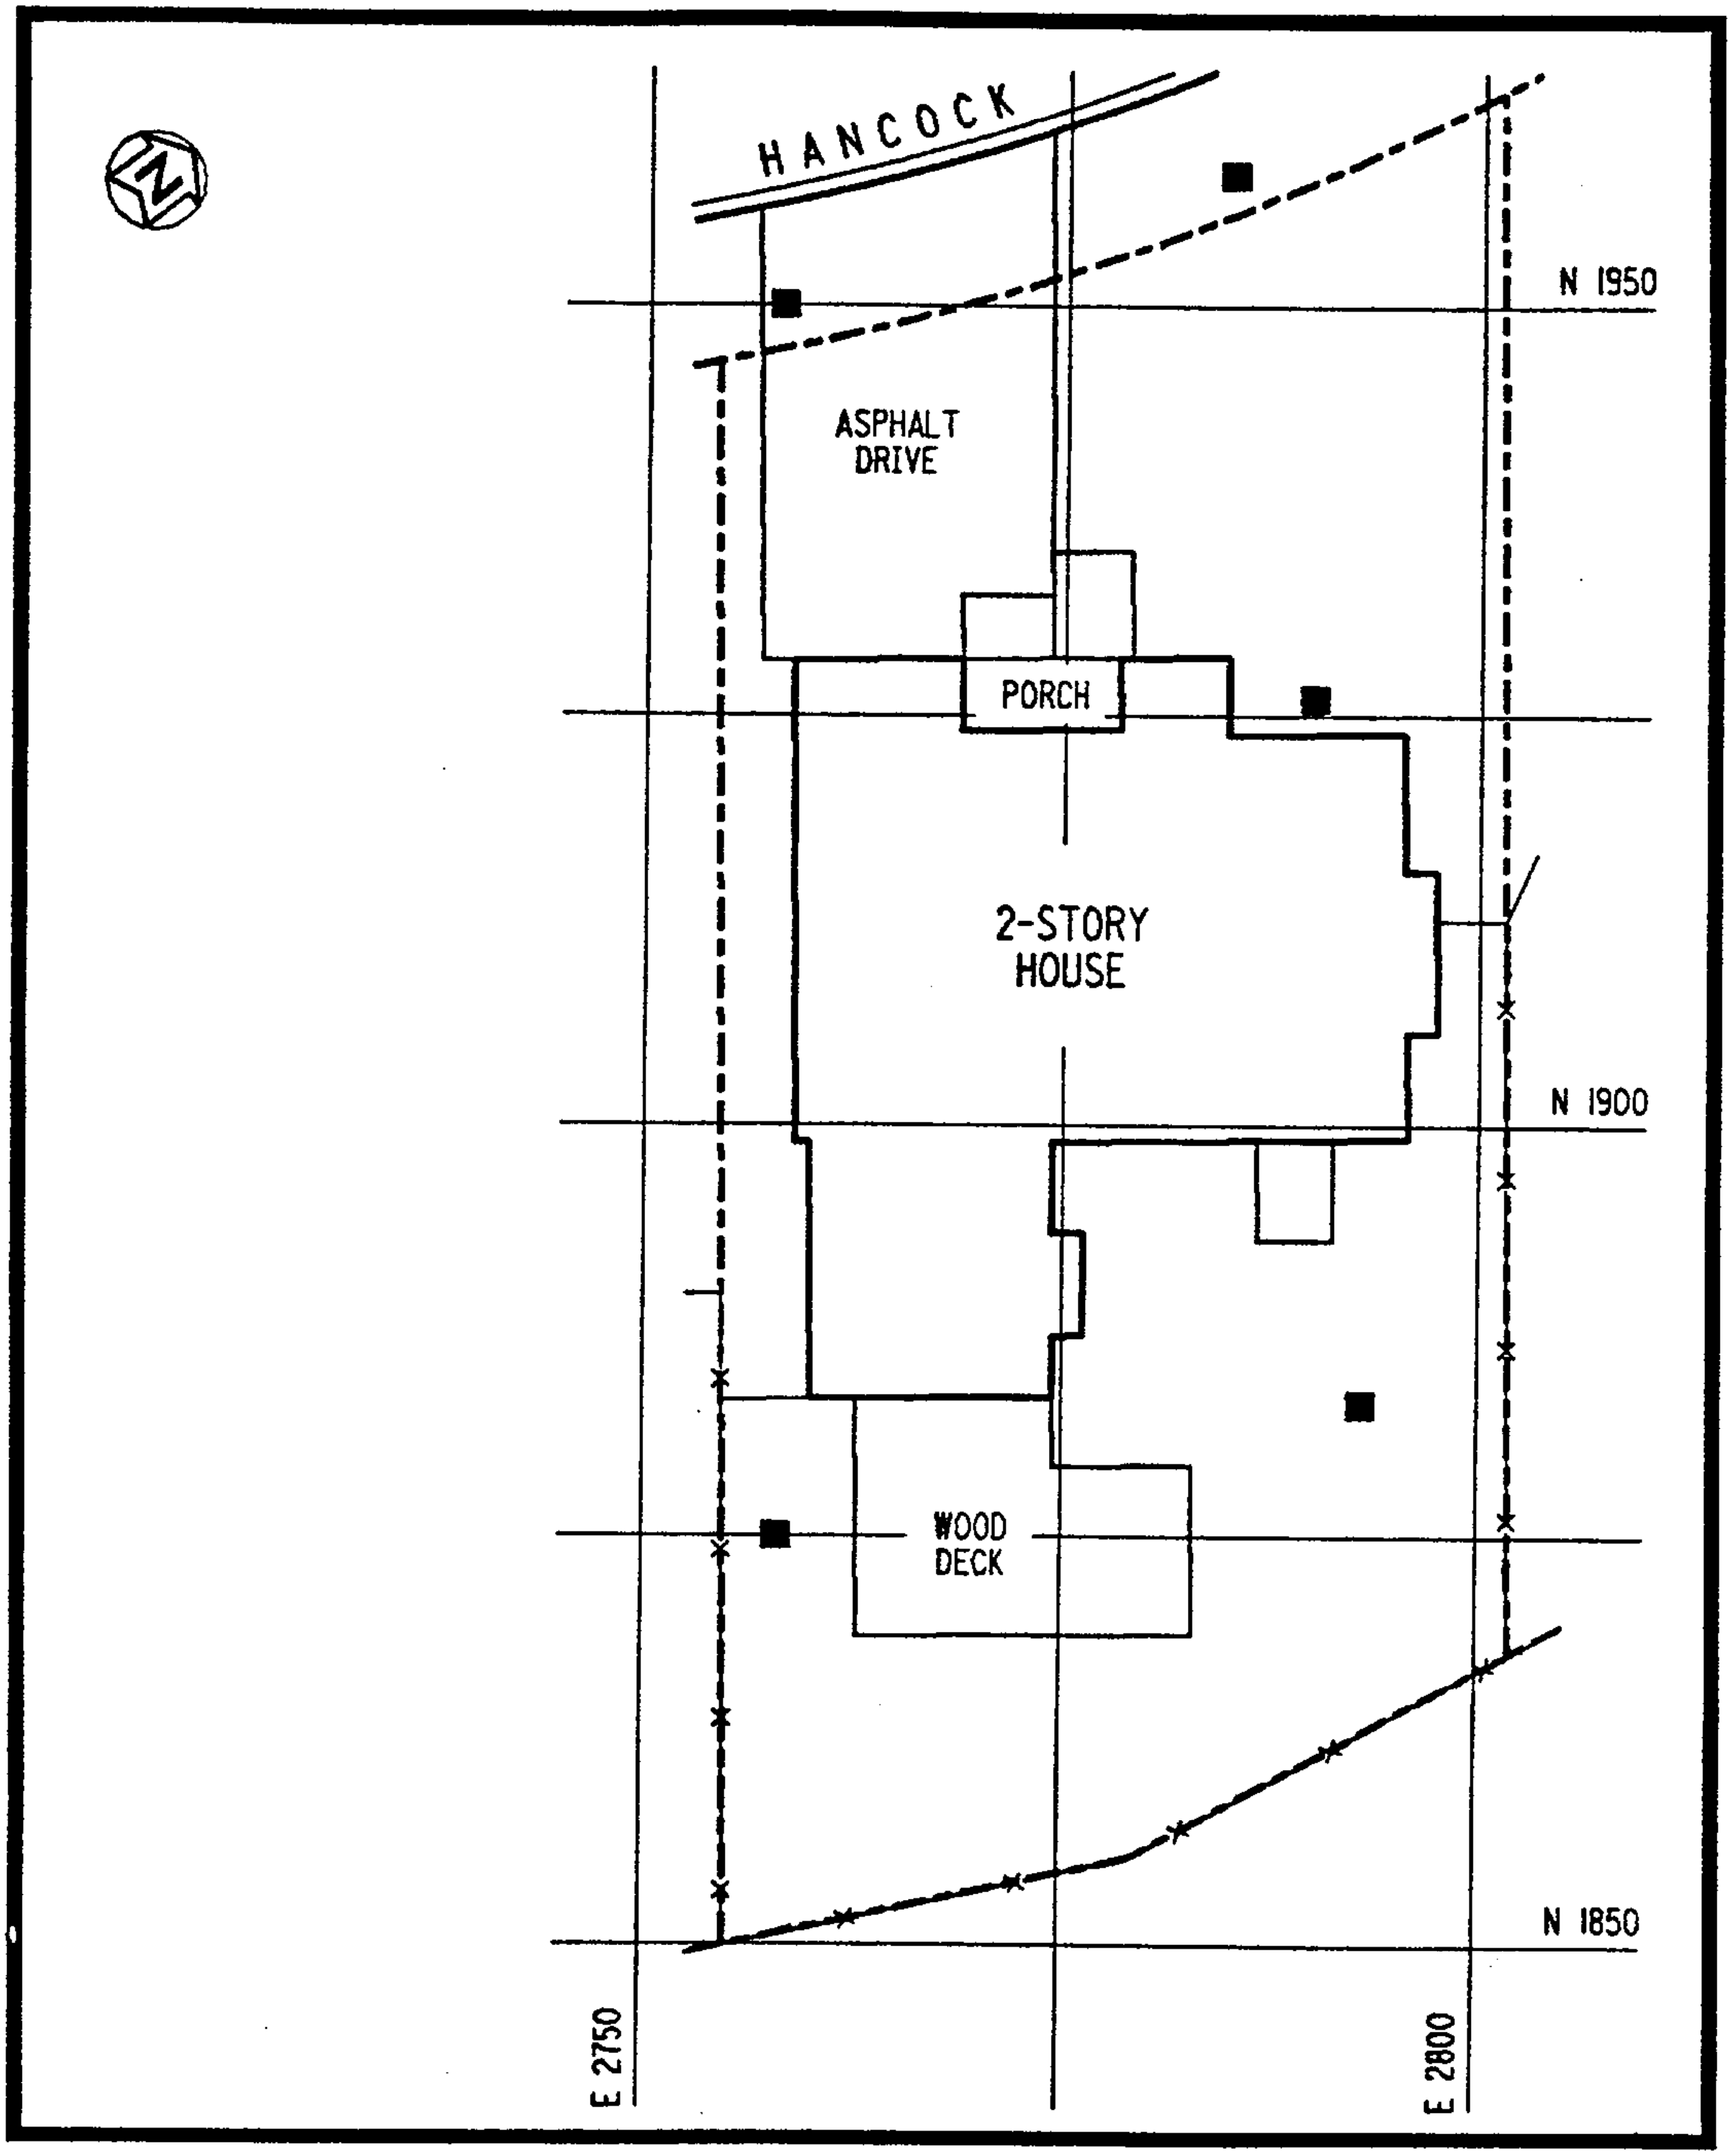
FIGURE 4-3 GAMMA EXPOSURE RATE MEASUREMENT LOCATIONS AT 6 HANCOCK STREET

Exterior gamma exposure rate measurements were made at five locations throughout the property grid system and at one location inside the residence. To obtain these measurements, either a 5.0- by 5.0-cm (2- by 2-in.) thallium-activated sodium iodide gamma scintillation detector designed to detect gamma radiation only or a pressurized ionization chamber (PIC) was used. Measurement locations are shown in Figure 4-3. The PIC instrument has a response to gamma radiation that is proportional to exposure in roentgens. A conversion factor for gamma scintillation to the PIC was established through a correlation of these two measurements at four locations in the vicinity of the property. The unshielded gamma scintillation detector readings were then used to estimate gamma exposure rates for each location. These measurements were taken 1 m (3 ft) above the ground. The locations were determined to be representative of the entire property. Interior measurements are generally obtained with the gamma scintillation instrument rather than the PIC because of its smaller size and the desire to minimize the technician's time inside the residence.

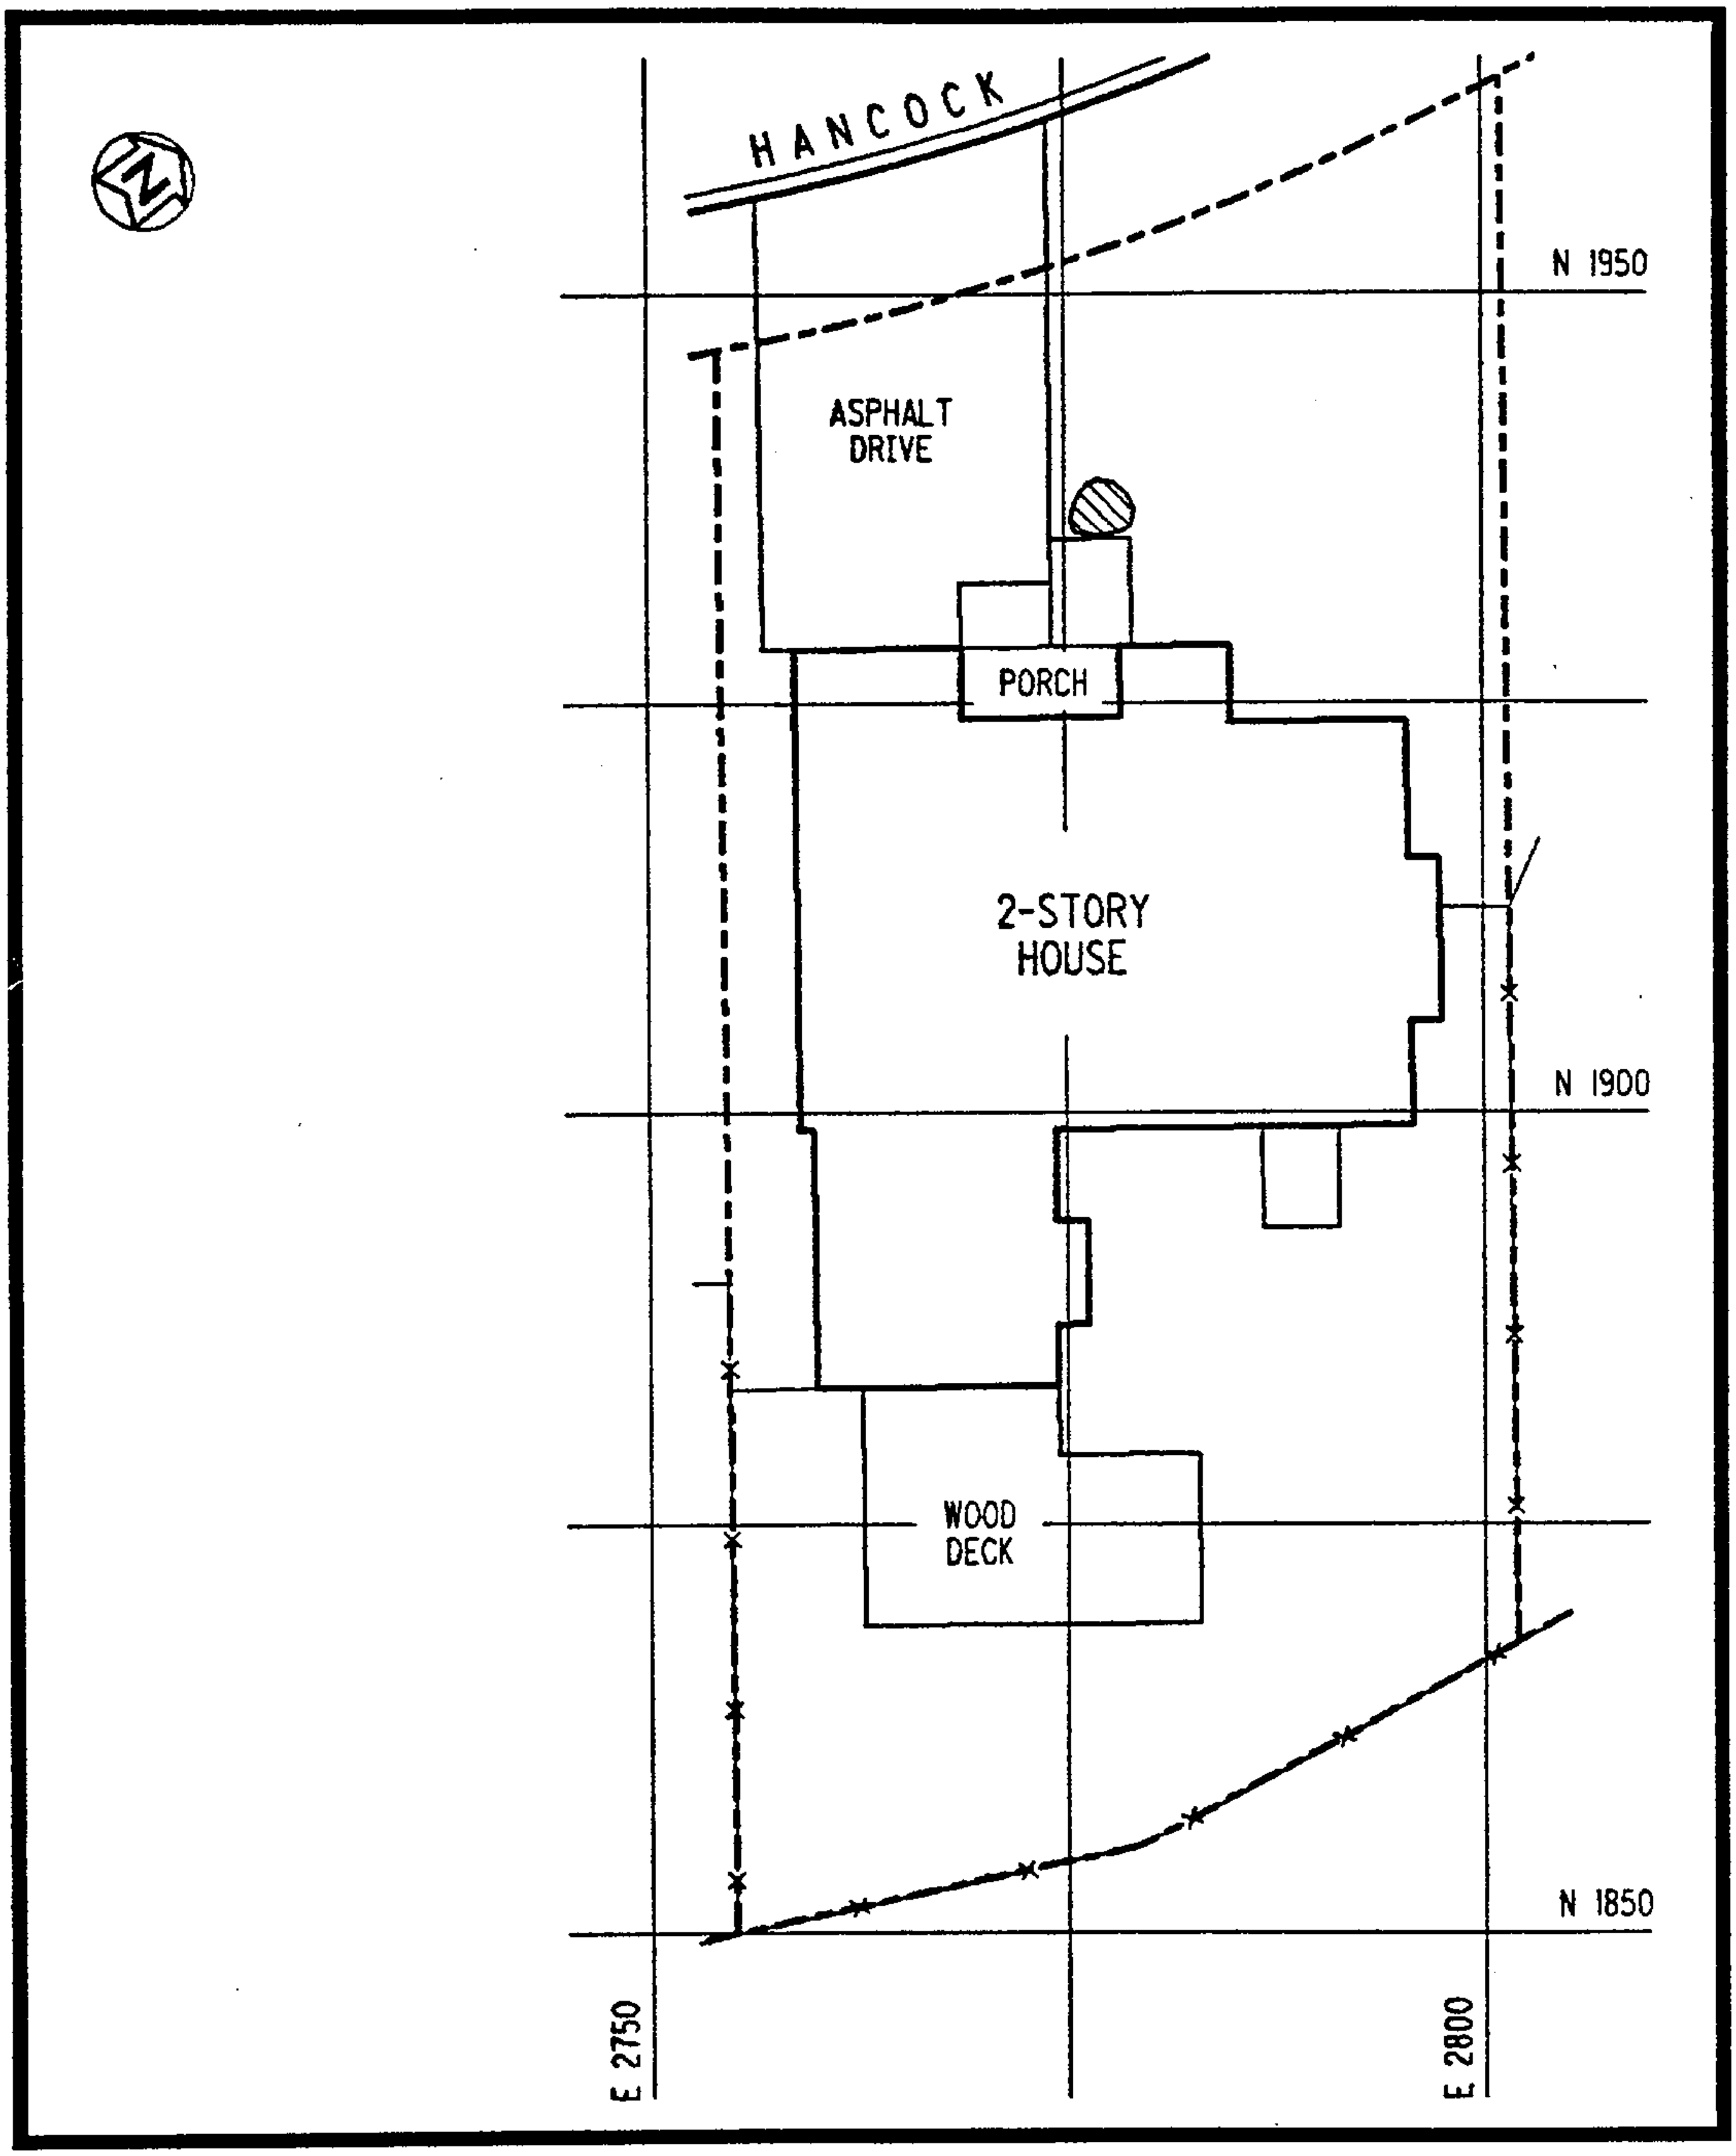
FIGURE 5-1 AREA OF SURFACE CONTAMINATION AT 6 HANCOCK STREET

Near-surface gamma radiation measurements on the property ranged from 1,700 cpm to approximately 8,000 cpm. The average background level for this area is 5,000 cpm. A measurement of 11,000 cpm is approximately equal to the DOE guideline for thorium-232 of 5 pCi/g above background for surface soil contamination. Using this correlation, the near-surface gamma measurements were used to determine the extent of surface contamination and the basis for selecting the locations of soil samples. Areas of surface contamination are shown in Figure 5-1.

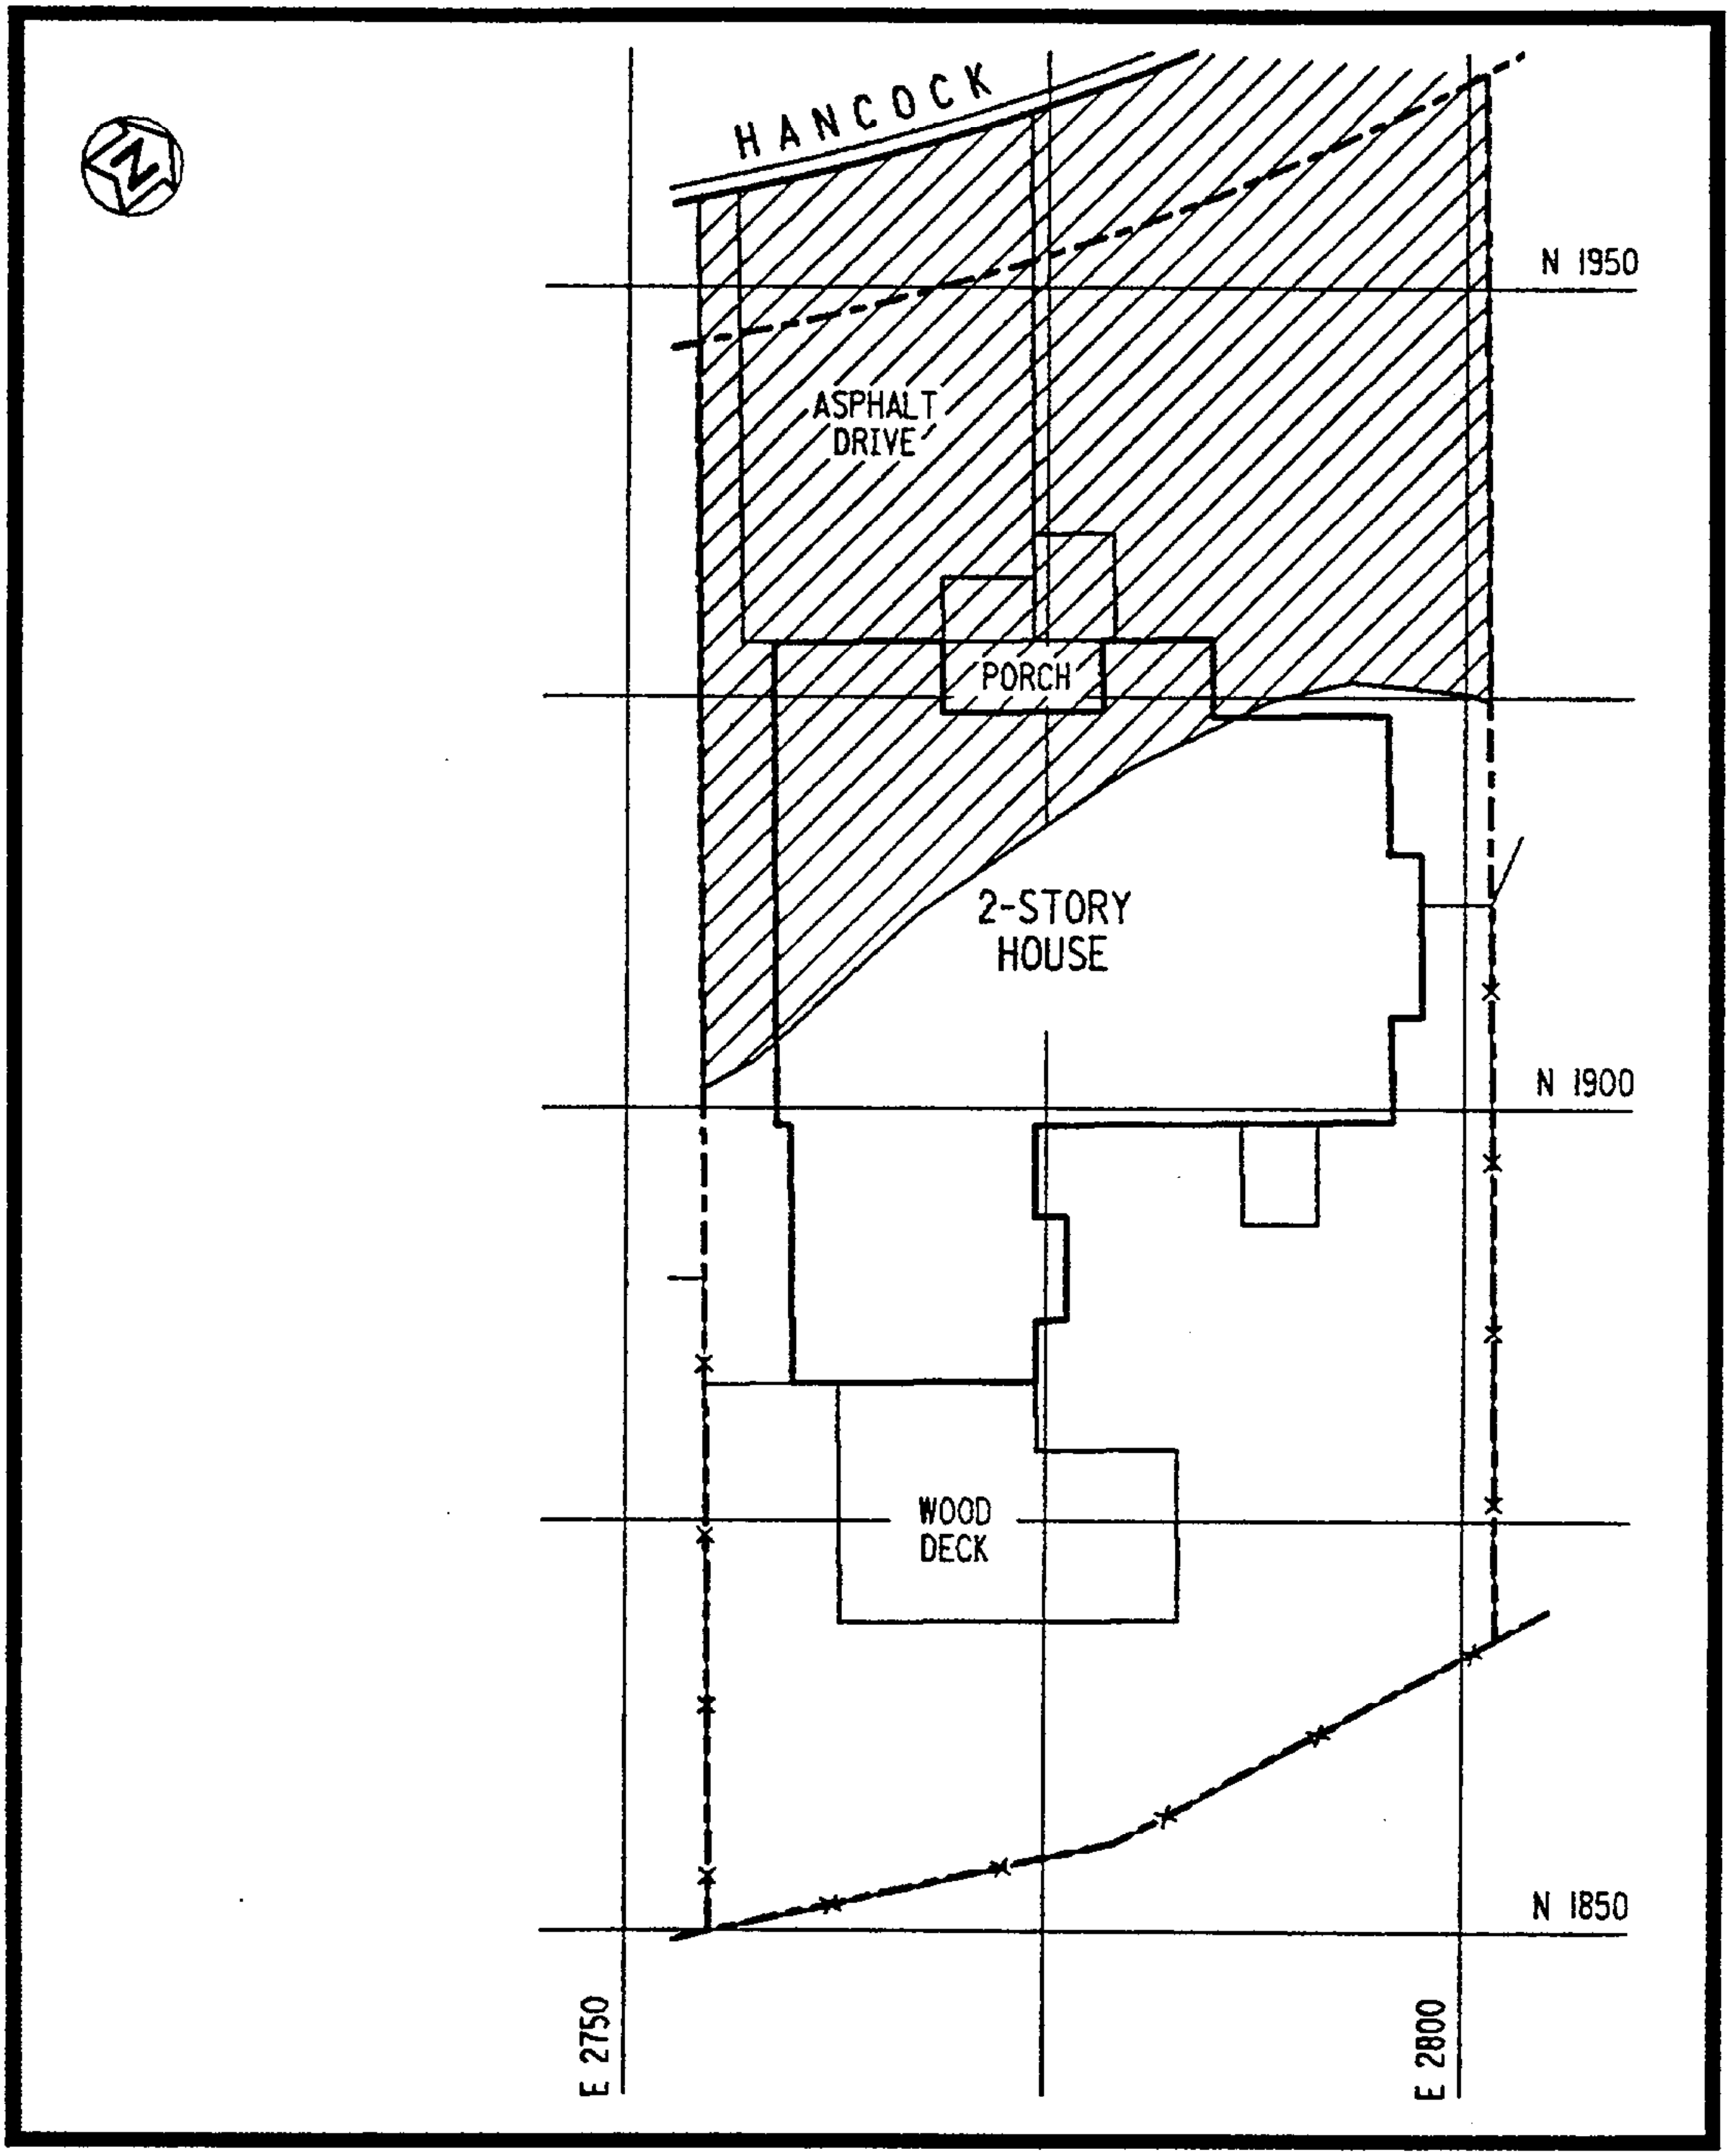
FIGURE 5-2 AREAS OF SUBSURFACE CONTAMINATION AT 6 HANCOCK STREET

On the basis of near-surface gamma radiation measurements, surface and subsurface soil sample analyses, and downhole gamma logging, contamination of this property is believed to consist primarily of subsurface contamination at depths ranging from 1.37 m (4.5 ft) to 2.43 m (8.0 ft). The areas of subsurface contamination are shown in Figure 5-2. The subsurface contamination appears to extend beneath the residence as well as into the street in front of the property.

It is apparent from review of historical documentation (e.g., aerial photographs of the area, interviews with local residents, and previous radiological surveys) that the subsurface contamination on this property lies along the former channel of Lodi Brook and its associated floodplain. The contamination on this property is similar to contamination found on residential properties in close proximity to this property. It has been established that the Lodi Brook channel through these neighboring properties once occupied locations connecting to those where stream sediments were found at 6 Hancock Street. Thus, the elevated gamma readings shown on gamma logs from boreholes drilled on this property serve as further indication of the suspected mechanism of transport for radiological contamination (i.e., stream deposition from Lodi Brook).
