ORNL/RASA-86/66
(LN002V)

RESULTS OF THE INDEPENDENT RADIOLOGICAL VERIFICATION SURVEY AT 59 TRUDY DRIVE, LODI, NEW JERSEY (LN002V)

Date of Issue — December 1986

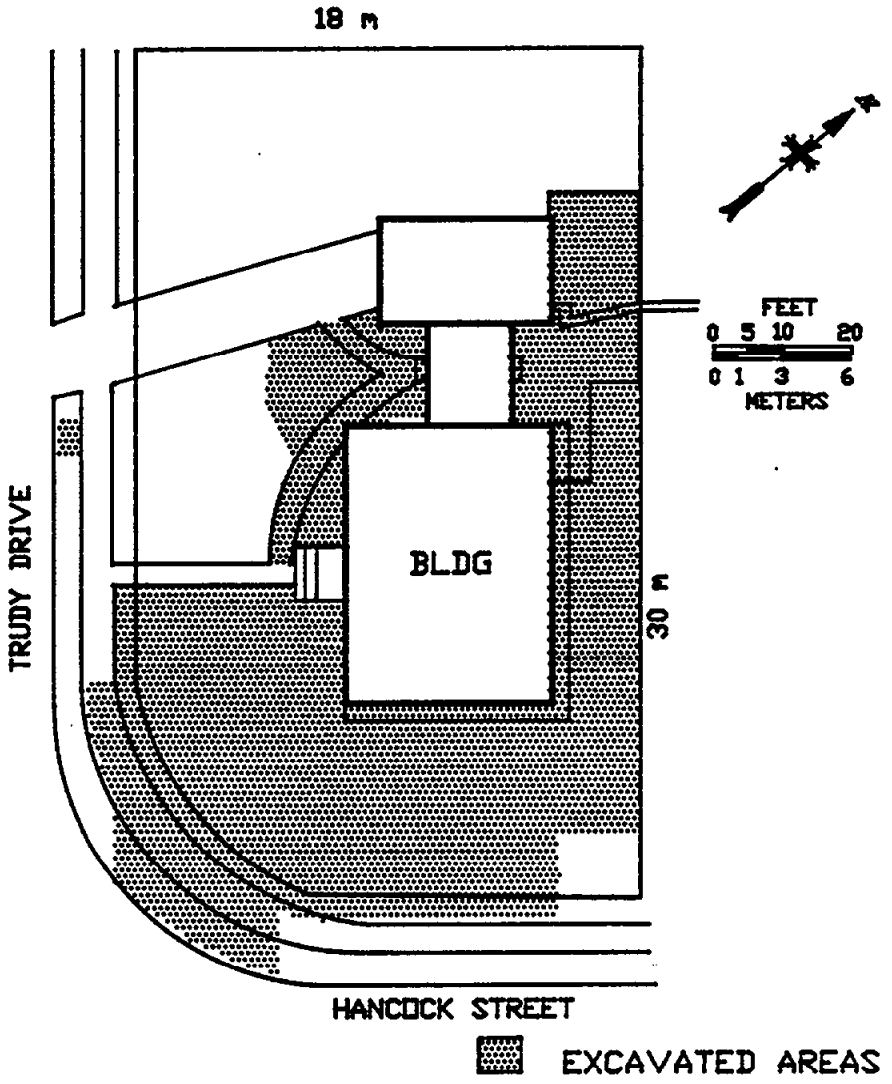
Fig. 3. Diagram showing excavated areas on the property at 59 Trudy Drive, Lodi, New Jersey (LN002V).

From January to June, 1986, ORNL conducted the verification activity for the Maywood vicinity properties, including this location at 59 Trudy Drive, Lodi, located southwest of the Maywood site. A diagram of the property showing the approximate property boundaries and excavated areas is shown in Fig. 3. This location is one in a series of vicinity properties near the Maywood site that was suspected of being radioactively contaminated and that has been surveyed by BNI[3] to identify horizontal and vertical boundaries of radionuclide concentrations exceeding remedial action criteria. (Verification of these properties will be completed in 1986.) A contaminated area of $\sim$200 m^2 that exceeded the guidelines was located in the yard surrounding the house, including part of the front sidewalk, and was excavated.

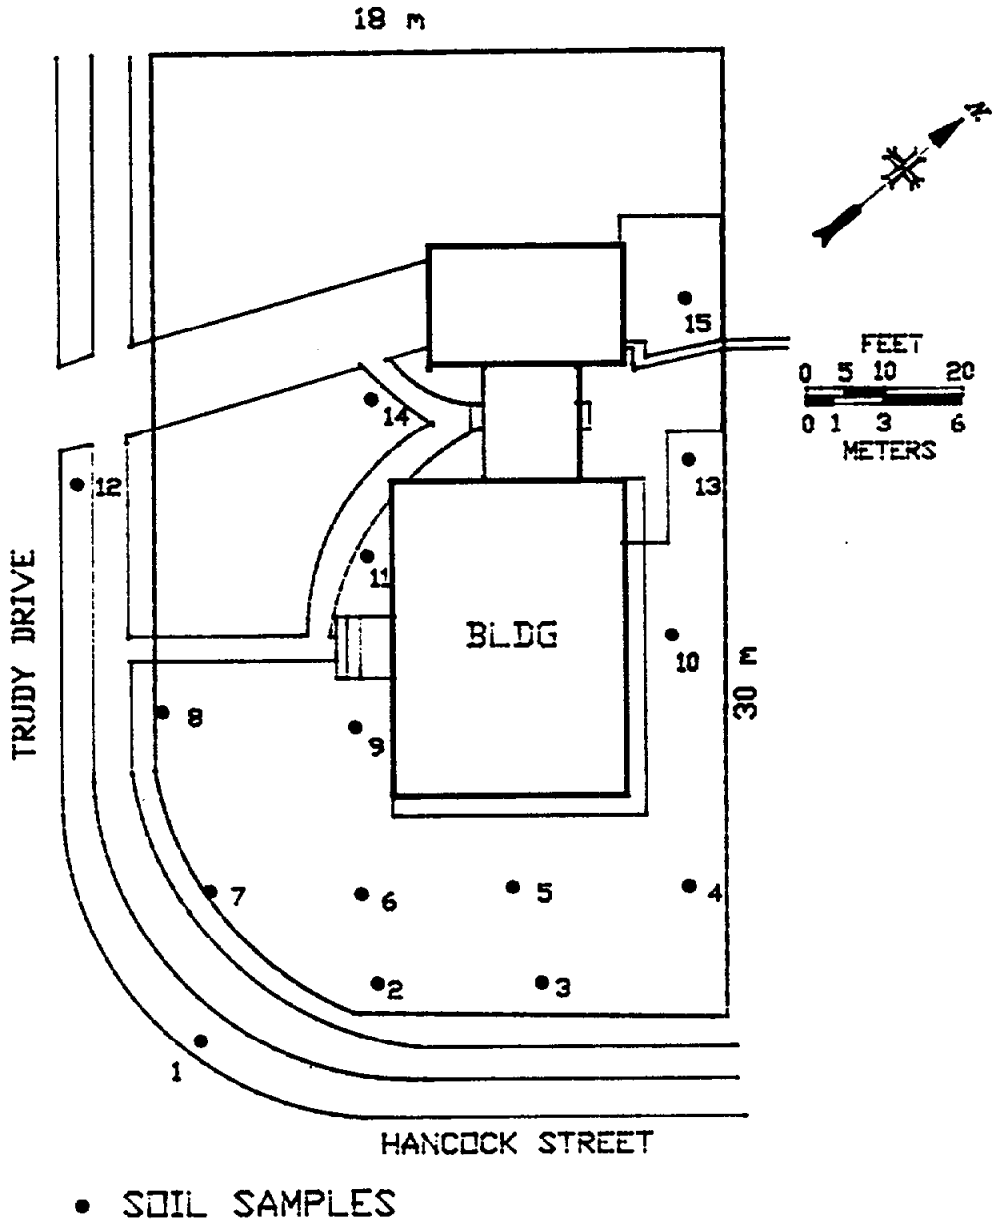
Fig. 4. Locations of soil samples on the property at 59 Trudy Drive, Lodi, New Jersey (LN002V).

Before backfilling, fifteen soil samples were taken by BNI in the excavated area. The procedures used for soil sample analysis have been described in Ref. 3. Locations of the soil samples are shown in Fig. 4.

The samples were analyzed by BNI to determine the concentrations of ^{238}U, ^{226}Ra, and ^{232}Th in the soil.[4] Concentrations of ^{238}U in the samples ranged from 0.9 to 3.5 pCi/g (picocuries† per gram) and averaged 1.7 pCi/g. Concentrations of ^{226}Ra ranged from 0.5 to 2.0 pCi/g and averaged 0.91 pCi/g. Concentrations of ^{232}Th in the soil samples ranged from 0.9 to 8.4 pCi/g and averaged 2.5 pCi/g. Results of the soil sample analysis are given in Table 3.
