ORNL/RASA-85/24

RESULTS OF THE RADIOLOGICAL SURVEY AT 76 WASHINGTON STREET (LJ010), LODI, NEW JERSEY

Date of Issue - December 1985

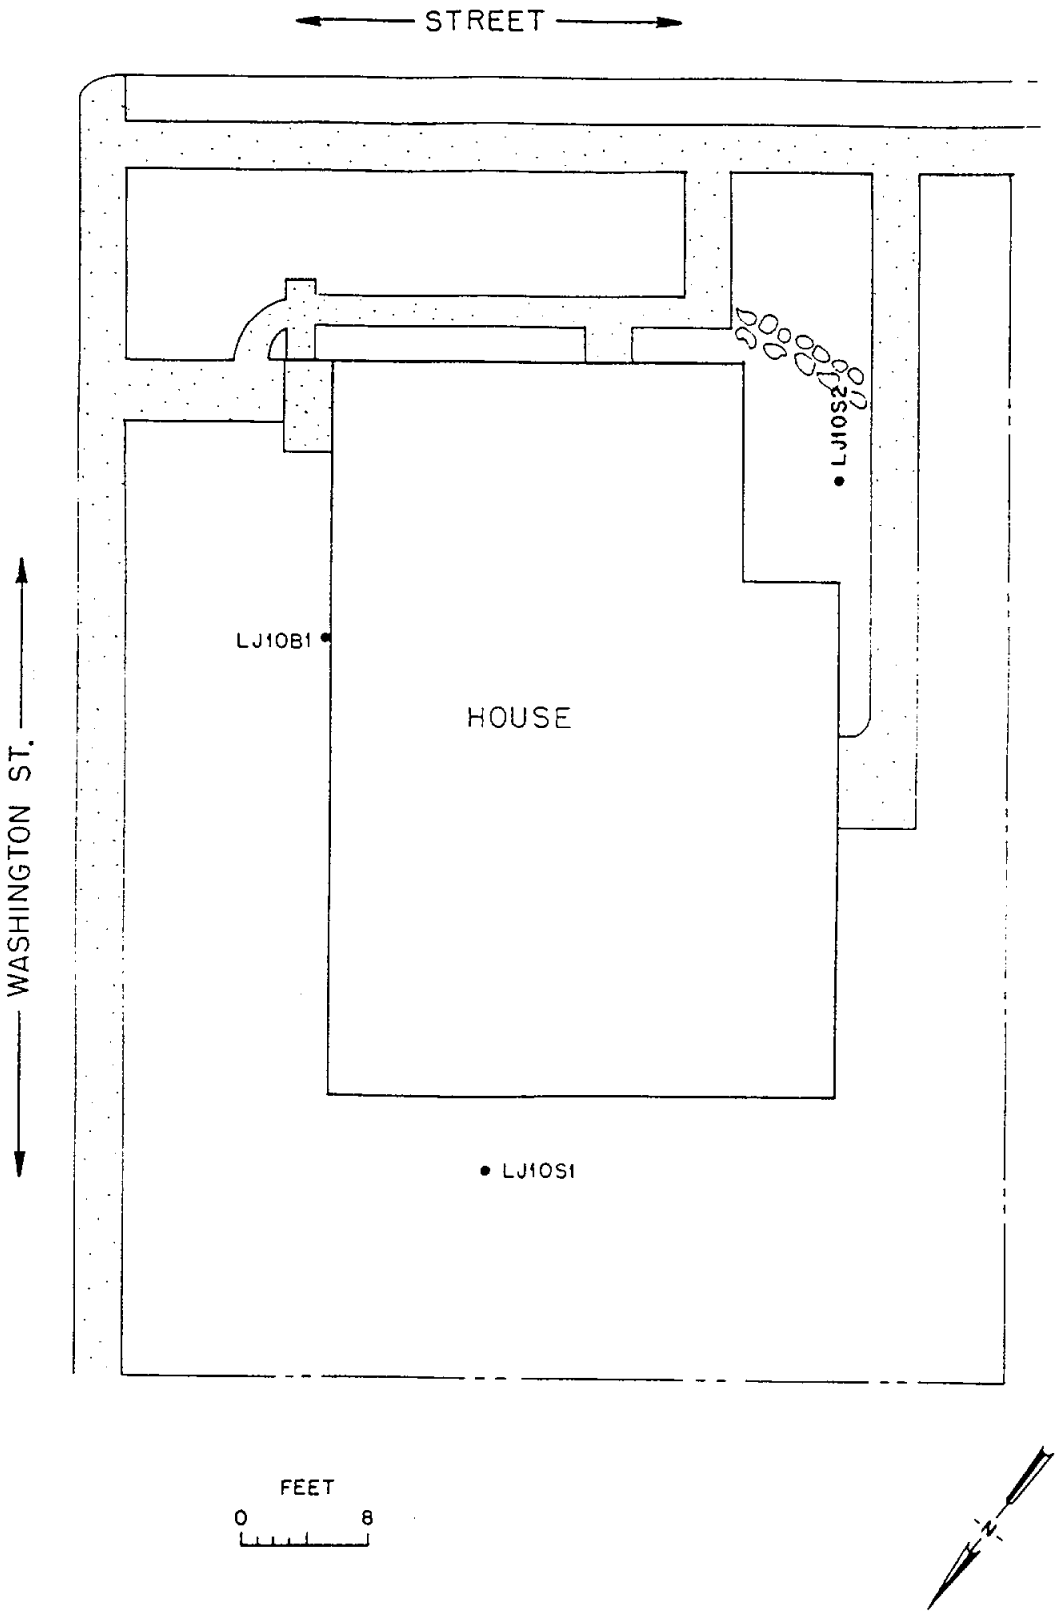
Systematic and biased soil samples were taken from various locations on the property for radionuclide analyses. Locations of the systematic (LJ10S) and biased (LJ10B) samples are shown in Fig. 1, with results of laboratory analyses provided in Table 3. Concentrations of uranium, radium, and thorium were at normal background levels.

Fig. 1. Diagram showing locations of soil samples taken at 76 Washington Street, Lodi, New Jersey.

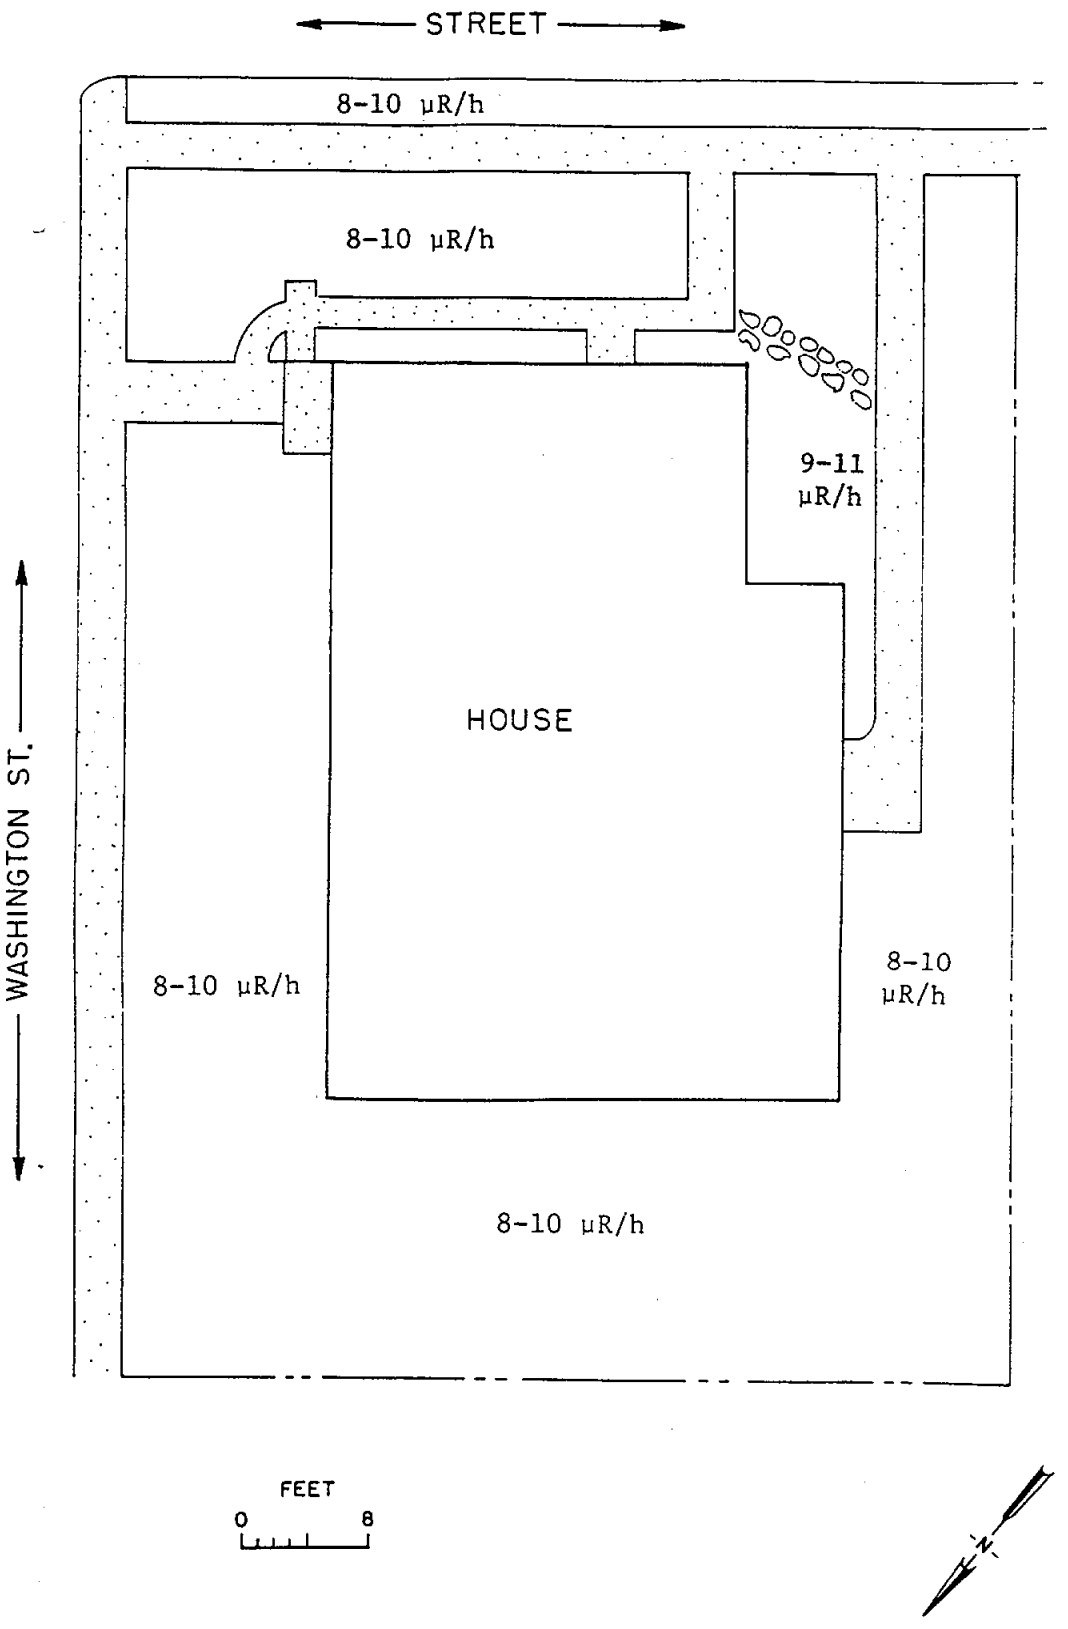
The gamma scan of the surface of the property showed no gamma exposure rates in excess of background radiation levels. The results of the gamma scan are shown in Fig. 2.

Fig. 2. Gamma radiation levels measured at 76 Washington Street, Lodi, New Jersey.
