ORNL/RASA-85/3

RESULTS OF THE RADIOLOGICAL SURVEY AT 101 PATERSON AVENUE (LJ025), HASBROUCK HEIGHTS, NEW JERSEY

Date of Issue - December 1985

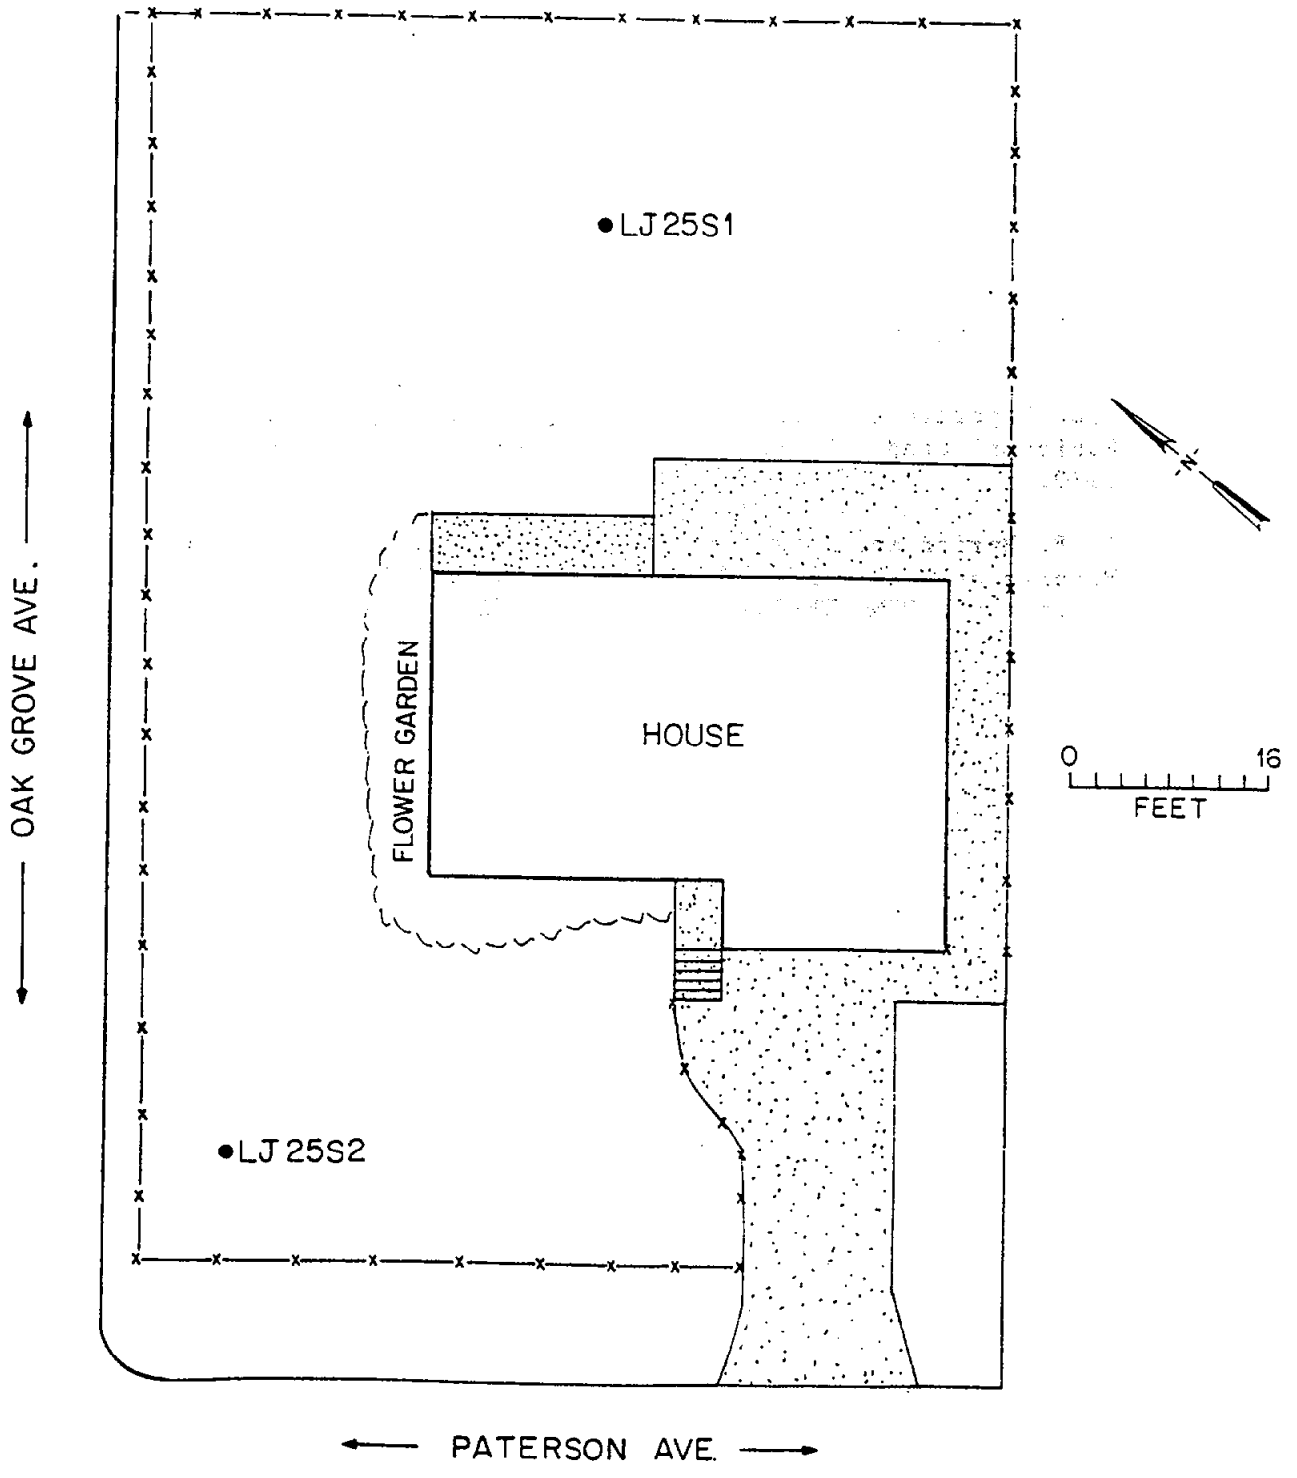
Systematic soil samples were taken from various locations on the property for radionuclide analyses. Locations of the systematic (LJ25S) samples are shown in Fig. 1, with results of laboratory analyses provided in Table 3. No biased soil samples were taken. Concentrations of uranium, radium, and thorium were within normal background levels in both systematic samples.

Fig. 1. Diagram showing locations of soil samples taken at 101 Paterson Avenue, Hasbrouck Heights, New Jersey.

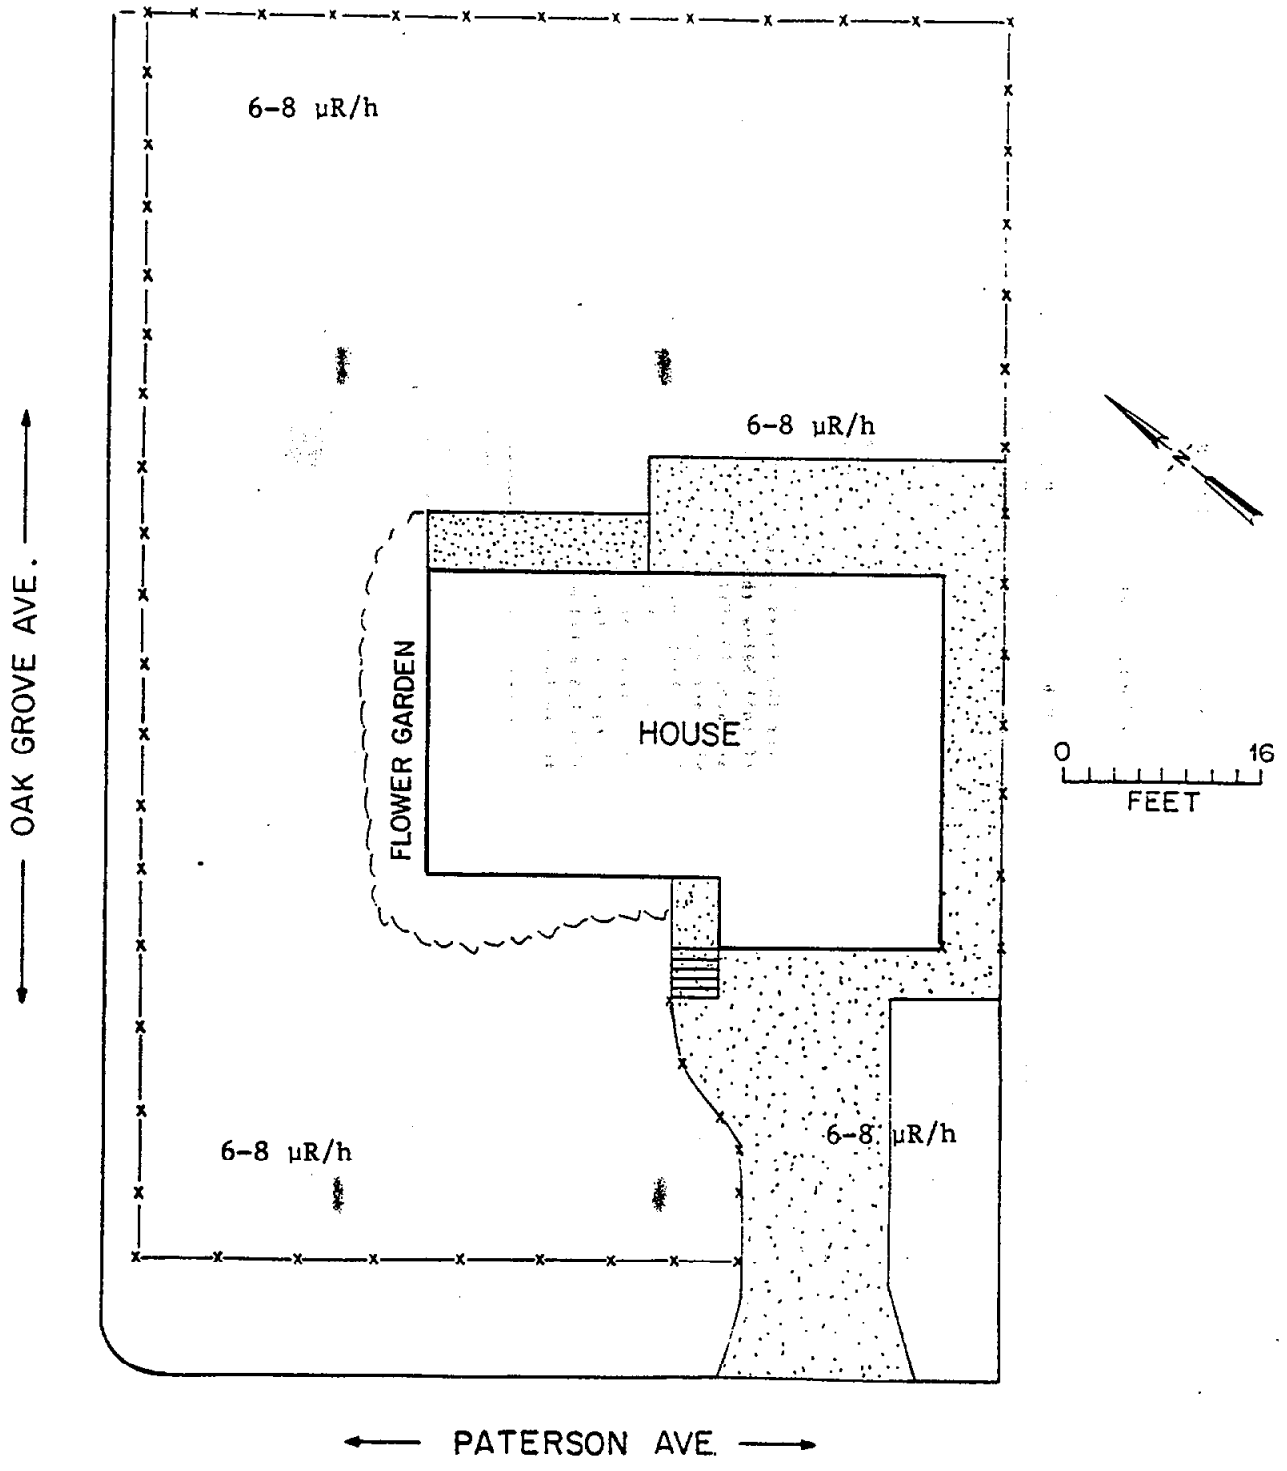
Results of the gamma scan of the surface of the property showed no gamma exposure rates in excess of natural background radiation levels. The range of exposure rates is 6-8 μR/h over the entire property.

Fig. 2. Gamma radiation levels measured at 101 Paterson Avenue, Hasbrouck Heights, New Jersey.
