for the Maywood Site, New Jersey

ORNL/RASA-88/82

RESULTS OF THE RADIOLOGICAL SURVEY AT THE ELECTRIC SUBSTATION ON WEST CENTRAL AVENUE, MAYWOOD, NEW JERSEY (MJ039)

Date Published – June 1989

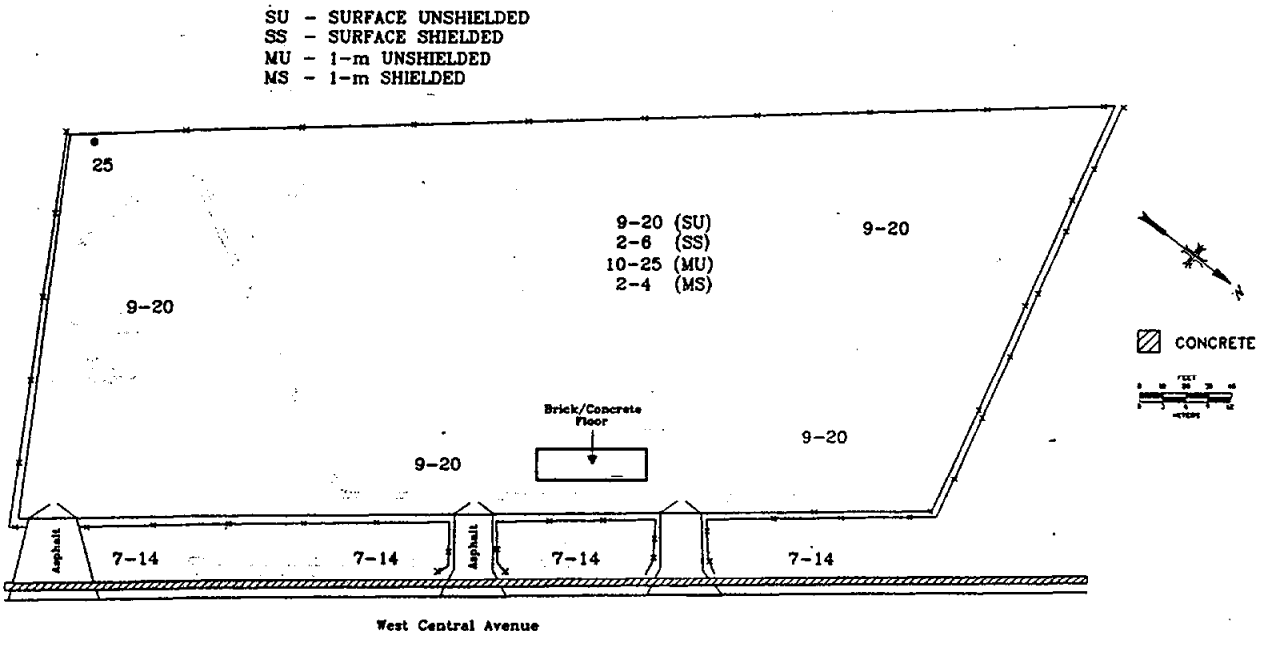
Gamma radiation levels measured during a gamma scan of the surface of the property are given in Fig. 1. Gamma exposure rates over the major portion of the property ranged from 9 to 20 μR/h. These measurements were taken at various locations at the Electric Substation. Levels ranging from 7 to 14 μR/h occurred at four locations near the trees, shrubs, and grass at the front of the substation. Gamma measurements were also taken at eleven of the twelve systematic and biased soil sample sites. Surface gamma measurements ranged from 9 to 20 μR/h. Corresponding measurements at 1 m ranged from 10 to 25 μR/h. Using a lead shielded probe, gamma measurements were taken at these same locations. Surface gamma measurements ranged from 2 to 6 μR/h, and the corresponding measurements at 1 m ranged from 2 to 4 μR/h. Under certain conditions, extraneous radiation emanating from a source outside the area of concern will confound measurements. For

this reason, shielded readings were taken at several locations to verify that the elevated levels were due to scattered radiation from the storage pile and not from the ground surface. The source of scattered radiation, or "shine," at this site is a storage pile containing significant amounts of residual radioactive material, located at the back of the property and across the railroad tracks.

Fig. 1. Gamma radiation levels (μR/h) measured on the surface at the Electric Substation on West Central Avenue, Maywood, New Jersey (MJ039).

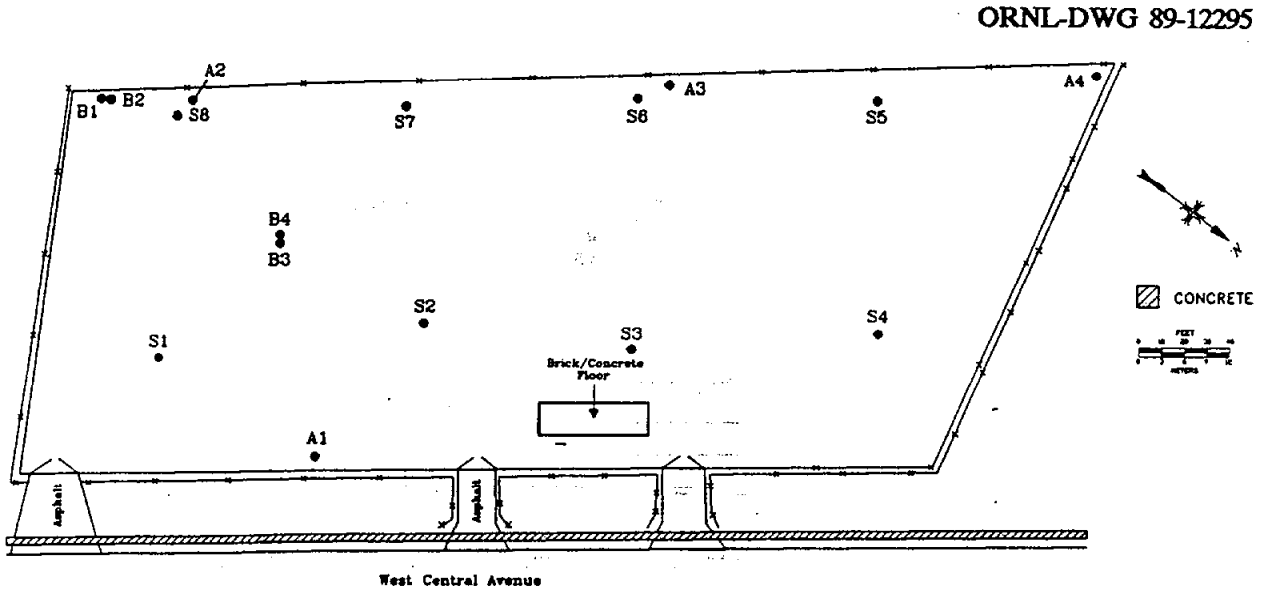
Systematic and biased soil samples were taken from various locations on the property for radionuclide analyses. Locations of the systematic (S) and biased (B) samples are shown in Fig. 2, with results of laboratory analyses provided in Table 3. Concentrations of ^{226}Ra and ^{232}Th in these samples ranged from 0.24 to 1.1 pCi/g and 0.30 to 2.3 pCi/g, respectively. These values are well within applicable DOE guidelines (Table 1). Determinable concentrations of ^{238}U ranged from 0.56 to 1.1 pCi/g. Radionuclide concentrations ranged from below to slightly above normal background levels for the northern New Jersey area (Table 2).

Varying thicknesses of subsurface soil were sampled from depths of 45 to 185 cm in three of the six auger holes (A) drilled at six separate locations. Auger hole locations from which soil samples were taken are shown in Fig. 2, and the results of analysis of these samples are given in Table 3. Concentrations of ^{226}Ra and ^{232}Th in soil samples ranged from 0.65 to 0.95 pCi/g and 0.89 to 1.2 pCi/g, respectively. These values are within applicable DOE guidelines (Table 1). Determinable concentrations of ^{238}U ranged from 0.84 to 12 pCi/g.

Fig. 2. Diagram showing locations of soil samples taken at the Electric Substation on West Central Avenue, Maywood, New Jersey (MJ039).

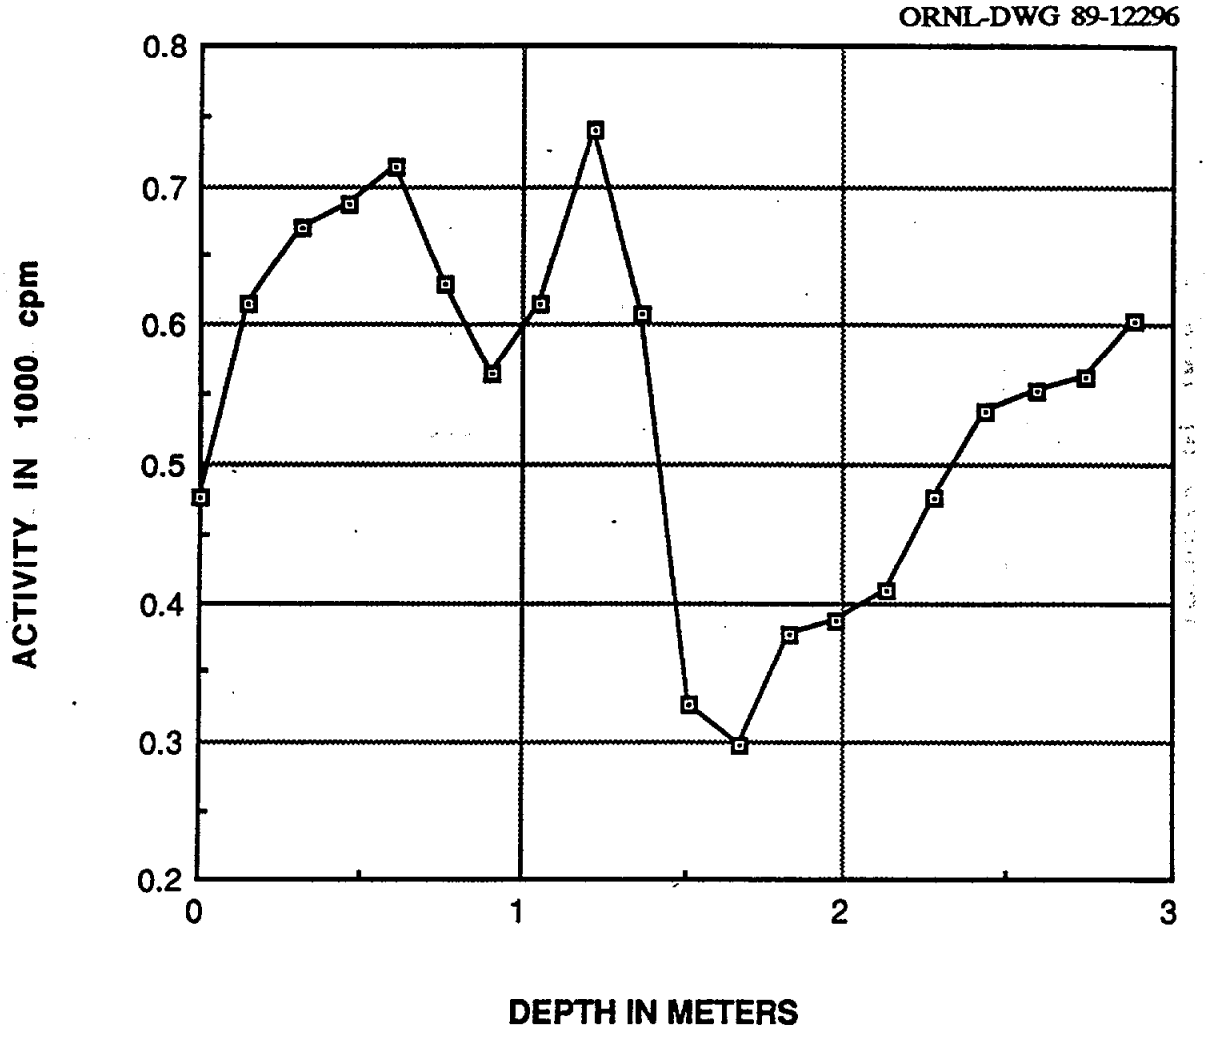
Gamma logging was performed in each of the six auger holes to characterize and further define the extent of possible contamination. The logging technique used here is not radionuclide specific. However, logging data, in conjunction with soil analyses data, may be used to estimate regions of elevated radionuclide concentrations in auger holes when compared with background levels for the area. Following a comparison of these data, it appears that any shielded scintillator readings of 1000 counts per minute (cpm) or greater generally indicate the presence of elevated concentrations of ^{226}Ra and/or ^{232}Th. Data from the gamma profiles of the logged auger holes are graphically represented in Figs. 3 through 8. Readings in auger hole 4 were slightly elevated from 1.5 to 1.7 m, with a maximum of 1098 cpm at 1.7 m. All readings in the other five holes were less than 1000 cpm.

Fig. 3. Gamma profile for auger hole 1 (MJ039A1) at the Electric Substation on West Central Avenue, Maywood, New Jersey.

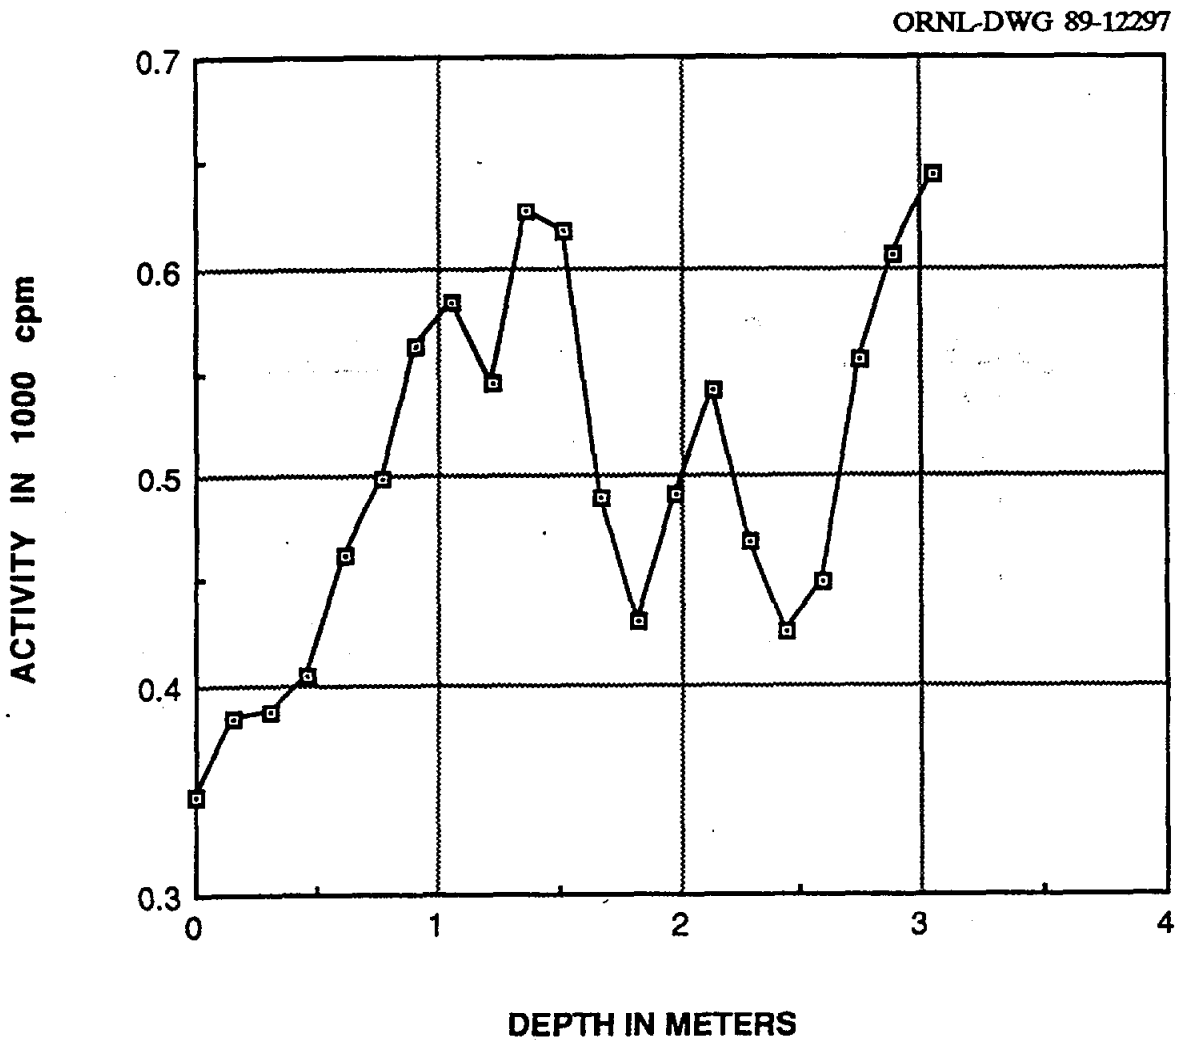
Fig. 4. Gamma profile for auger hole 2 (MJ039A2) at the Electric Substation on West Central Avenue, Maywood, New Jersey.

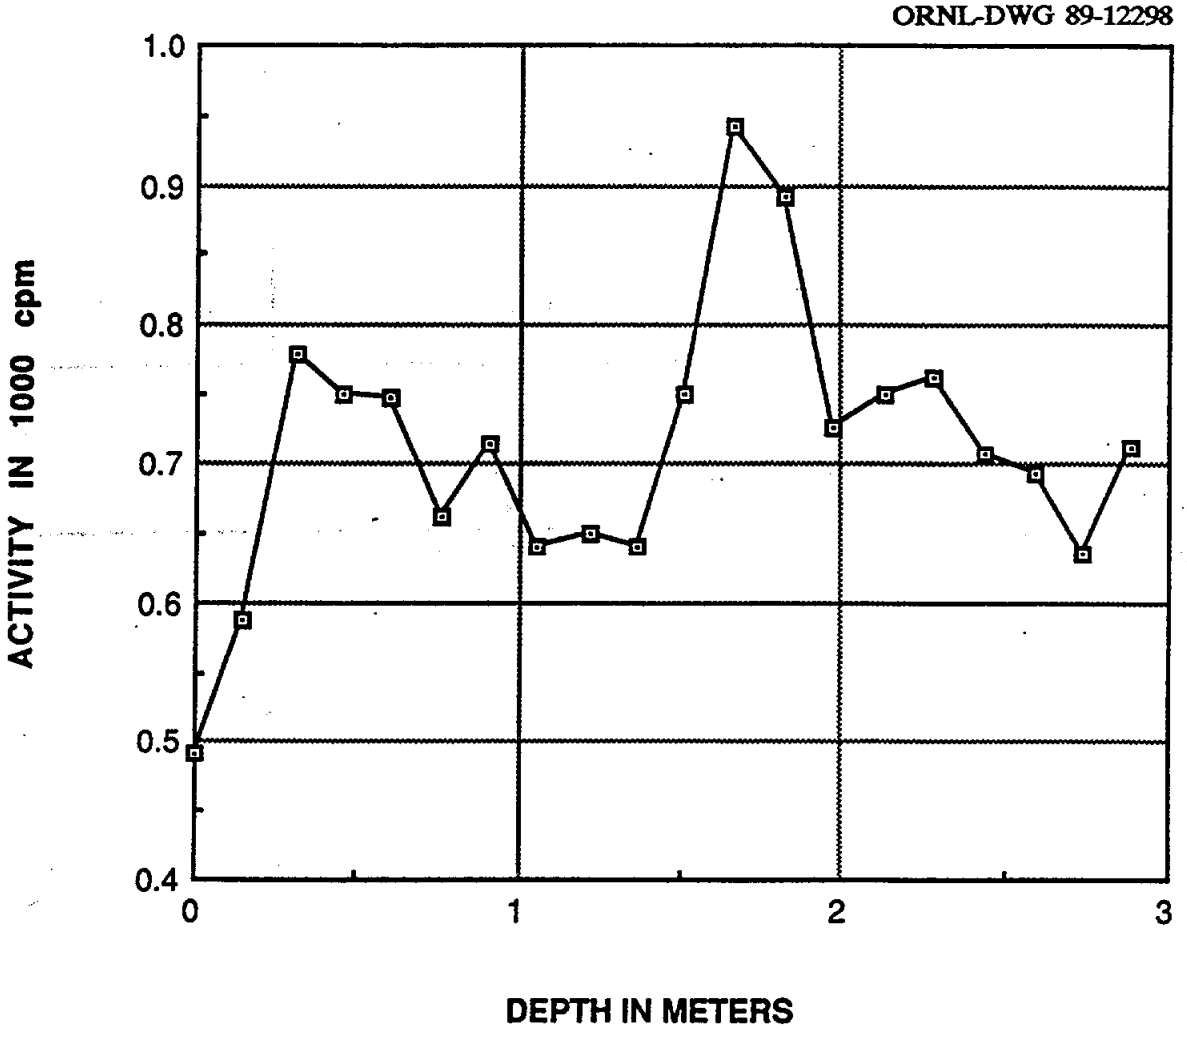
Fig. 5. Gamma profile for auger hole 3 (MJ039A3) at the Electric Substation on West Central Avenue, Maywood, New Jersey.

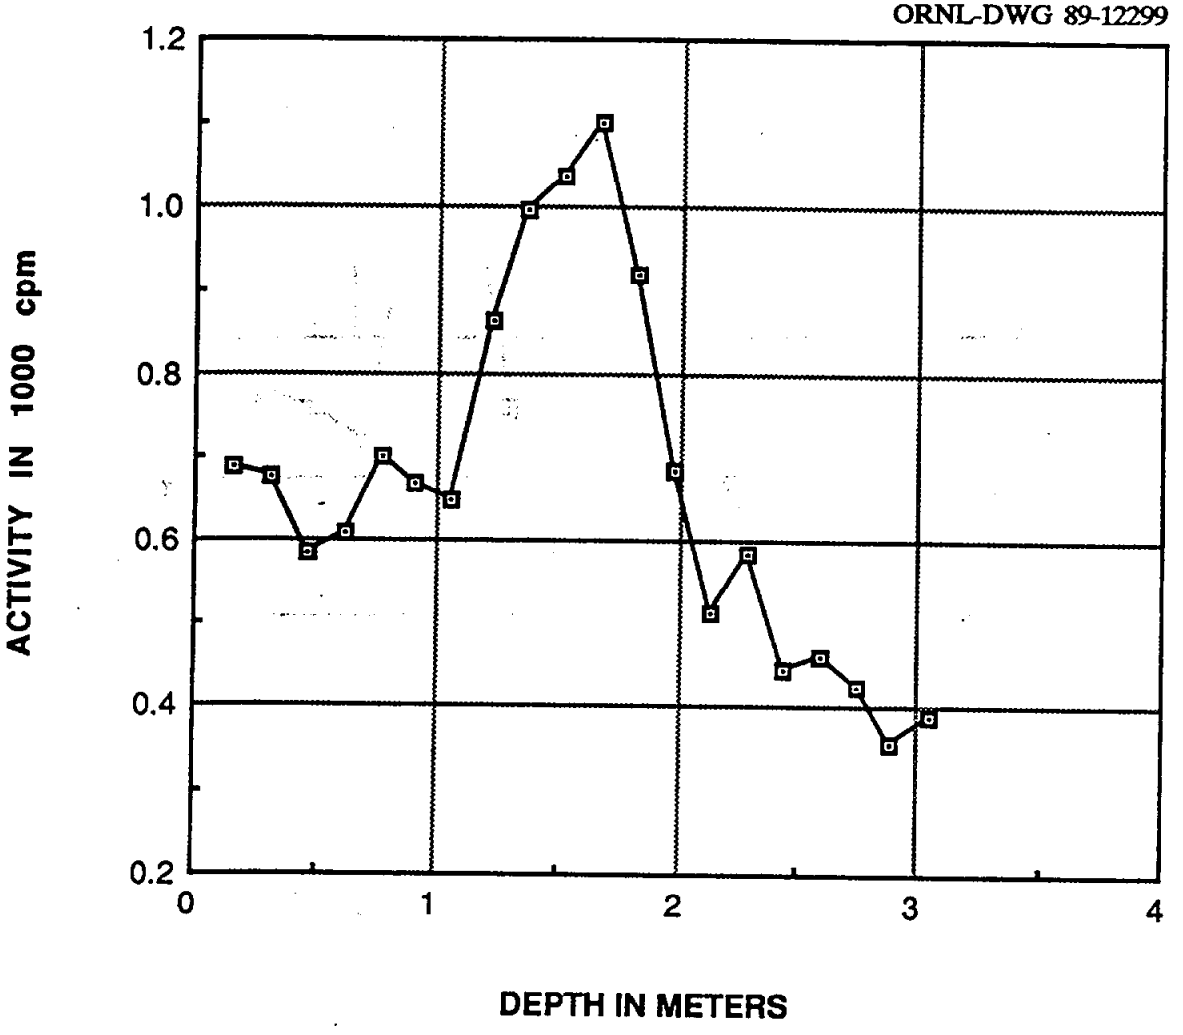
Fig. 6. Gamma profile for auger hole 4 (MJ039A4) at the Electric Substation on West Central Avenue, Maywood, New Jersey.

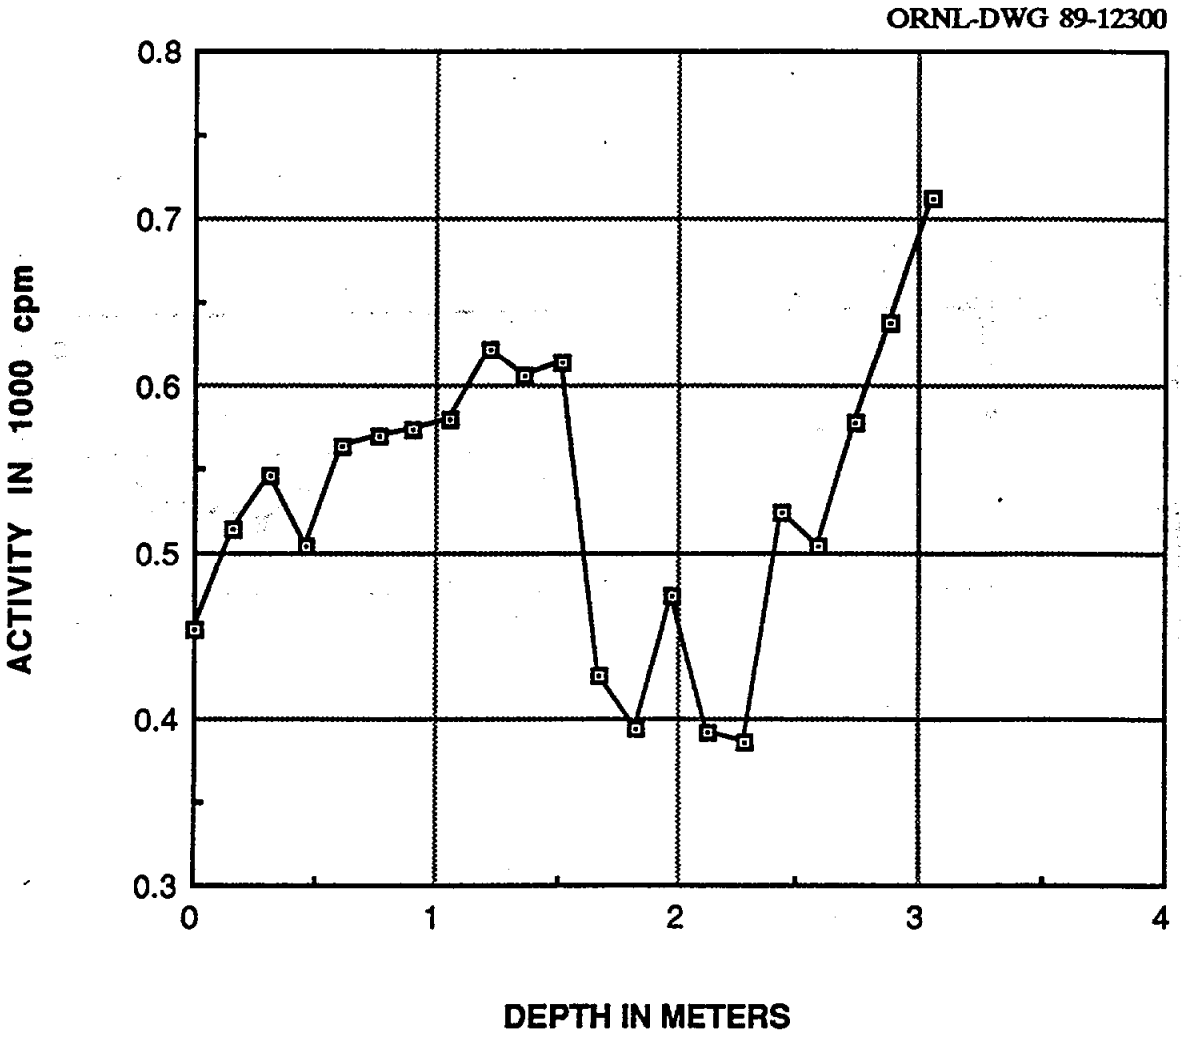
Fig. 7. Gamma profile for auger hole 5 (MJ039A5) at the Electric Substation on West Central Avenue, Maywood, New Jersey.

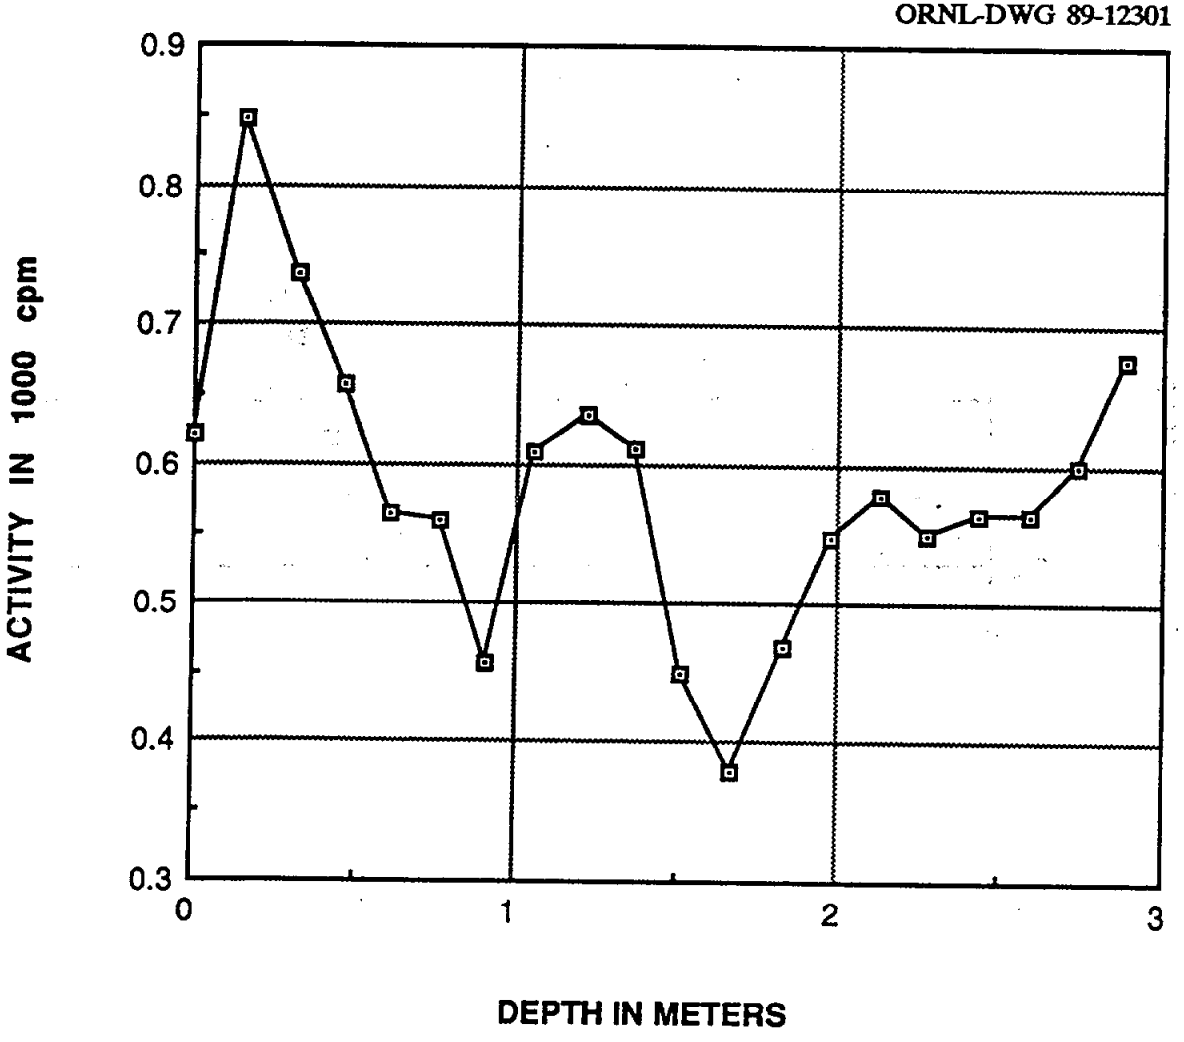
Fig. 8. Gamma profile for auger hole 6 (MJ039A6) at the Electric Substation on West Central Avenue, Maywood, New Jersey.
