Maywood Chemical Company Superfund Site

MISS- 118.

RESULTS OF THE RADIOLOGICAL SURVEY* AT 8 MILL STREET, LODI, NEW JERSEY

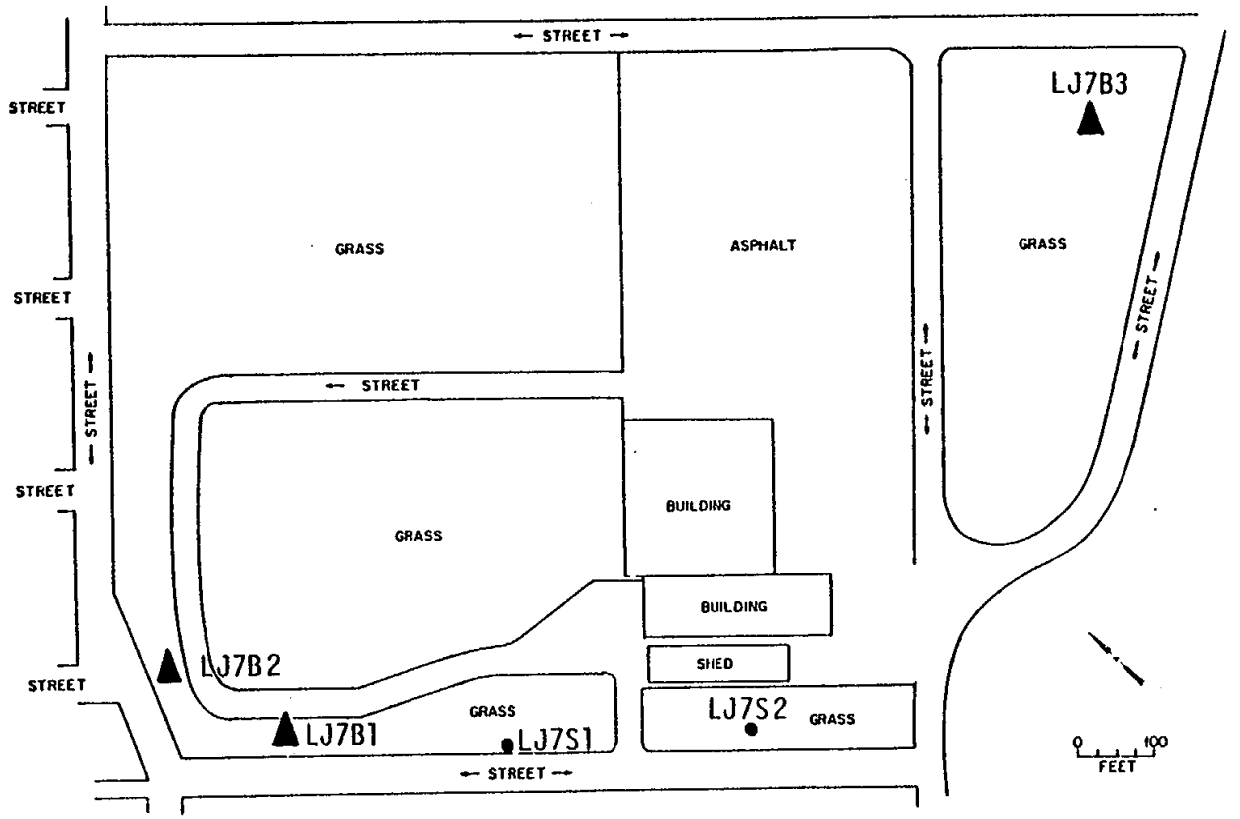
Fig. 1. Diagram showing locations of soil samples taken at 8 Mill Street.

Systematic and biased soil samples were taken from various locations on the property for radionuclide analyses. Locations of the systematic (LJ7S) and biased (LJ7B) samples are shown in Fig. 1, with results of laboratory analyses provided in Table 3. Concentrations of ^{232}Th exceeded the background concentrations of ^{232}Th anticipated for northern New Jersey in the biased soil samples collected at 8 Mill Street (LJ7B1 - LJ7B3). These results indicate that ^{232}Th-bearing residues exist on this site. The amount of material present is in excess of DOE guidelines (Table 1).

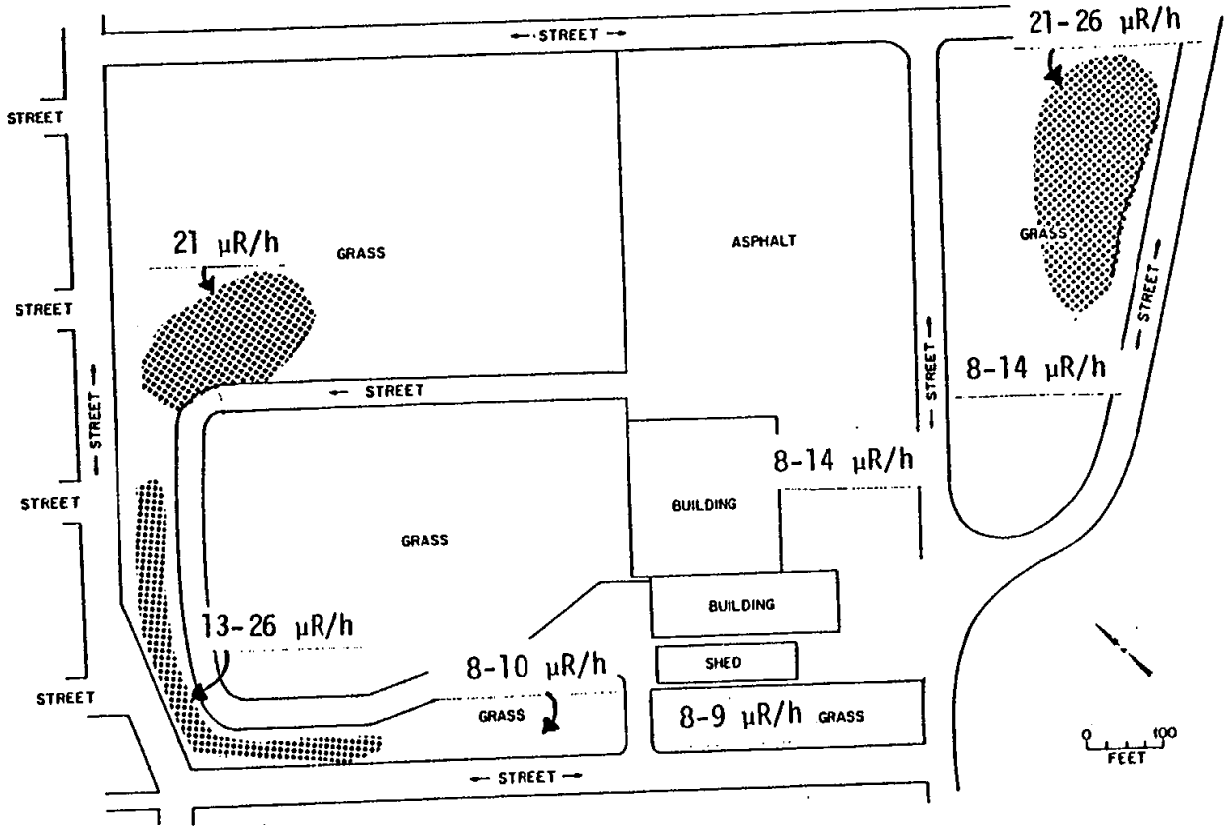
Fig. 2. Location of elevated gamma radiation levels at 8 Mill Street.

Results of the gamma scan of the surface of the property show areas where gamma exposure rates are in excess of background radiation levels. These locations are shown in Fig. 2, and the measurements are quantified. These locations suggest where potential ^{232}Th contamination exists. Gamma exposure rate levels up to 26 μR/h exist on the ground surface at this property.

Measurements taken at 8 Mill Street indicate that the property contains radioactive contamination primarily from the ^{232}Th decay chain, and to a lesser extent from the ^{238}U decay chain. This material is found in the locations shown in Fig. 2. Concentrations of these radionuclides were elevated significantly above background, and the levels are in excess of DOE remedial action guidelines. It is recommended that this property be designated for further evaluation. A comprehensive radiological survey will be required to delineate the extent of contamination to plan for any necessary remedial action.
