Maywood Chemical Company Superfund Site

Results of Radon and Gamma Radiation Measurements at 19 Commercial and Governmental Properties of the Maywood Site

Maywood, New Jersey

August 1994

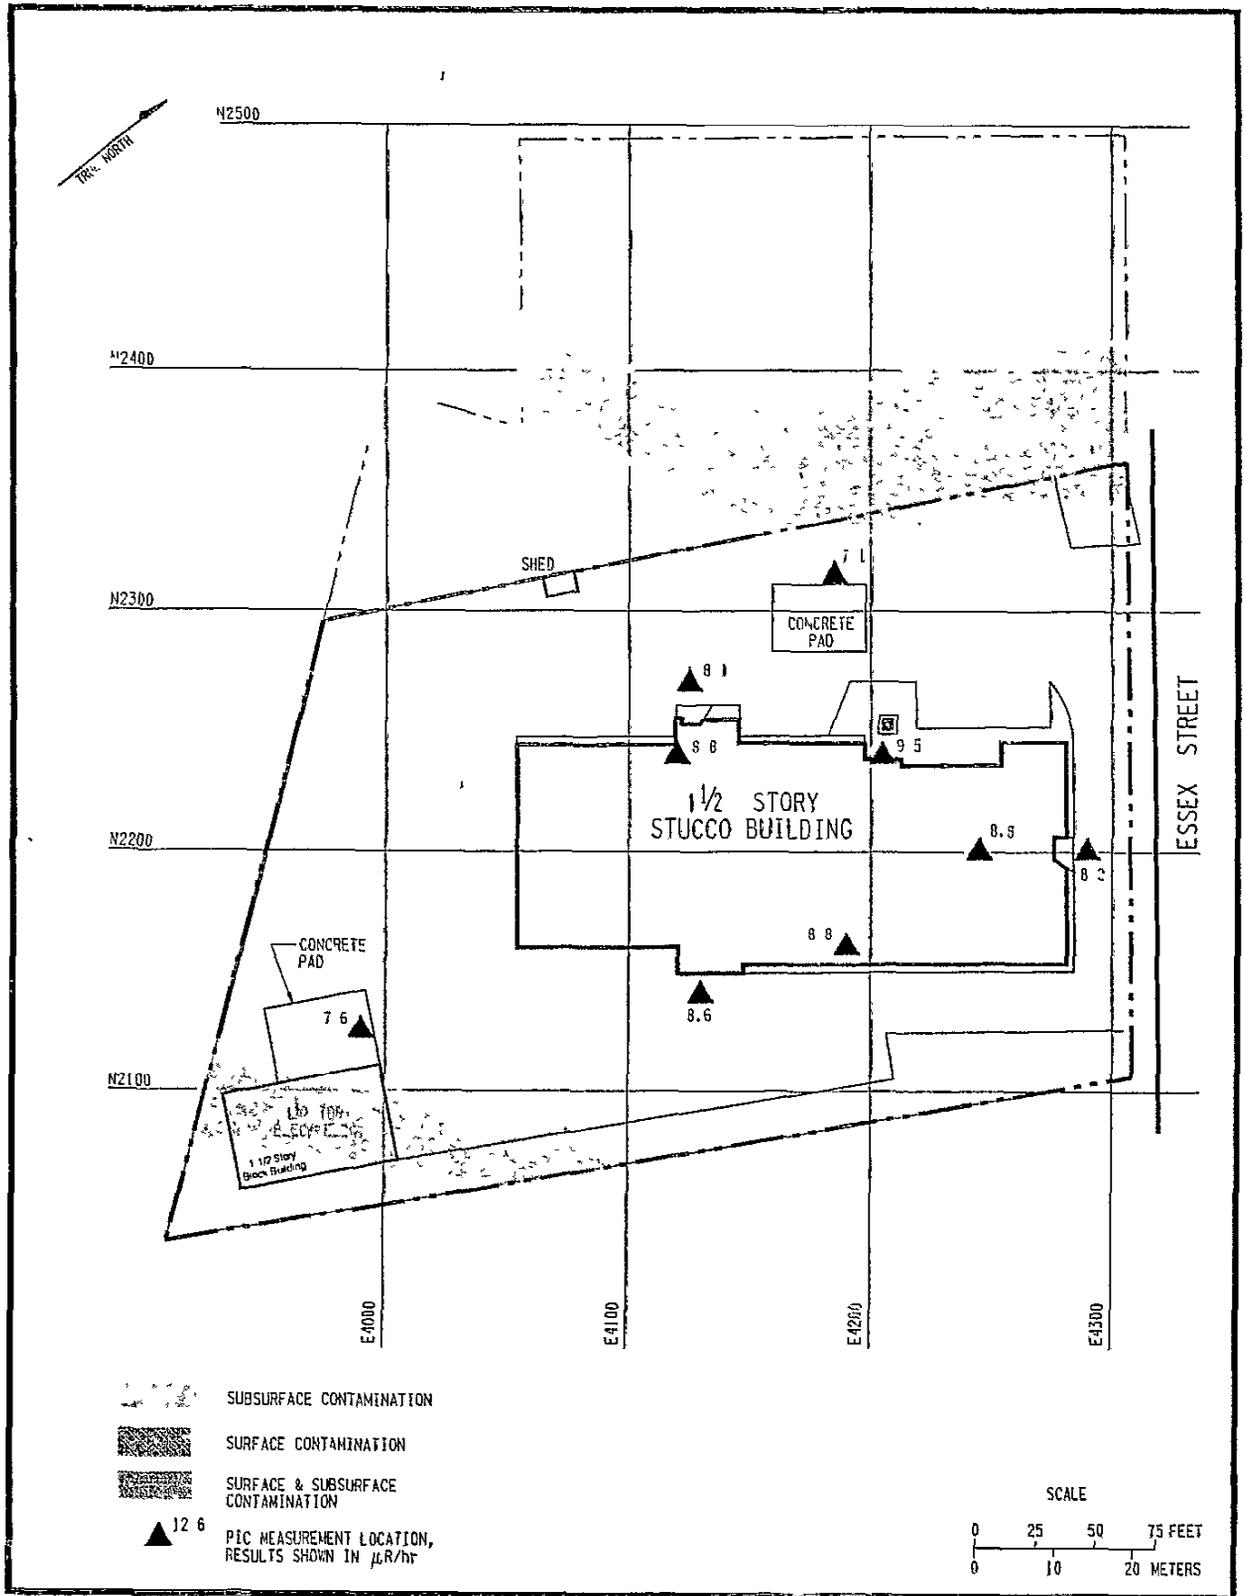
Figure 4-1
PIC Measurement Locations and Areas of Contamination
at National Community Bank 160 and 174 Essex Street

Three interior gamma exposure rate measurements were made at the bank property; locations and data for these measurements are shown in Figure 4-1. All three interior measurements were 8.8 $\mu\text{R}/\text{h}$ and were within background. The six exterior measurements ranged from 7.1 to 9.5 $\mu\text{R}/\text{h}$ and were within background (see Figure 4-1 for locations). None of the interior gamma exposure rate measurements exceeded the DOE guideline of 20 $\mu\text{R}/\text{h}$ above background for habitable structures. Exterior gamma exposure rate measurements taken during this investigation were compared with exterior measurements taken during radiological characterization of the property in 1987 (BNI 1989a). The 1987 exterior measurements ranged from 5 to 8 $\mu\text{R}/\text{h}$ and were within background. No significant change is seen between the 1987 and 1994 measurements.

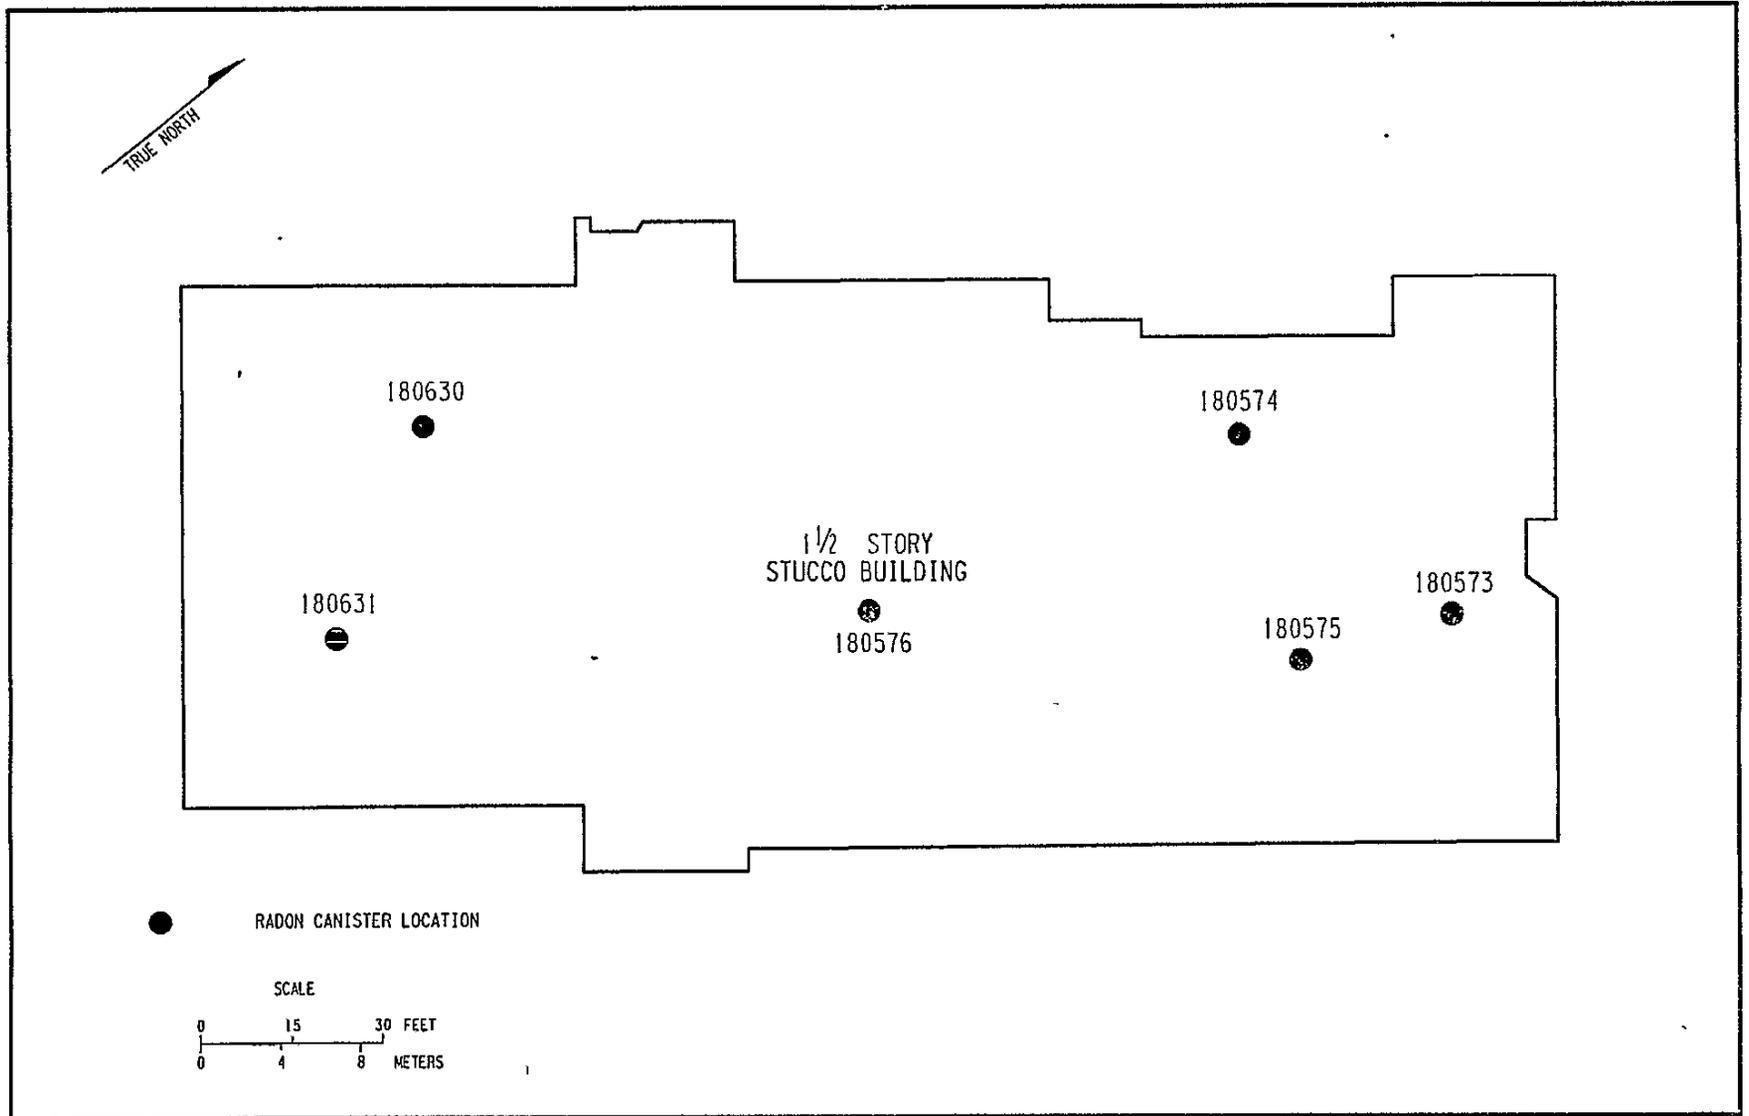
Figure 4-2
Locations of Radon Canisters at
National Community Bank 160 and 174 Essex Street

Radon concentrations were measured in six locations inside the building (see Figure 4-2) Concentrations measured ranged from less than 0.2 pCi/L to 0.3 pCi/L and

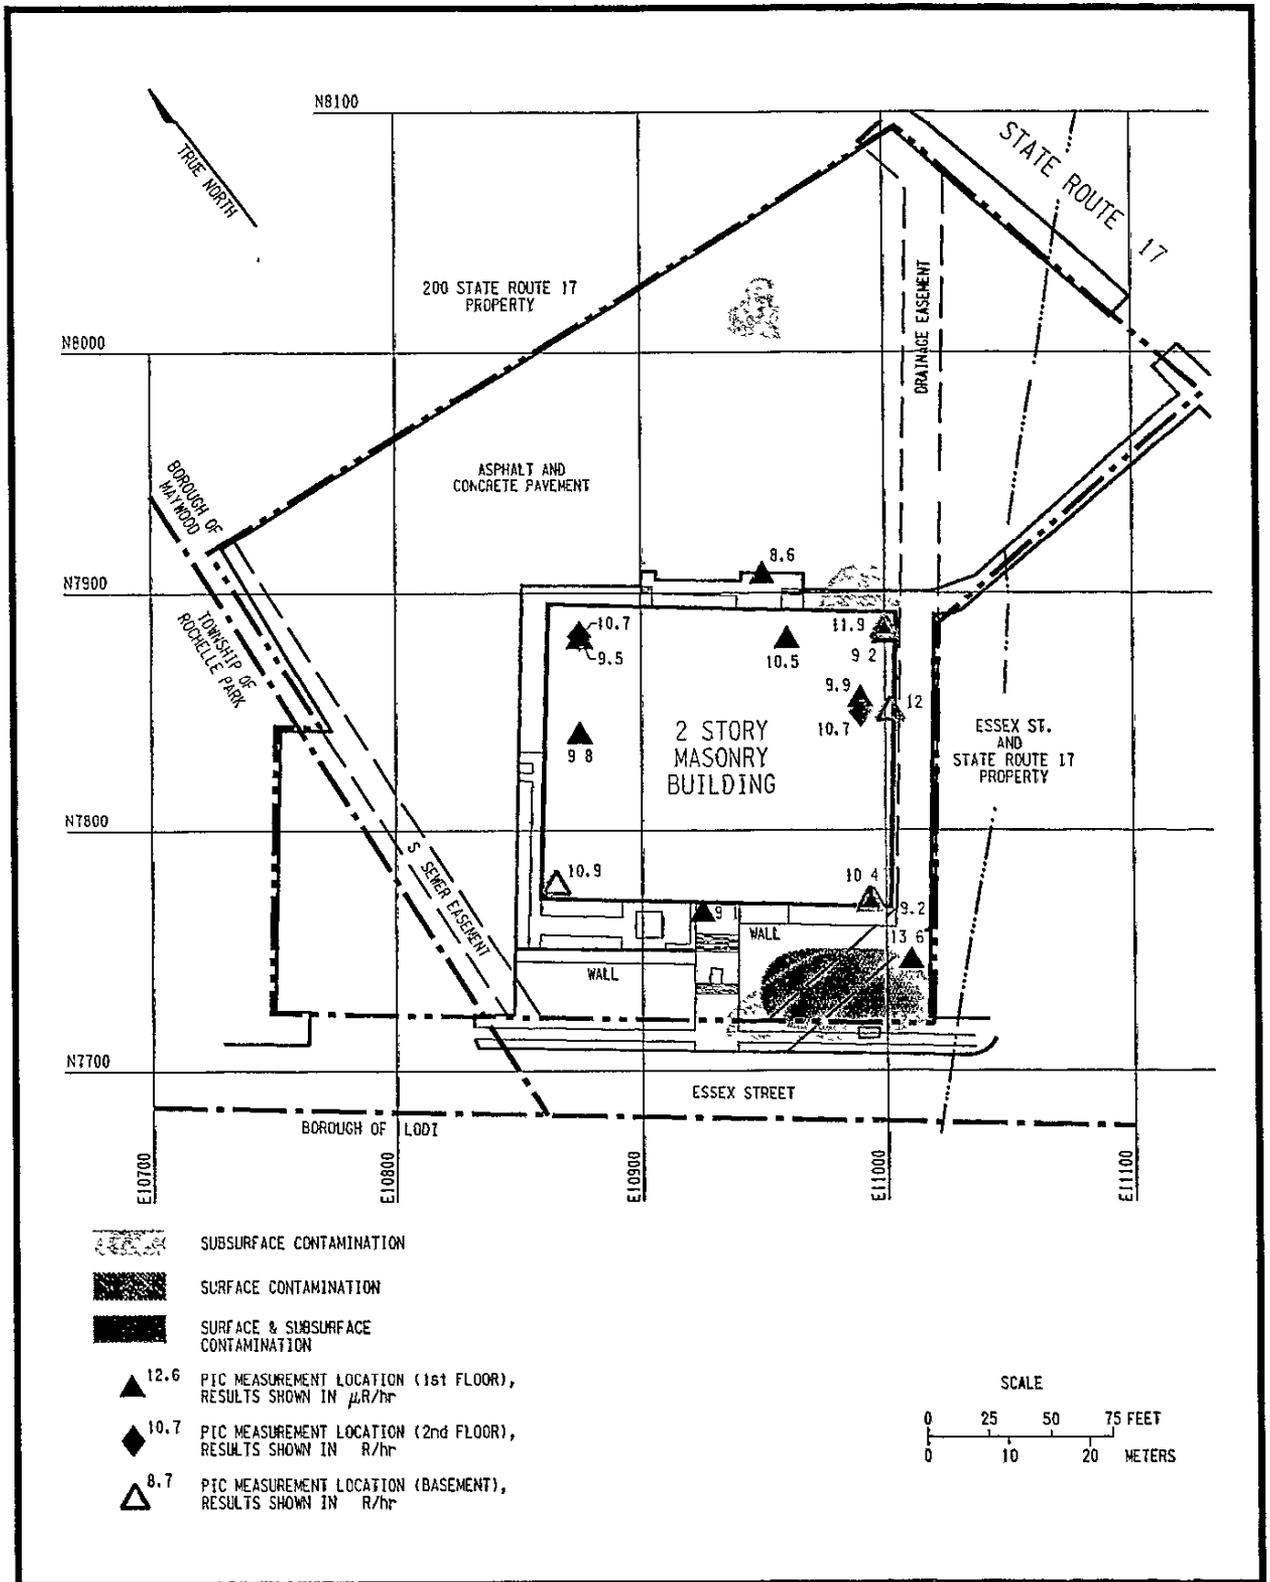
Figure 4-3
PIC Measurement Locations and Areas of Contamination at
National Community Bank 113 Essex Street

DOE guideline for habitable structures of 20 $\mu\text{R}/\text{h}$ above background. Figure 4-3 shows the locations and the data for each of these measurements.

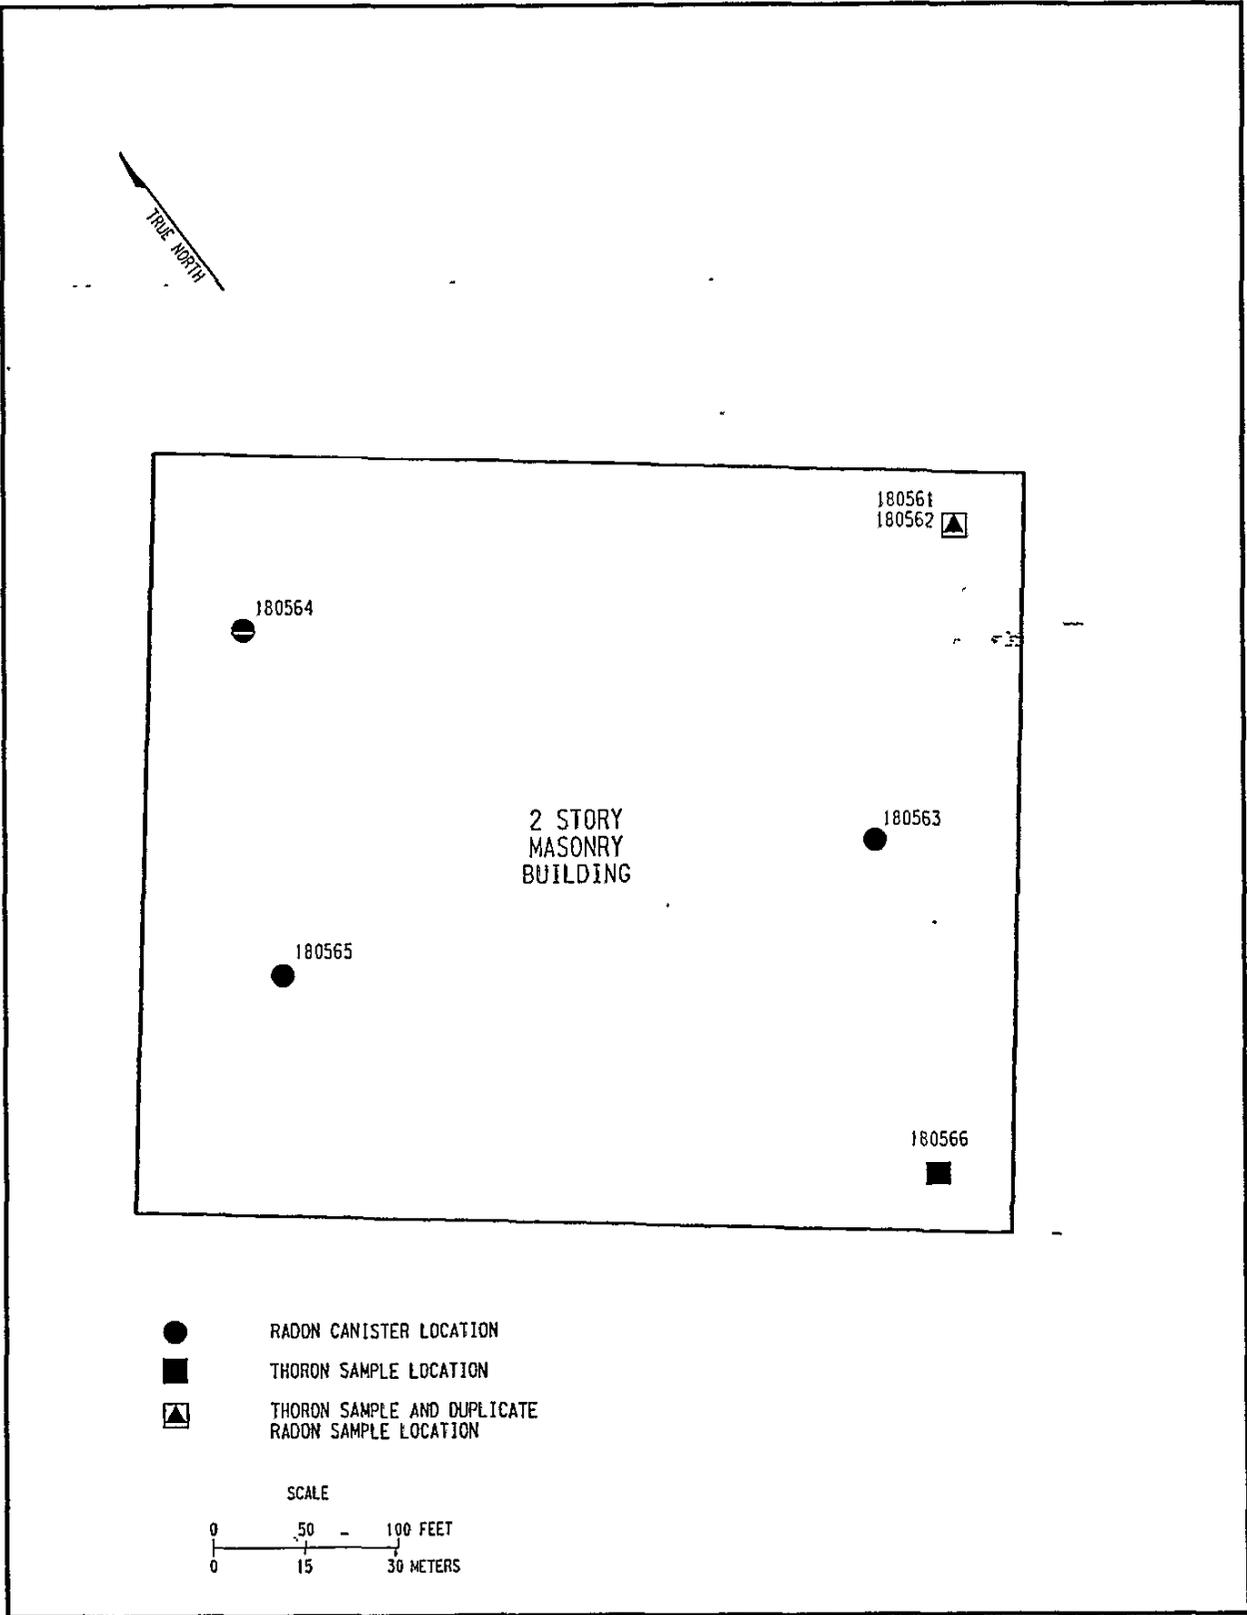
Figure 4-4
 Locations of Radon Canisters in the Basement
 at National Community Bank 113 Essex Street

Radon concentrations were measured by deploying 12 activated charcoal canisters throughout the basement and first floor of the building. Analytical results indicated concentrations ranging from less than 0.2 to 0.6 pCi/L, all within background. These concentrations are well below the DOE guideline of 3.0 pCi/L above background (background is 1.0 pCi/L for the Maywood site). Locations of the radon canisters are shown in Figures 4-4 and 4-5; data for each canister are presented in Table 4-2.

During previous characterization activities at this property (BNI 1992a), radioactively contaminated soil was identified at the rear of the building (eastern corner) and at the front of the building (southern corner). This contamination is probably the result of overbank deposition of contaminated material transported by the former channel of Lodi Brook that once flowed across this property. Because of the presence of this material, three of the canisters were analyzed for thoron concentrations. Concentrations of thoron ranged from less than 0.9 to less than 1.0 pCi/L (within background) and do not exceed the DOE guideline. DOE is reviewing the guideline for thoron at present and therefore currently applies the same guideline for thoron as for radon of 3.0 pCi/L above background. Figure 4-4 shows the location of the canisters analyzed for thoron, and Table 4-2 presents the data.

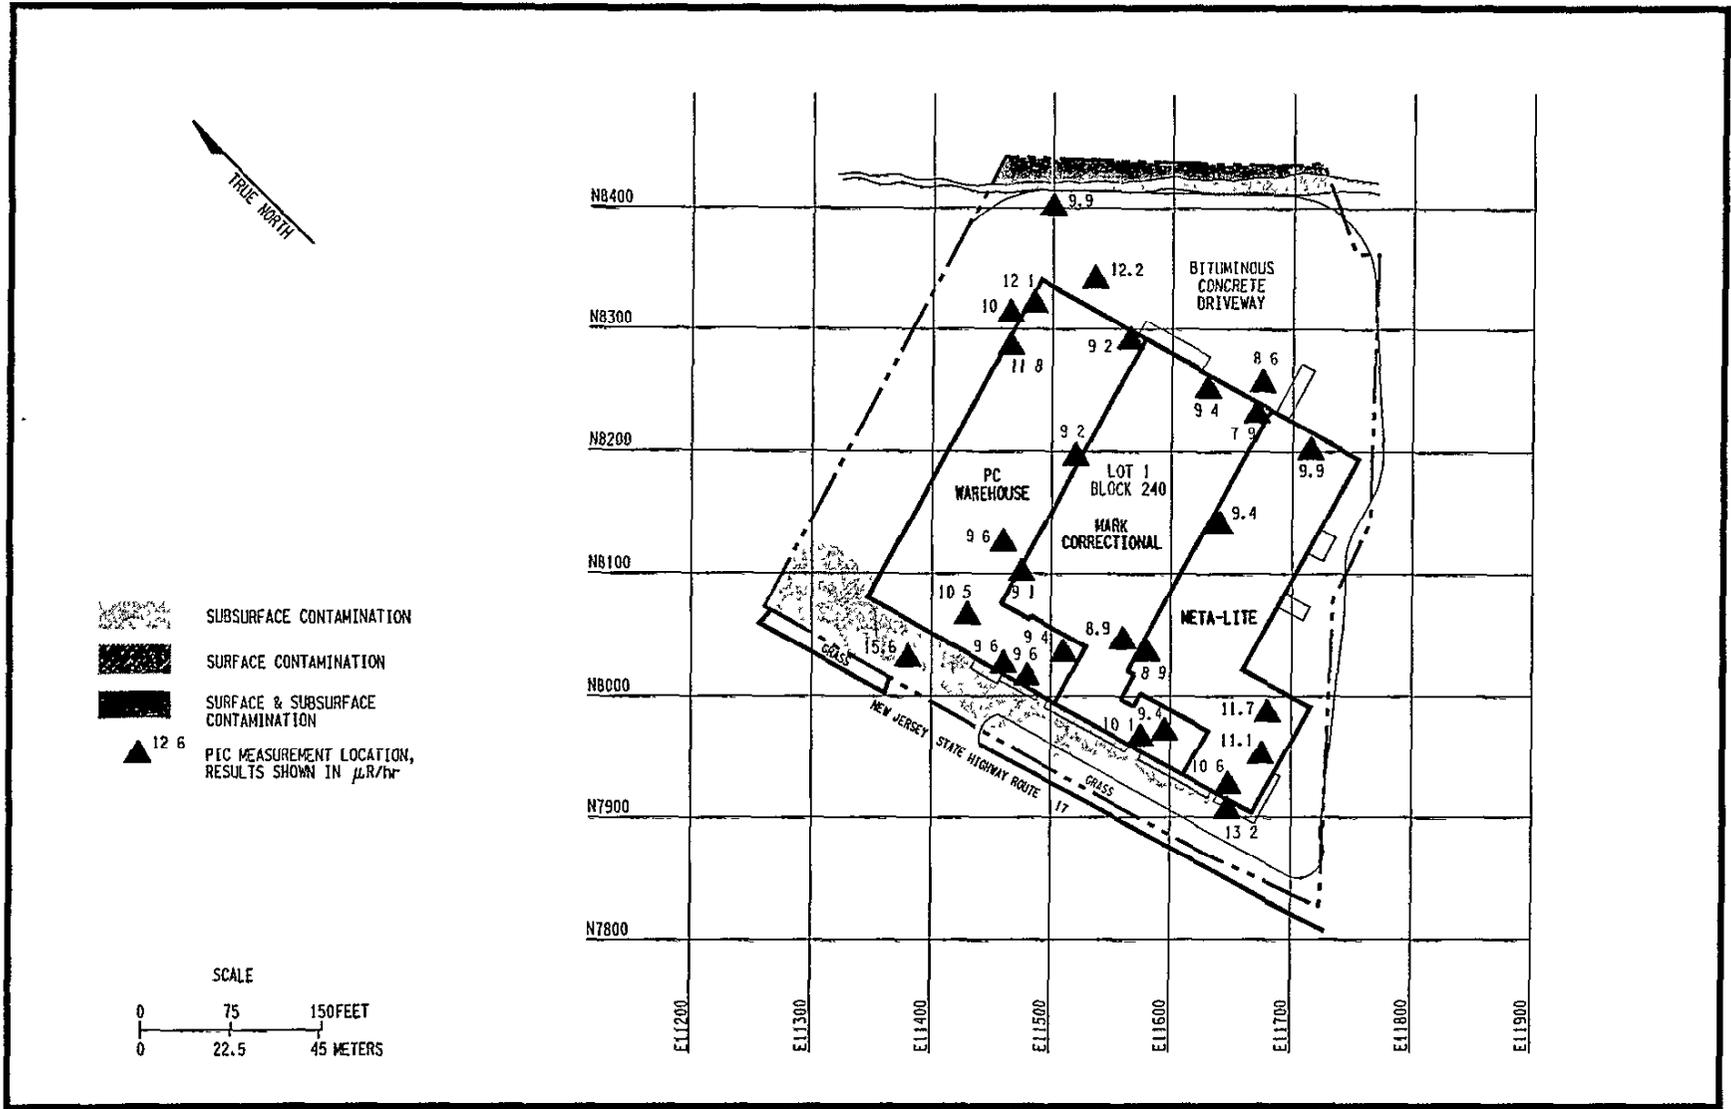
Figure 4-6
PIC Measurement Locations and Areas of Contamination at the
Former Hunter Douglas Property 85-99 Route 17 North

Six interior gamma exposure rate measurements were obtained at Meta-Lite. The measurements ranged from 8.9 to 11.7 $\mu\text{R}/\text{h}$, including background. The highest measurement, 11.7 $\mu\text{R}/\text{h}$, was obtained in the manufacturing area (see Figure 4-6) but does not exceed the DOE guideline of 20 $\mu\text{R}/\text{h}$ above background. The exterior gamma exposure rate measurements ranged from 8.6 to 15.6 $\mu\text{R}/\text{h}$, including background. The highest measurement, 15.6 $\mu\text{R}/\text{h}$ including background, was obtained in the parking area in front of the building and may be the result of granitic material mixed with the asphalt pavement covering the area. There is no known radioactive contamination present at this location. There are no previous external gamma radiation data for comparison with the data collected during this investigation. However, the exterior measurements at this property are consistent with the range of exterior gamma exposure rate measurements at neighboring properties.

Six interior and six exterior gamma exposure rate measurements were made at this property. The locations of these measurements and the data are shown on Figure 4-6. Interior gamma exposure measurements ranged from 7.9 to 10.1 $\mu\text{R/h}$ and were within background. Average background for the Maywood site is 9 $\mu\text{R/h}$. These measurements do not exceed the DOE guideline of 20 $\mu\text{R/h}$ above background for habitable structures. The range of exterior gamma radiation measurements was 8.6 to 15.6 $\mu\text{R/h}$, including background. The highest exterior measurement, 15.6 $\mu\text{R/h}$ including background, was obtained in the parking area at the front of the building and may be the result of granitic material mixed with the asphalt pavement covering the area. There is no known radioactive contamination at this location.

Nine interior and six exterior gamma exposure rate measurements were obtained at the PC Warehouse property. Figure 4-6 shows the location and data for each of these measurements. Interior gamma radiation measurements ranged from 9.2 to 12.1 $\mu\text{R}/\text{h}$, including background. The highest measurement, 12.1 $\mu\text{R}/\text{h}$, was recorded in northwest corner of the facility but does not exceed the DOE guideline of 20 $\mu\text{R}/\text{h}$ above background for habitable structures. The exterior gamma exposure rate measurements were the same as those for the two other tenants of the former Hunter Douglas, ranging from 8.6 to 15.6 $\mu\text{R}/\text{h}$, including background.

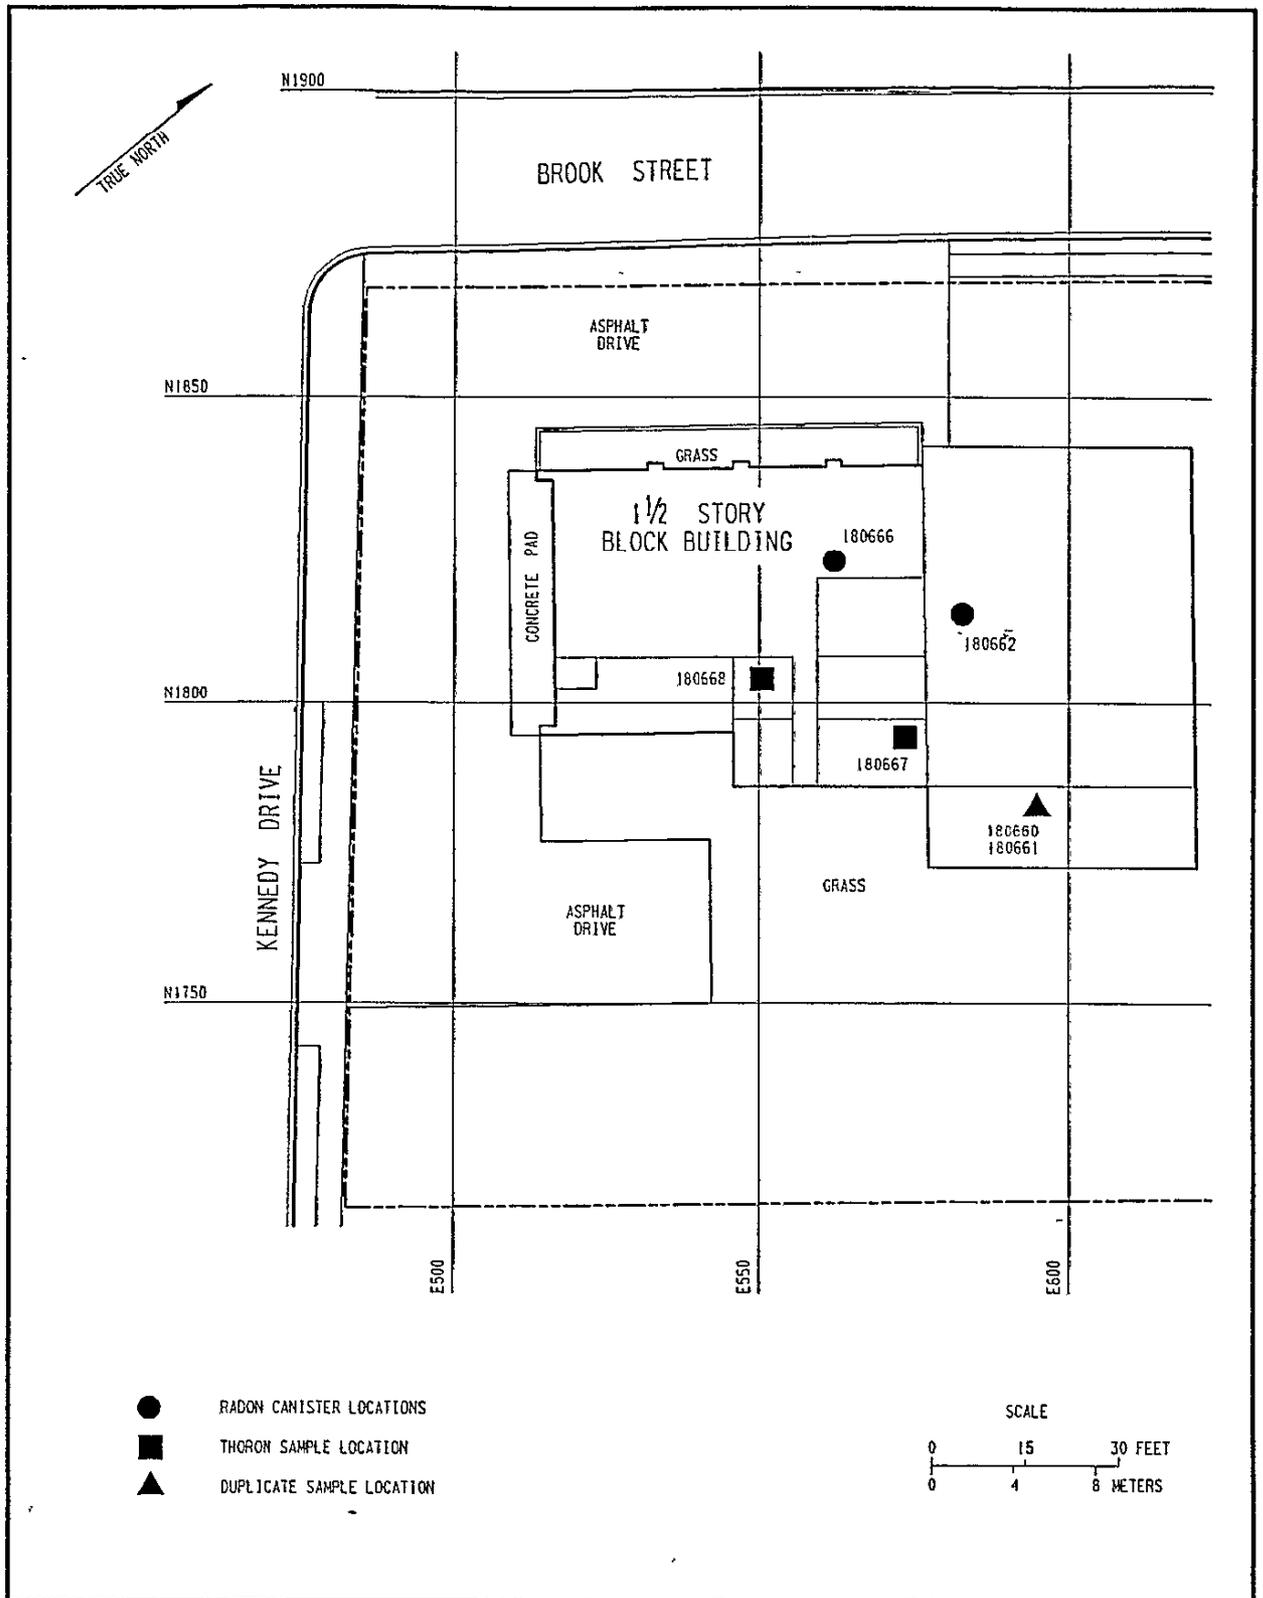
Figure 4-51
 PIC Measurement Locations and Areas of Contamination at the
 Fire Station No. 2 Property Kennedy Drive and Brook Street

Three interior and five exterior gamma exposure rate measurements were made at the fire station property. Figure 4-51 shows the locations of these measurements. The interior measurements ranged from 9.9 to $10.5 \mu\text{R/h}$ and were within background. The locations of the highest interior measurements, $10.5 \mu\text{R/h}$, were the women's restroom and the equipment

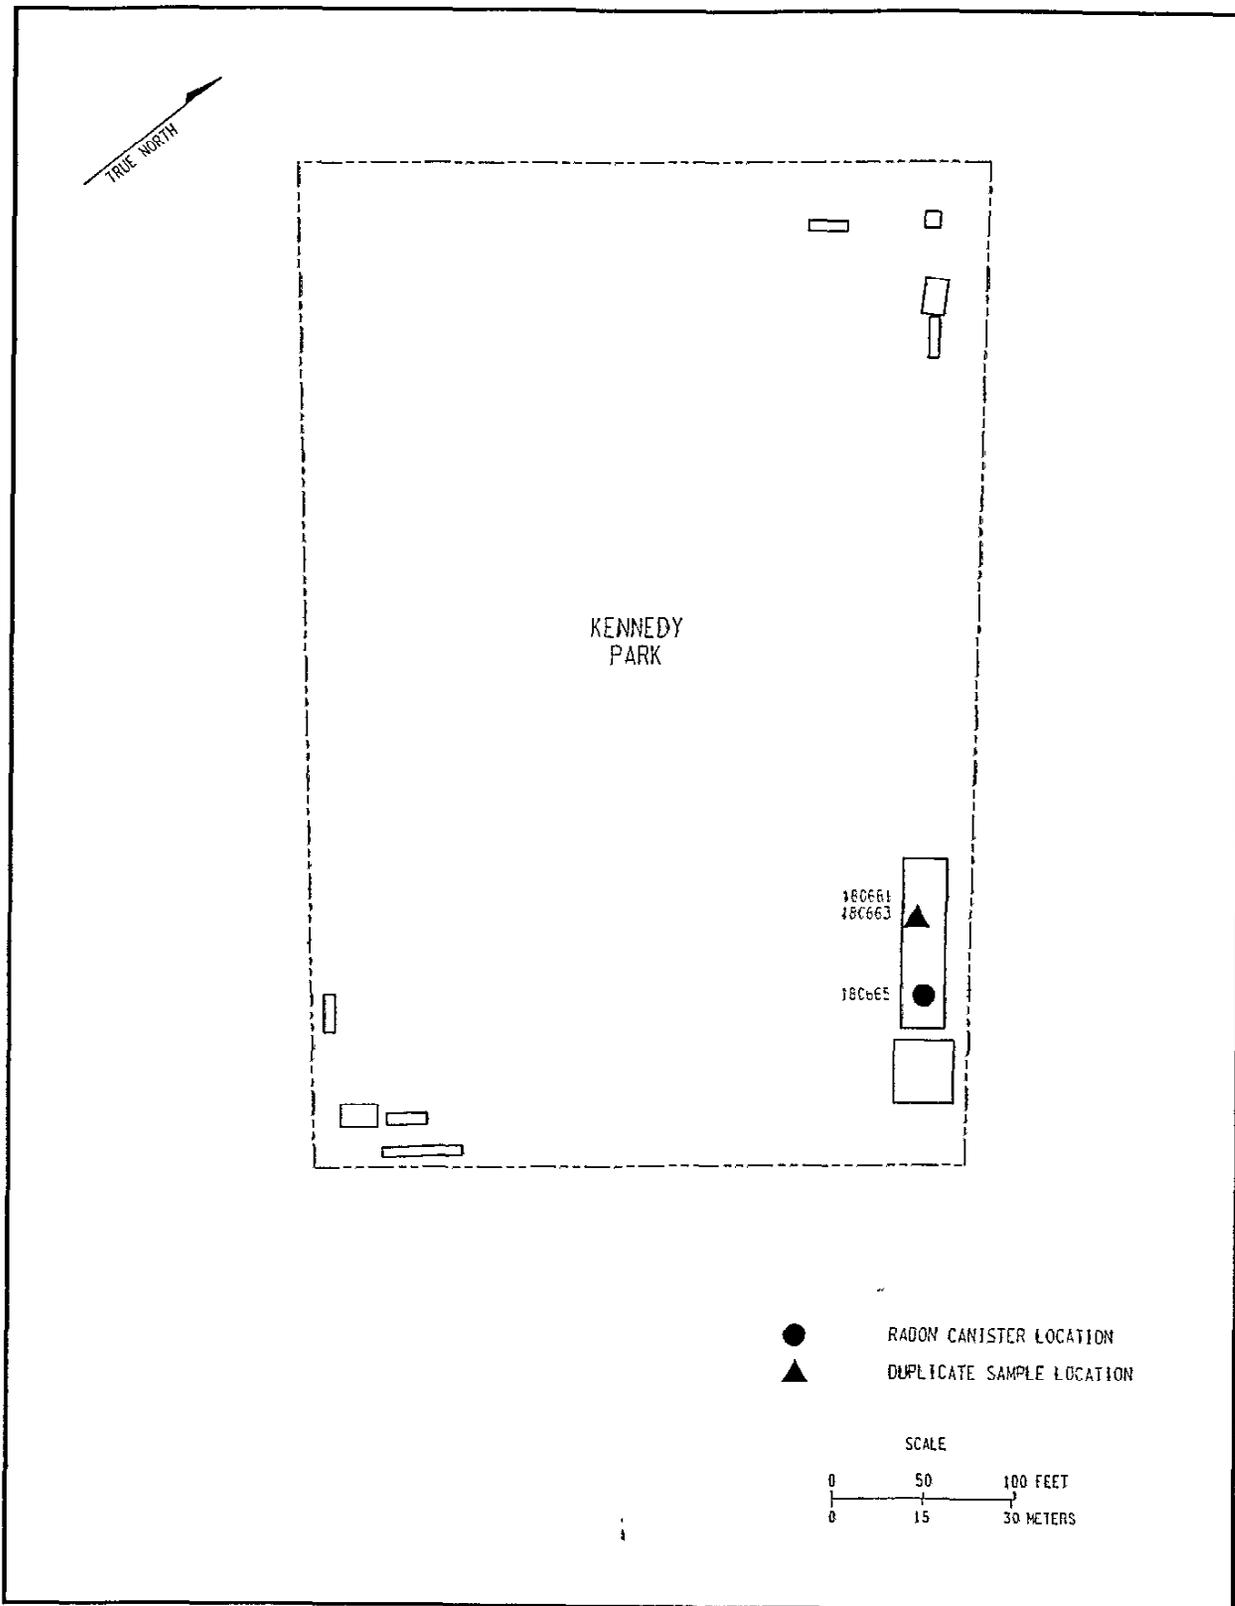
Figure 4-53
 PIC Measurement Locations and Areas of Contamination
 at John F. Kennedy Park
 Kennedy Drive and Money Street

The two interior gamma exposure rate measurements made in the park building (see Figure 4-53) were 8.6 $\mu\text{R/h}$ in the maintenance area and 9.3 $\mu\text{R/h}$ in the office area. These measurements are within the range of background, which is 8 to 12 $\mu\text{R/h}$. No radioactive contamination is known to be present beneath the building. The seven exterior gamma exposure rate measurements ranged from 8.2 to 12.3 $\mu\text{R/h}$ and were within background. Radioactively contaminated soils are known to be present at the end of the park bordered by Money Street. These soils were identified during radiological characterization of the property in 1987 (BNI 1989g), and this area is suspected to be near the original channel of Lodi Brook before it was contained in conduit during development of the area. The measurement of 12.3 $\mu\text{R/h}$, including background, was obtained in this area. The interior gamma exposure rate measurements do not exceed the DOE guidelines of 20 $\mu\text{R/h}$ above background for habitable structures. Data from these measurements were compared with data recorded during the 1987 radiological characterization of this property (BNI 1989g). Exterior gamma radiation measurements in 1987 ranged from 5 to 22 $\mu\text{R/h}$ (background has not been subtracted). Comparison of the data from this investigation indicates no significant changes at this property.
